Final Technical Report

A Multi-Sensor Approach for Measuring Bird and Bat Collisions with Offshore Wind Turbines

Prepared by:
Western EcoSystems Technology, Inc.

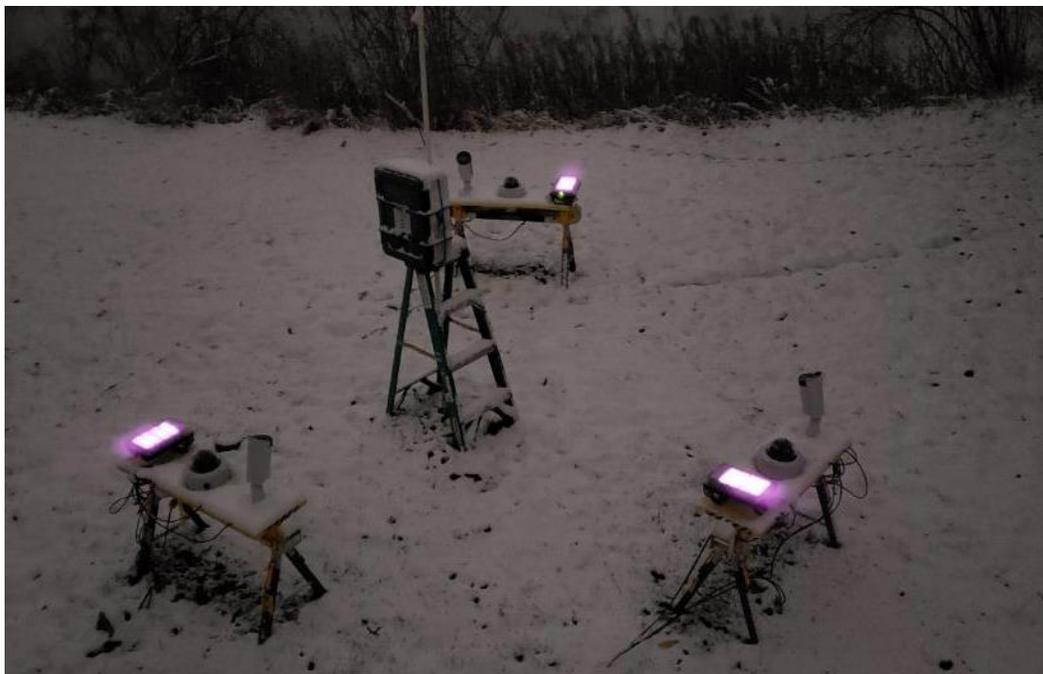
Figure 3.1. Stationary camera setup in Roseville, Minnesota, during an overnight snow in November 2021.

The camera setup was similar at each of the four survey locations. The team placed the cameras on stationary observation platforms (modified sawhorse) positioned in an equilateral triangle surrounding the turbine (NWTC and Hendricks) or within a smaller area (Roseville and Mount Desert Rock). The team roughly leveled and anchored the observation platforms in place to minimize movement with either bags of sand and gravel or tie-downs (Figure 3.1). In all cases, we aimed the cameras (spectral and thermal) upward, ensuring the camera views focused on the extent of the turbine hub and blades, where available, ensuring visual overlap with the adjoining cameras to make sure birds and bats that flew through the area would be captured. Visual cameras switched to gray-scale at night and were supported by IR illuminators (Figure 3.1). On-site electricity powered all camera equipment, and we transmitted power and data from the cameras via PoE cables to a network area storage device kept in a nearby building or turbine. At the NWTC, the data cables were connected to the WT-Bird[®] system. The team used thermal cameras as a contrasting image platform for day and night, particularly to verify bat presence during nighttime data collection. We set visual cameras to the maximum resolution and recorded 2.5 fps. Thermal cameras recorded 30 fps at their maximum resolution, but their field of view was less than 25% of the visual cameras. To summarize camera footage captured, we counted the number of days per camera with complete footage and reported that as the count of camera days.

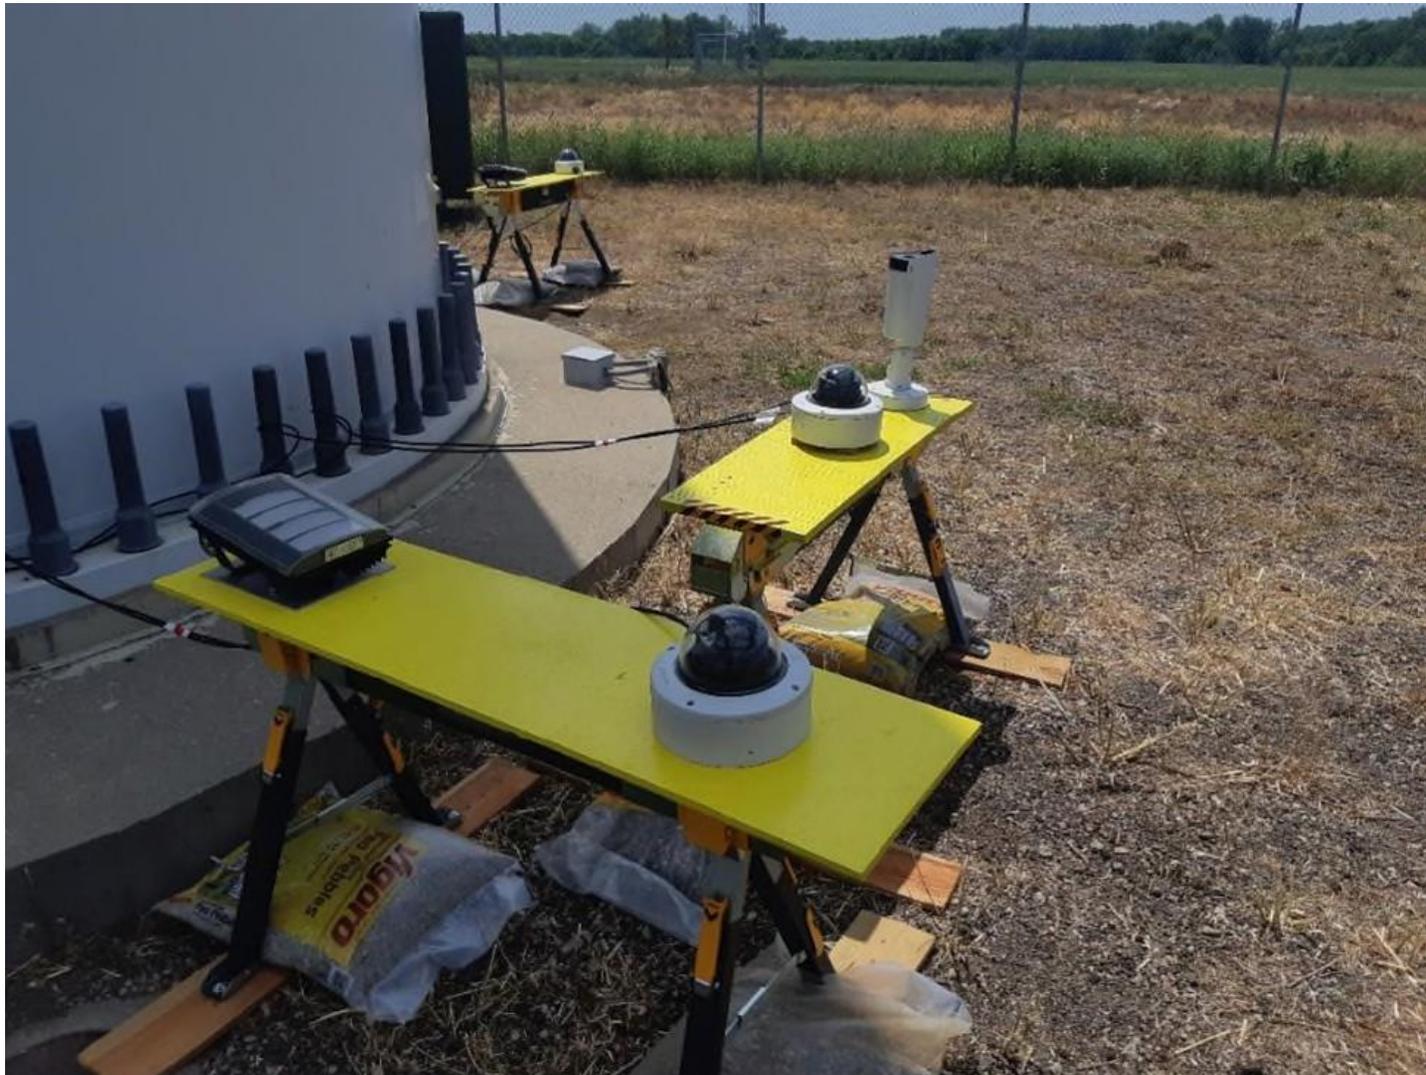
Figure 4.1. The camera stations at the University of Minnesota Eolos Wind Turbine, Dakota County, Minnesota.

model development (Task 3). The second camera at each station was an Axis (Q1942-E) thermal camera equipped with 35-mm lenses; we had also previously used this camera during Task 3 deployments. This thermal camera recorded video in 640 x 480 resolution and 30 fps. The thermal cameras were set to record continuously, and the Sony color cameras were programmed to save one image per second at night and 2.5 images per second during the day. Our team used the thermal camera data specifically for development of the computer vision algorithm and detection of birds and bats, while the Sony color cameras provided better resolution data during the daytime. The three Sony color cameras were supported at night by an Axis IR illuminator (T90D40 IR-LED) at each camera station. The IR illuminators automatically initiated operations in low-level visible light conditions based on the integrated low-light sensor; low-light sensor was set as sensor default and observed to activate after sunset and prior to civil twilight, and other periods of low-level visible light. The WT-Bird[®] system received constant video feed from the Sony color cameras via PoE cables, which provided power and transmitted data from cameras to in-turbine computer components (WT-Bird[®] or WEST storage). Similarly, the Axis thermal cameras received power via a PoE cable and transmitted data back to WEST data storage. The illuminators were powered by a dedicated electrical cable from the turbine.

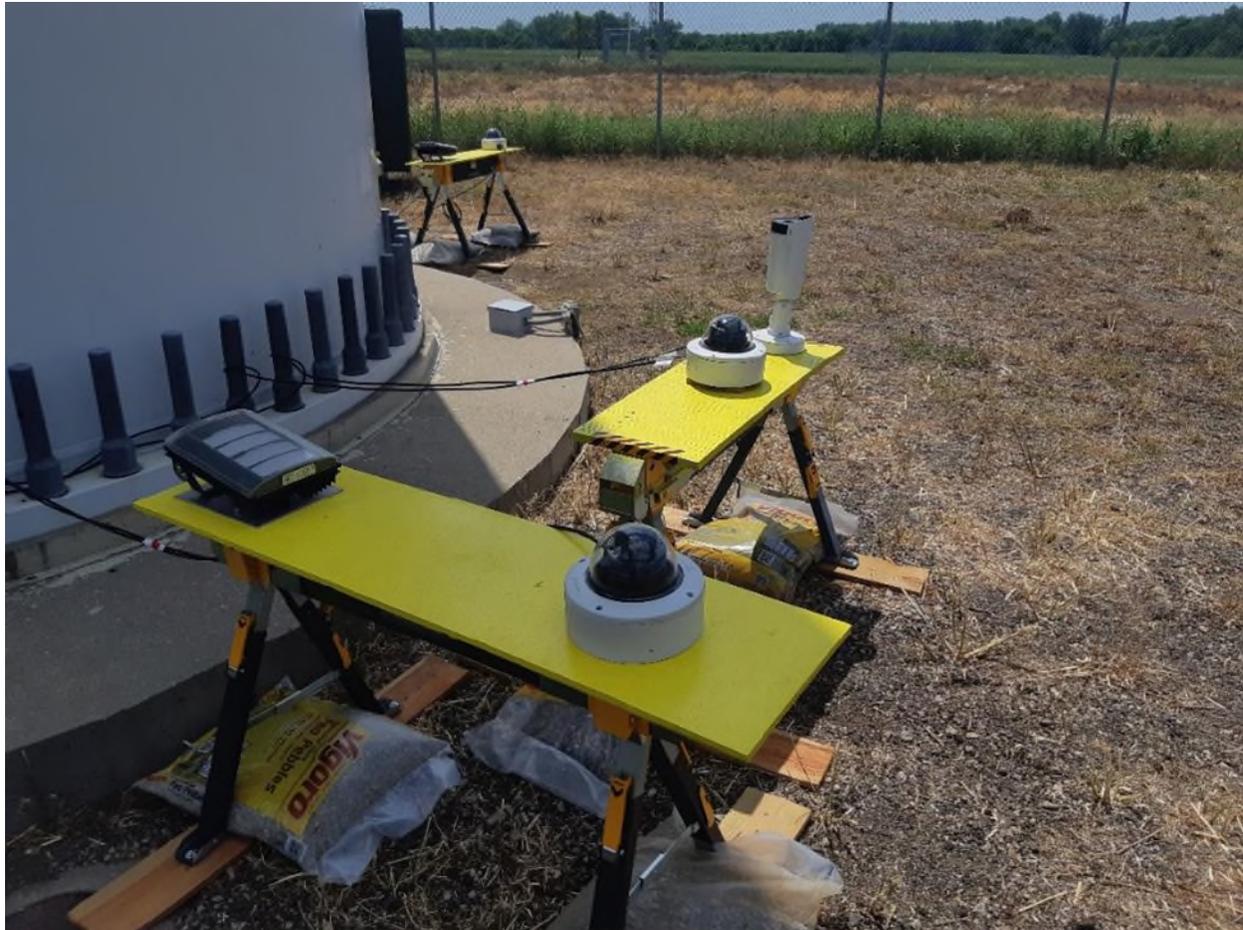
Figure 1. The camera stations at the University of Minnesota Eolos Wind Turbine, Dakota County, Minnesota.

The 2022 camera monitoring system consisted of camera stations located approximately one to two m from the turbine base at a location similar to the expected turbine platform railing location on an offshore turbine. Cameras and illuminators were installed on a modified adjustable-height sawhorse, stabilized with 50-pound bags of gravel (Figure 1). During 2022, the three paired camera stations were spaced equidistantly around the turbine tower with the cameras facing upwards and the field of view centered on the turbine nacelle. Each camera station included a Sony SNC-VM772R color camera with an 8.8-millimeter (mm) focal length and 5,472x3,648 resolution; the Sony cameras were used previously in the WT-Bird® deployment at NREL and for data collection in Task 2 and during WEST's computer vision model development (Task 3). The second camera at each station was an Axis Q1942-E thermal camera equipped with 35-mm lenses; this camera was also previously used during Task 3 deployments. This thermal camera recorded video in 640x480 resolution and 30 frames per second. The thermal cameras were set to record continuously, and the Sony color cameras were programmed to save 1 image per second at night, and 2.5 images per second during the day. The thermal camera data was used specifically for development of the computer vision algorithm and detection of birds and bats, while the Sony color cameras provided better resolution data during the daytime. The three Sony color cameras were supported at night by an Axis infrared (IR) illuminator (T90D40 IR-LED) at each camera station. The IR illuminators automatically initiated operations in low-level visible light conditions based on the integrated low-light sensor. The WT-Bird® system received constant video feed from the Sony color cameras via power-over-ethernet (PoE) cables, which provided power and transmitted data from cameras to in-turbine computer components (WT-Bird® or WEST storage). Similarly, the Axis thermal cameras received power via a PoE cable and transmitted data back to WEST data storage. The illuminators were powered by a dedicated electrical cable from the turbine.

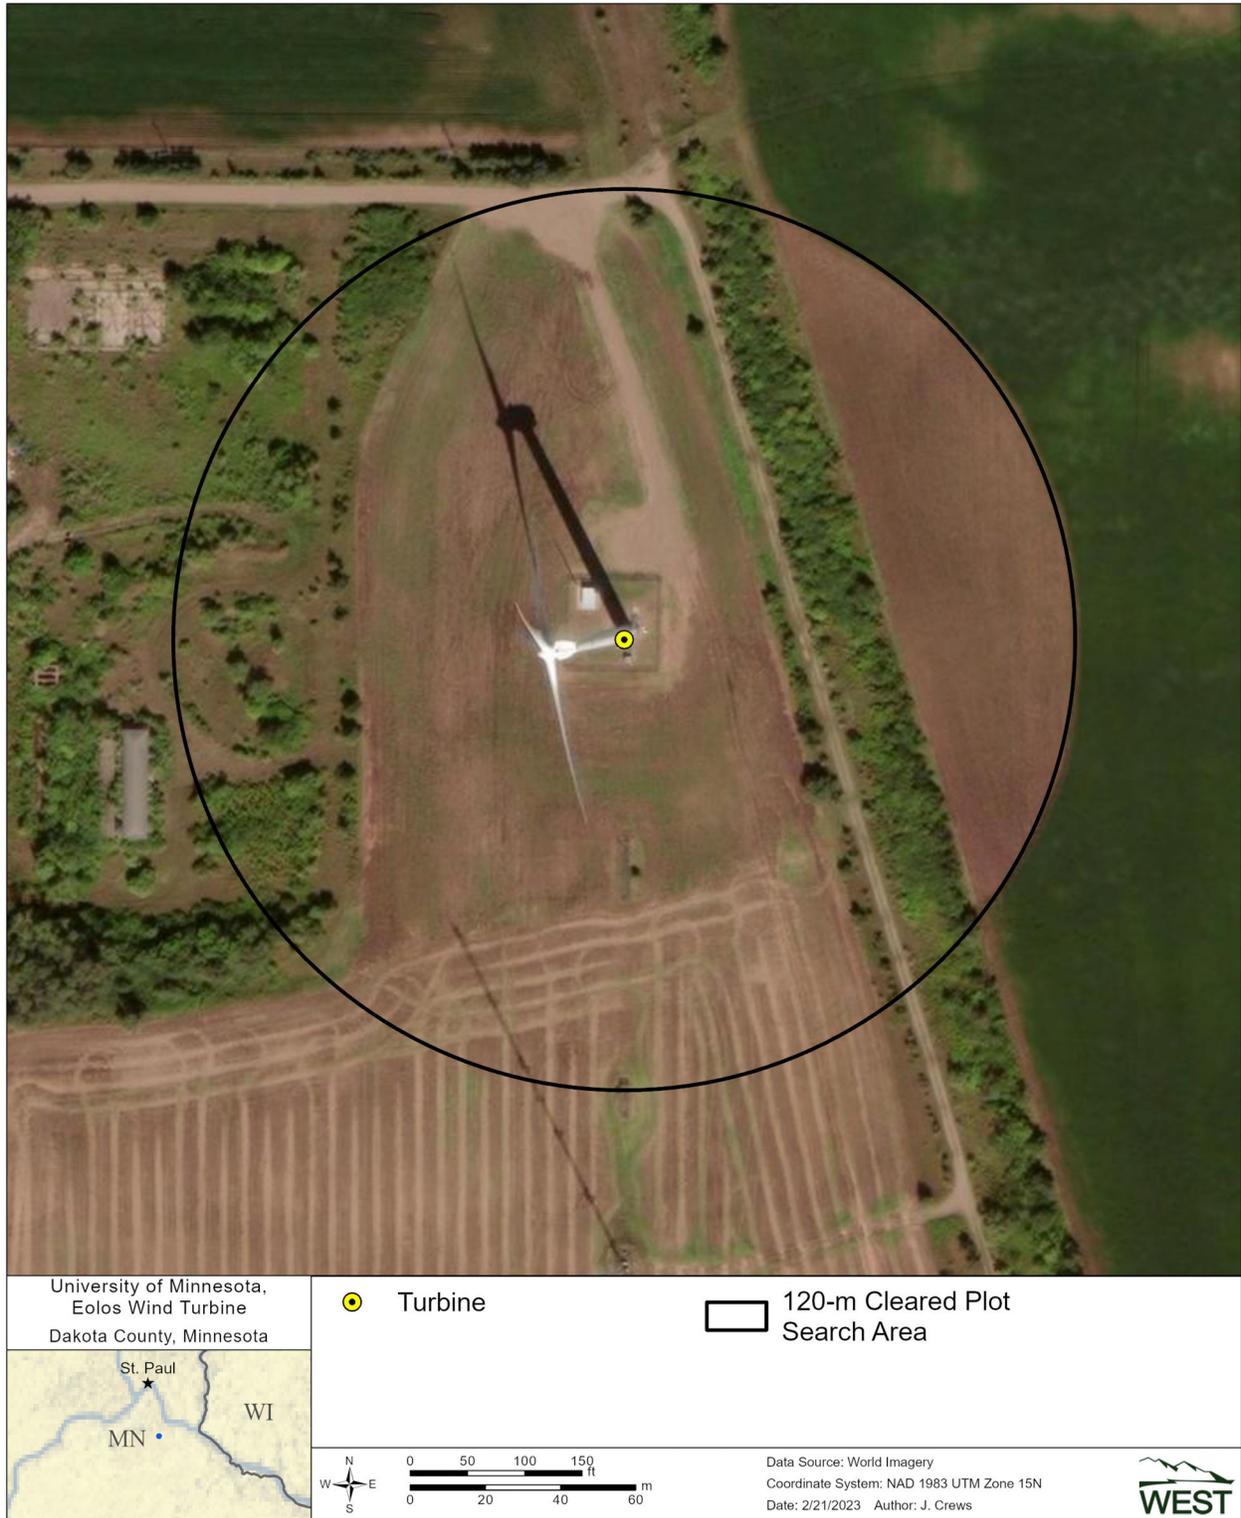
Figure 2. Schematic illustrating the cleared plot search area of the University of Minnesota Eolos Turbine at the Rosemount Research Station, Dakota County, Minnesota.

Searchers walked transects six m apart at a pace of approximately 45–60 m per minute looking for carcasses. While walking transects, searchers would scan both sides out to three m for fatalities within the plot. All areas within the plot were searched. To the extent possible, searches were rotated throughout the day so that plots were surveyed during all daylight periods (i.e., morning, midday, and afternoon).

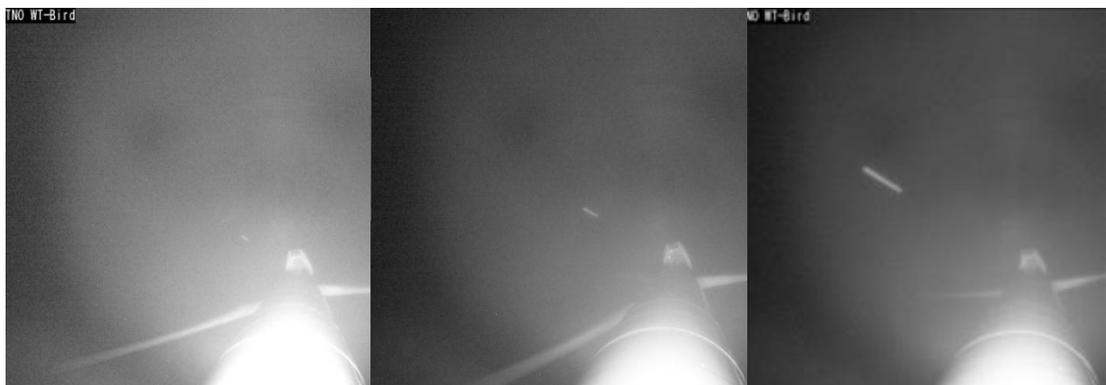
Figure 3.13: Pictures of collision 26-08-2022 084520

Right after the collision something is falling down from hub height, depicted in Figure 3.13. This is recorded by the day cameras.
