## **Geophysical Surveys of the Wave Energy Test Site at MCBH, Kāneʻohe**

Prepared by:  
Sea Engineering, Inc.

**GEOPHYSICAL SURVEYS OF THE WAVE ENERGY TEST  
SITE (WETS) AT MCBH, KANEOHE**

**OAHU, HI**

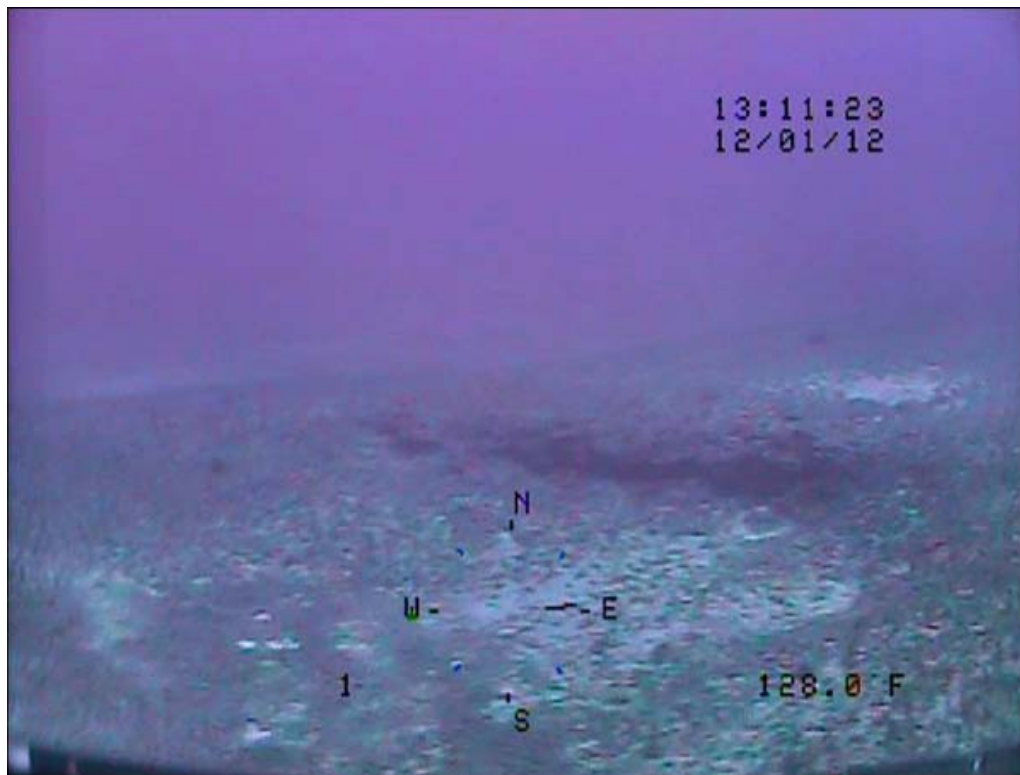
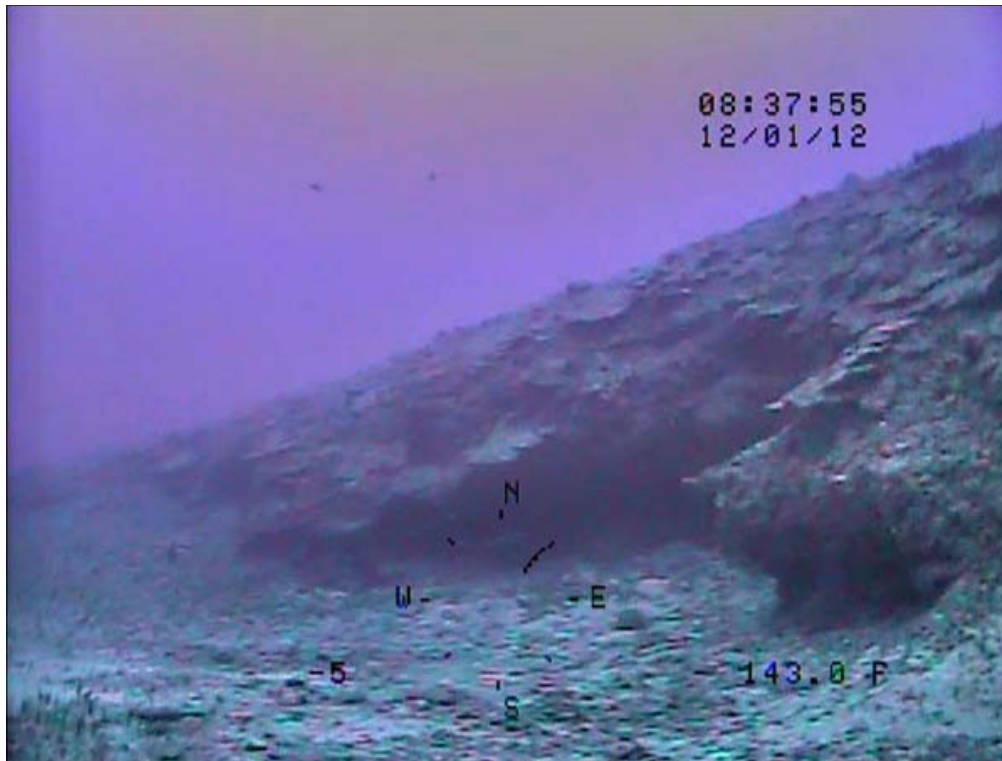
2. Steeply sloping escarpment - A steeply sloping, irregular escarpment is present at water depths between approximately 40 and 45 meters. Slopes as steep as 1V:8H occur between 40 and 45 meter water depths. Relief of 1 to 2 meters, spur and groove morphology, small ledges and scattered coral heads are typical in this zone. Figure 4-3 and Figure 4-4 are photographs of the bottom in this zone.

Figure 4-3. Reef ledge at 40 meter water depth (Site 14).

Figure 4-4. Ledge at 40 meter depth (Site 1).

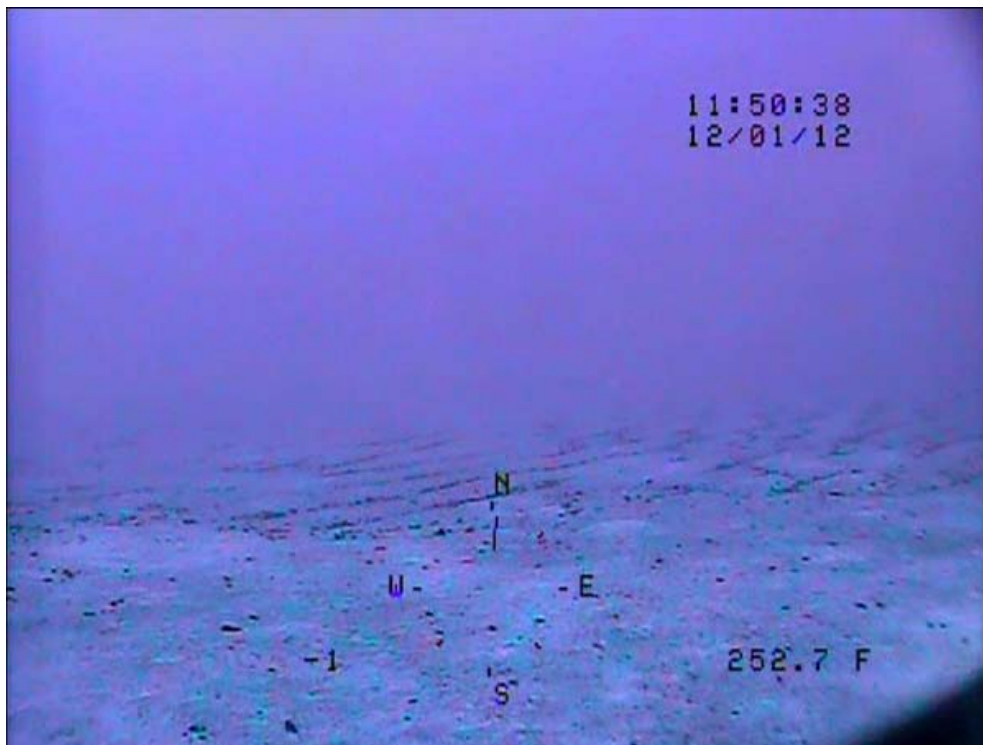
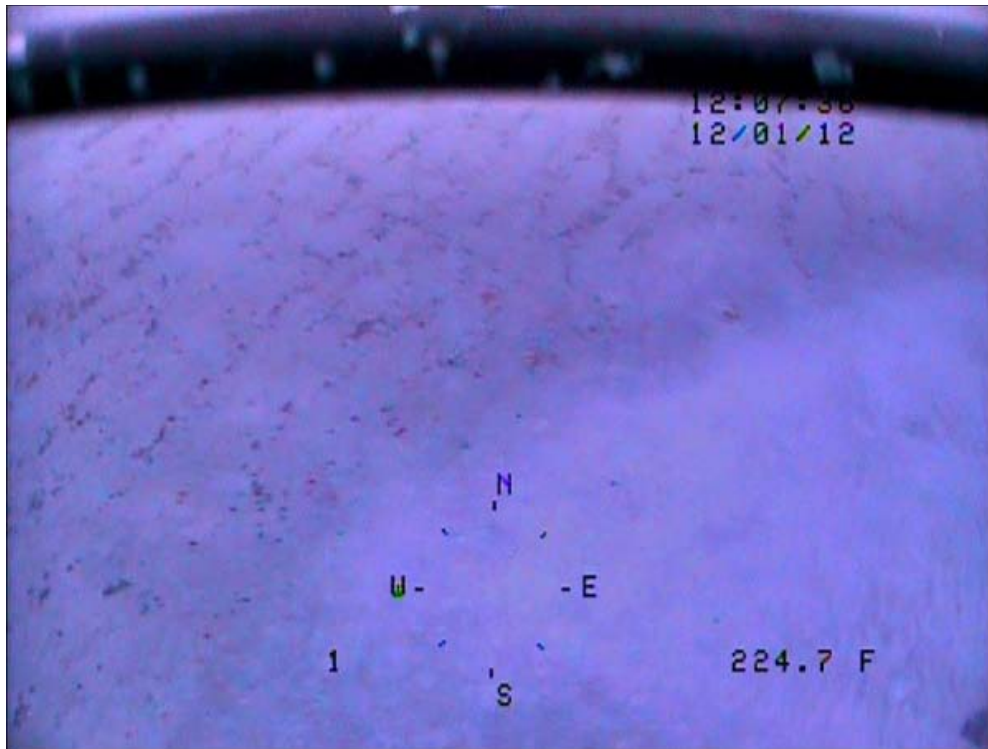
5. Reef limestone and sand less than 3 meters thick – Thin sand, typically less than 2 to 3 meters thick, with exposures of reef limestone bottom occurs seaward of the 70-meter depth in the eastern part of the project site. The barchan dune bedforms are present in water depths of 72 to 82 meters in the northeastern corner of the site. The dunes are only 1-2 meters thick, and 150 to 200 meters long, and up to 100 meters wide. Figure 4-9 and Figure 4-10 are representative photographs of the bottom in this zone.

Figure 4-9. Edge of a Barchan feature at Site 11 at a water depth of 77 meters. Barchan sand is visible in the foreground. Thin sand with ripples with pebbles and algae in the trough are visible beyond the Barchan.

Figure 4-10. Transition from thin, rippled sand with cobbles (upper left) to thick sand (lower right) at Site 9 in a water depth of 76 meters.
