# Shetland Tidal Array Monitoring Report July 2024 to June 2025

*Revision 1.0*

| Document ID: | STA-016 |

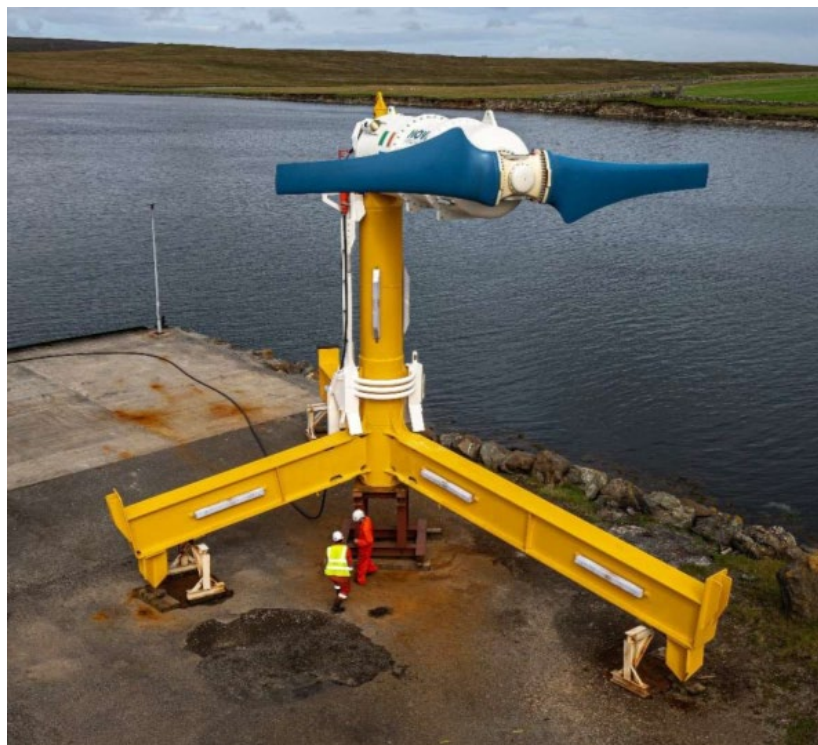
**Figure 3-2:** The Nova M100-D turbine. *Source: Nova Innovation.*

During the current reporting period (July 2024 to June 2025), the Shetland Tidal Array comprised three Nova M100-D 100 kW direct drive tidal turbines.

Figure 3-2 shows an M100-D turbine on the quayside in Bluemull Sound, before being installed in the Shetland Tidal Array.

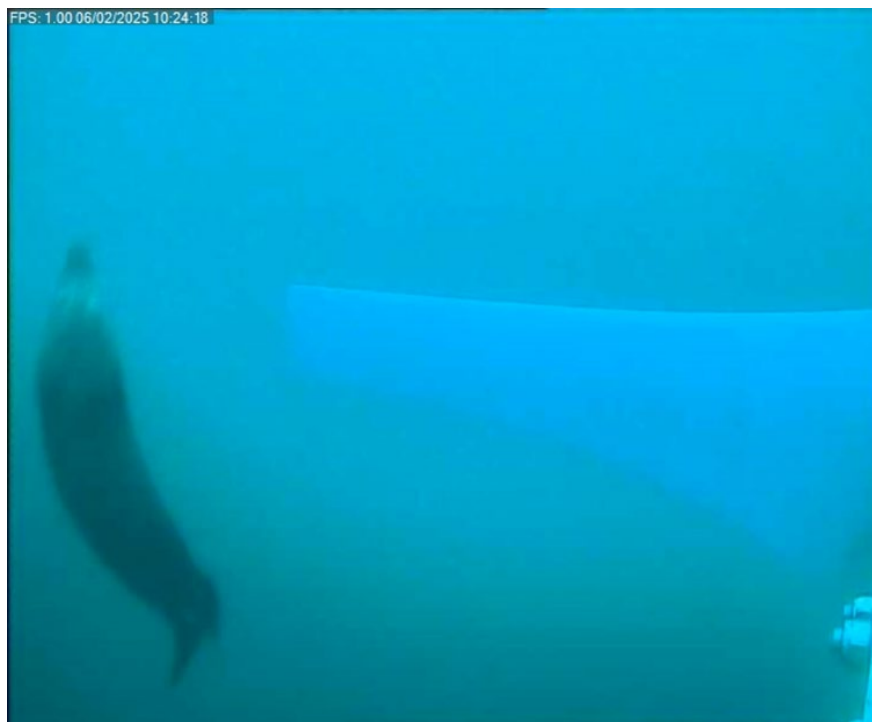
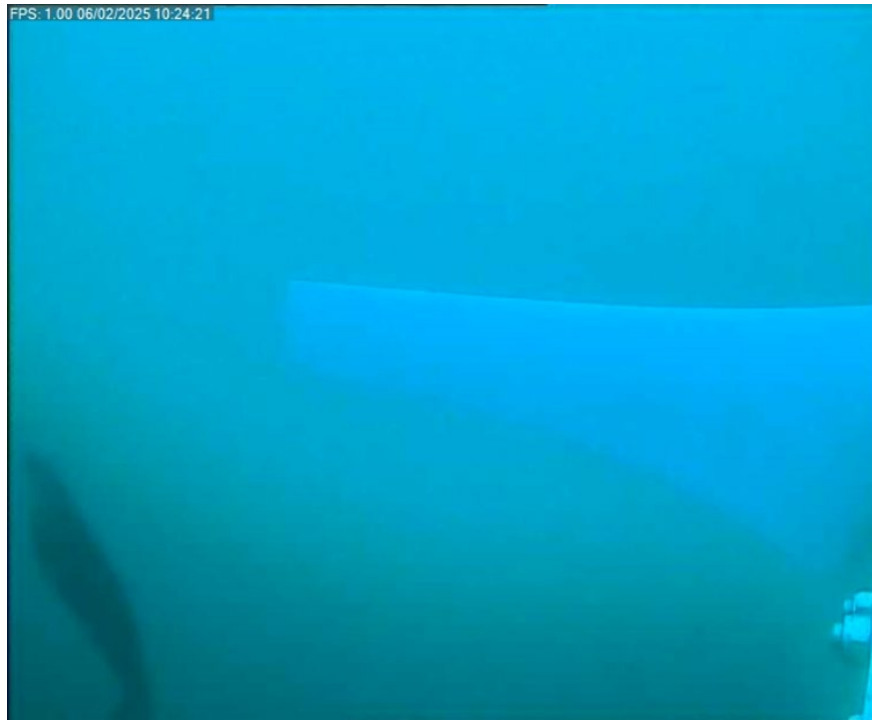
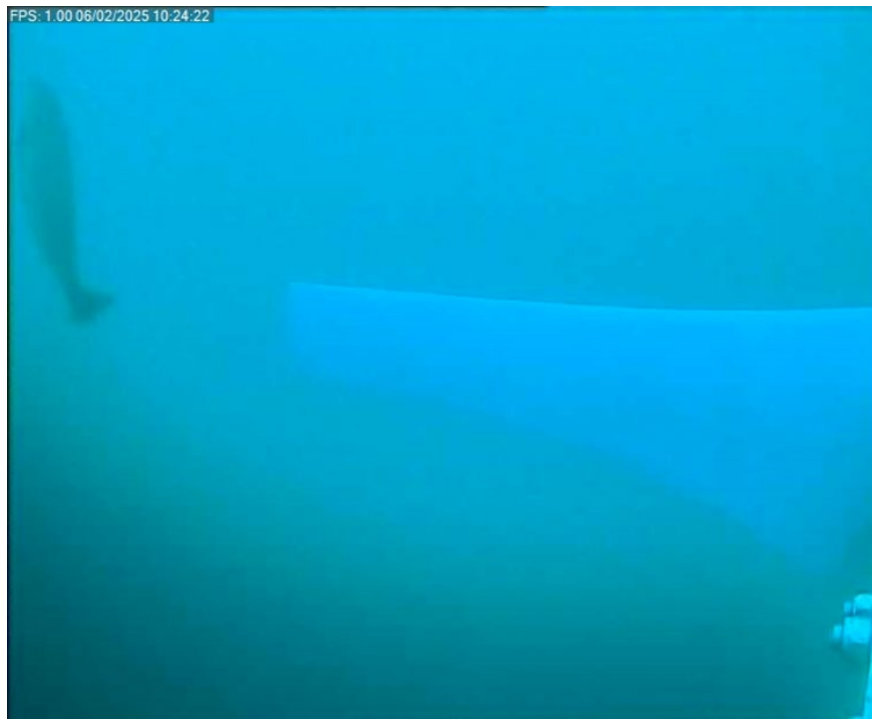
**Figure 6-1:** Harbour seal (*Phoca vitulina*) observed in video footage from T5 on 06/02/2025 at 10:24AM a) surfacing past the turbine nacelle, b) diving towards the seabed and c) resurfacing again past the nacelle.

Of the fourteen thousand, nine hundred and ninety-eight (14,998) files analysed in this report only one contained a confirmed occurrence of a single harbour seal (*Phoca vitulina*). The animal was observed three times in one 14 second video file at 10:24AM on 06/02/2025. The seal was observed surfacing past the nacelle of T5, then diving towards the seabed before resurfacing again. The turbine blades were stationary and the tidal state based on Nova's hydrodynamic model for Bluemull Sound was decreasing ebb/low water slack. Figure 6-1 shows still images of the sequence of harbour seal observations from this video file.

a) Harbour seal surfacing past the nacelle of T5.

**b) Harbour seal diving past the nacelle of T5.**

**c) Harbour seal surfacing again past the nacelle of T5.**

A confirmed harbour seal (*Phoca vitulina*) was observed three times in one video from T5 on the decreasing ebb/low slack tide, when tidal flow was less than 0.8 m/s and the turbine blades were stationary. There was a second possible occurrence of a seal (potentially the same animal), in a video from T6 also on 06/02/2025 at 10:14AM (decreasing ebb tide and stationary blades) some distance to the north of the turbine.

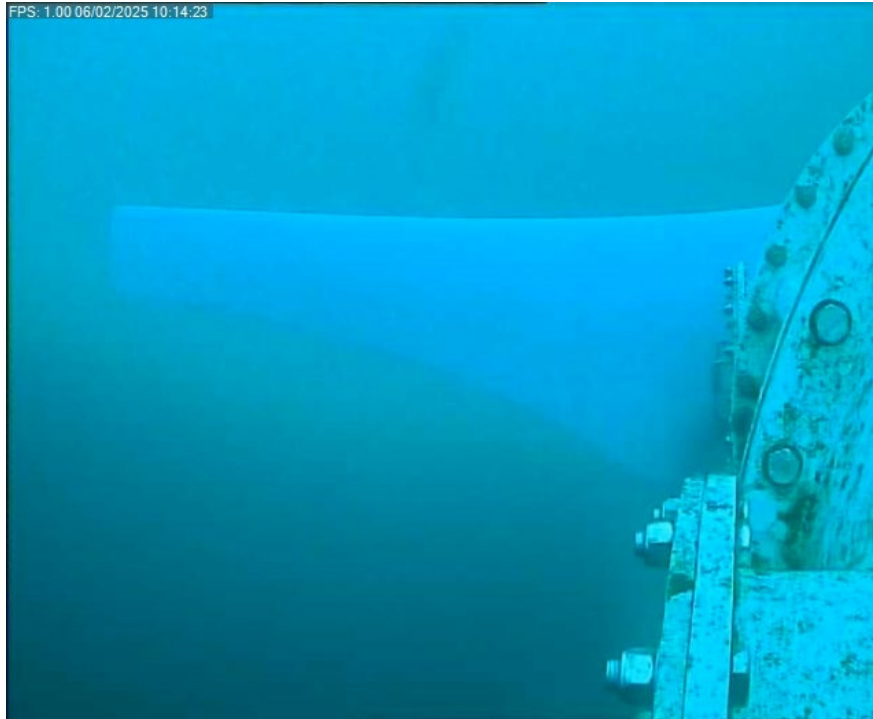
**Figure 6-2:** Possible harbour seal (*Phoca vitulina*) in video footage on 06/09/2024 at 10:14AM diving towards the seabed some distance to north of the turbine (T6).

Ten minutes earlier on the same day a dark object which appeared to be a seal diving towards the seabed was observed in a file captured from the camera on T6. The seal, shown in Figure 6-2, was some distance north of the turbine but may have been the same animal seen diving around the nacelle of T5, which is located to the north-west of T6 (see Figure 3-3). As with the images captured from T5, the turbine blades of T6 were stationary and the tidal state was decreasing ebb.
