**Screening for Biofouling and Corrosion of Tidal Energy Device Materials:
In-situ results for Admiralty Inlet, Puget Sound, Washington**

Northwest National Marine Renewable Energy Center Technical Memorandum

University of Washington, Seattle, WA, United States

April 8, 2010

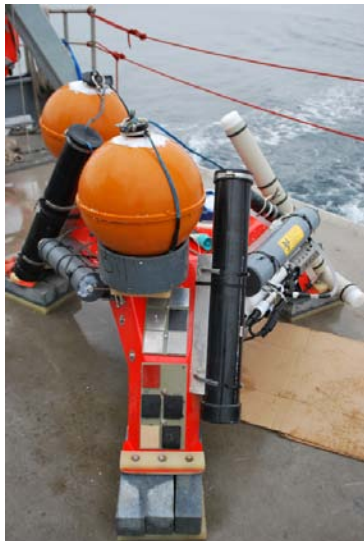
The test matrices consist of uncoated and coated coupons, nominally 2.5 inches wide, 2.25 inches long, and 0.125 inches thick. For expediency, coupons are attached to a fiberglass plate using a marine grade adhesive (3M 5200). Each plate is secured to the leg of an instrumentation tripod, as shown in Figure 1.1. The primary purpose of this tripod is to characterize the physical and biological environments at tidal energy sites.

Figure 1.1 – Material samples attached to instrumentation tripod
