WAVE ENERGY
IN SOUTHERN EUROPE

DELIVERABLE 2.4 MONITORING OF SEAFLOOR INTEGRITY

WP 2.4
Deliverable 2.4 Monitoring of seafloor integrity

D2.4 Monitoring of seafloor integrity

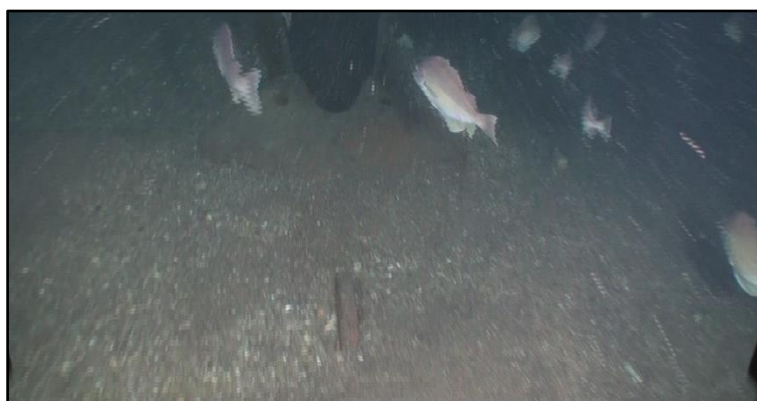
Despite the above mentioned, the anchors may be working as fish and invertebrate attractors as shoals of poutings (*Trisopterus luscus*) have been recorded swimming around them (Figure 23). European congers (*Conger conger*) were also recorded hidden by the anchor (Figure 24). Finally, an European lobster (*Homarus gammarus*) seeking for protection by the B2 anchor was also captured by the video (Figure 25).

Figure 23. Shoal of putings (*Trisopterus luscus*) in the vicinity of F1 anchor.

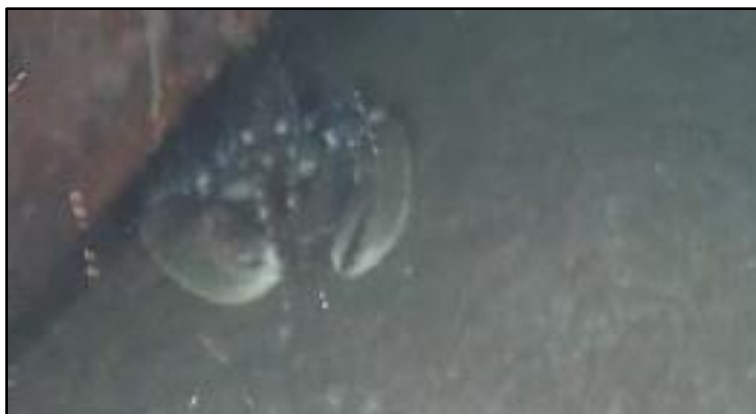
Figure 25. European lobster (*Homarus gammarus*) seeking for protection under the B2 anchor.

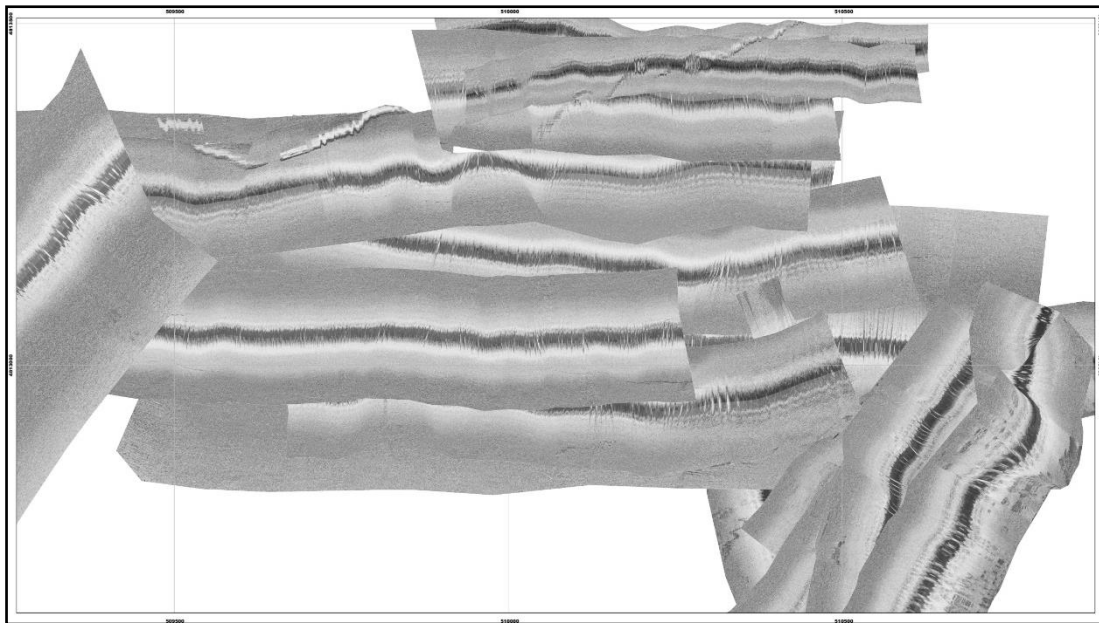
Regarding the side-scan SONAR survey, as indicated in section 4.1, the acquired data does not give a clear image of the seafloor and consequently it was not possible to collect data useful for the analysis of the impact associated to the anchors, mooring lines and umbilical cable. Hence, the assessment based on video recordings using the ROV could not be compared with the assessment using acoustic methods.

After processing the data obtained during the campaign, the side-scan sonar records were analysed in order to determine the position of the anchorages and mooring lines that anchor the MARMOK-A-5 converter to the bottom. The records have also been analysed along the initial route of the cable and connector to the marine infrastructure, detecting buried and unburied sections observed in the sonographic mosaic.

Figure 34. Sonographic mosaic (100 kHz).

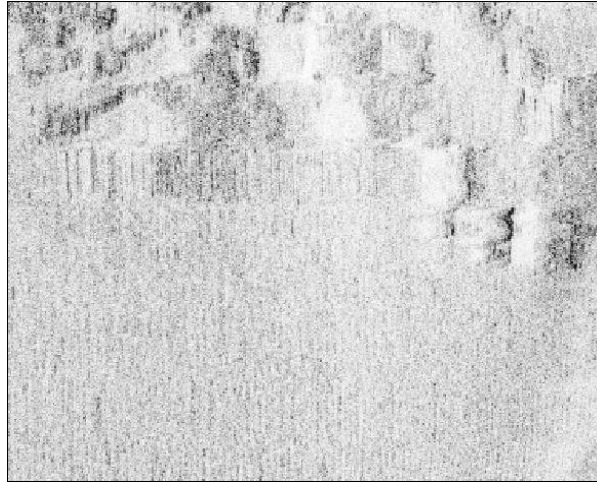
In general, the study area is mainly made up of sand bottoms with SSO-NNE crest direction ripples (Figure 35). Scattered rocky outcrops have also been observed, more abundant towards the southeast of the WEC location area and towards the northern edge of the cable route.

Figure 35. Sonar record (100kHz) with rocky outcrops (top) and sand with ripples (bottom).

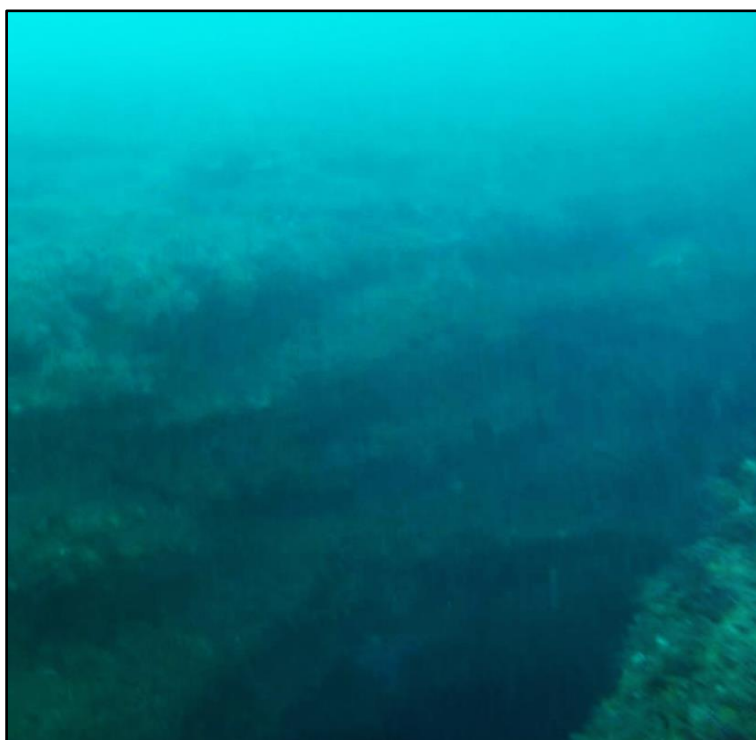
During all transects the seafloor was mostly made of sandy substrate (e.g., WR_T1 11:02, WR_T2 12:32). Smaller areas with rocky substrate covered by sand (e.g., WR_T2 12:34, WR_T5 15:39) and few sections with rocky outcrops (e.g., WR_T1 11:10, WR_T2 12:35), “canyons” (WR_T2 12:36, WR_T4 14:53; Figure 38) and biogenic reefs (WR_T2 12:45 to 12:49) were identified.

Figure 38. Rocky “canyon” (GoPro video).

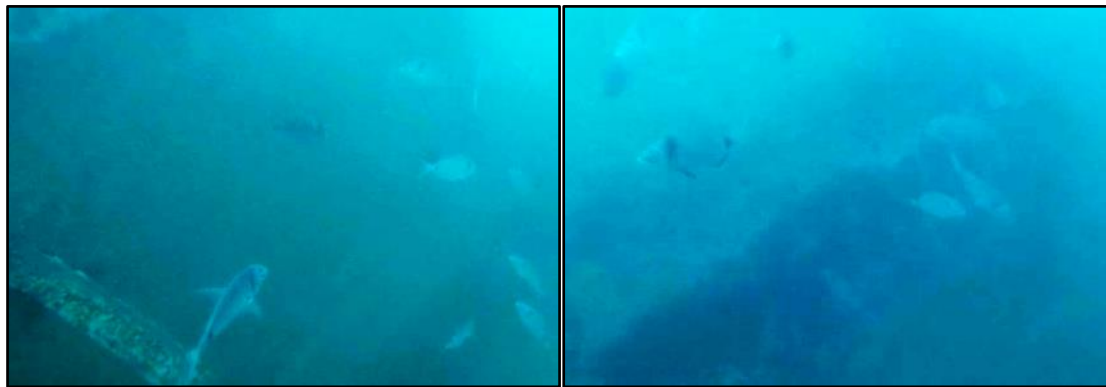
Figure 40. Several fishes aggregating right next to the WaveRoller foundation. About 25 individuals could be counted. (GoPro camera)

to 14:58; Figure 47) and the synthetic strap was colonized by algae (WR_T3 13:41; Figure 46). Also, several fishes (about 25 individuals) were registered near to the WaveRoller foundation (WR_T4 14:41 to 14:43; Figure 40).

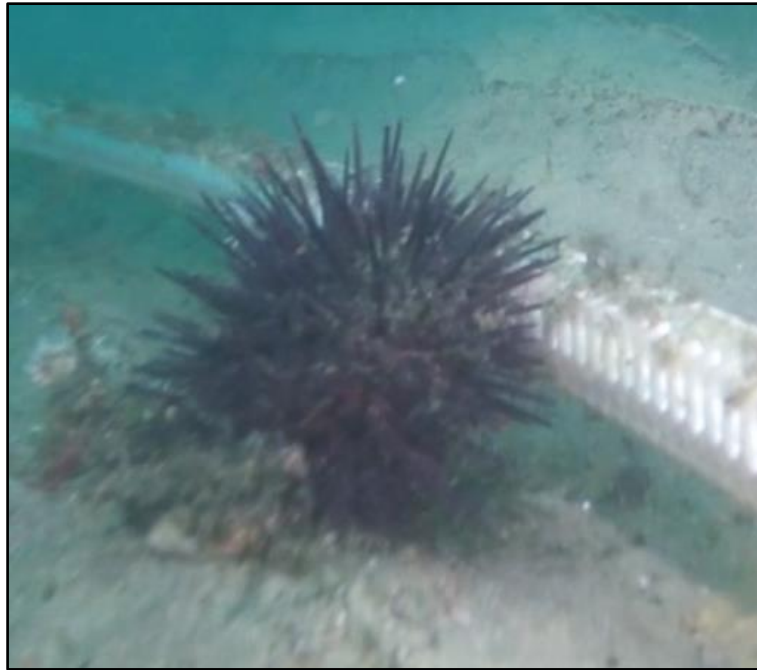
Figure 41. A sea urchin (*Paracentrotus lividus*) on a synthetic mooring cable. (GoPro camera).

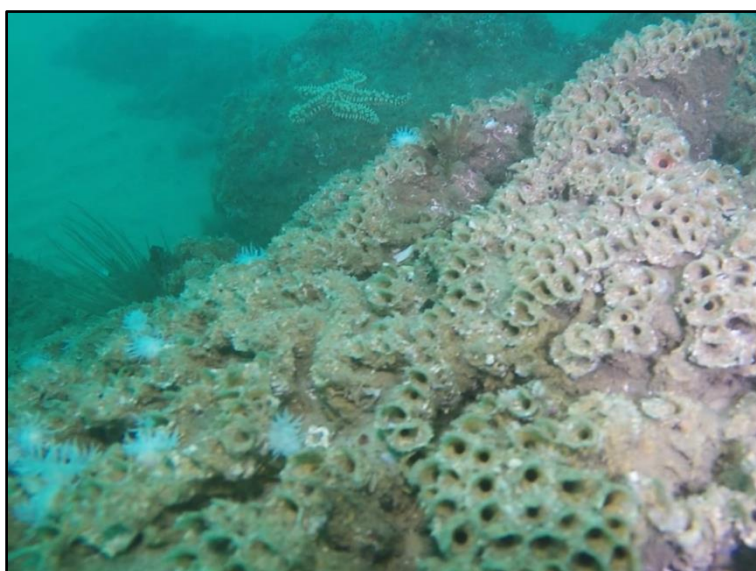
Figure 44. Portion of *Sabellaria* reef, with anemones and a starfish visible. (GoPro video).

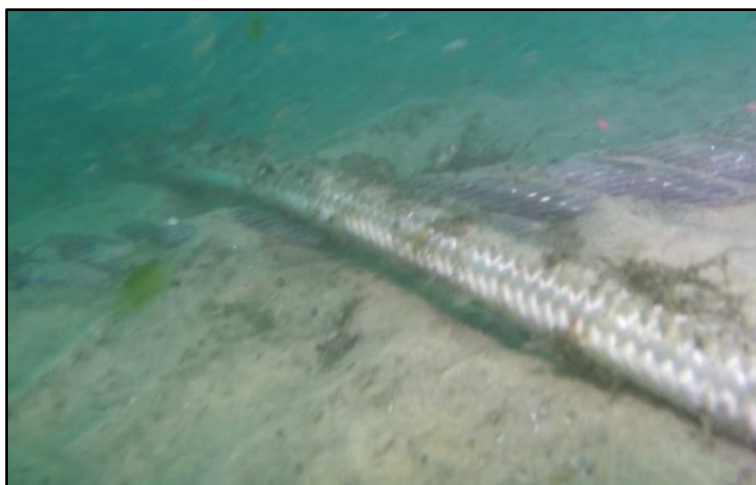
Some artificial equipment/structures were found along the transects, namely two kinds of moorings, one made of steel and another synthetic (e.g., WR_T5 15:30 to 15:31;

Figure 45), and the WaveRoller electrical cable and foundation. Another object was found, a synthetic strap (Figure 46) probably used for lifting operations that remained on the seafloor.

Figure 45. A synthetic mooring cable crossing a steel mooring cable. (GoPro camera).

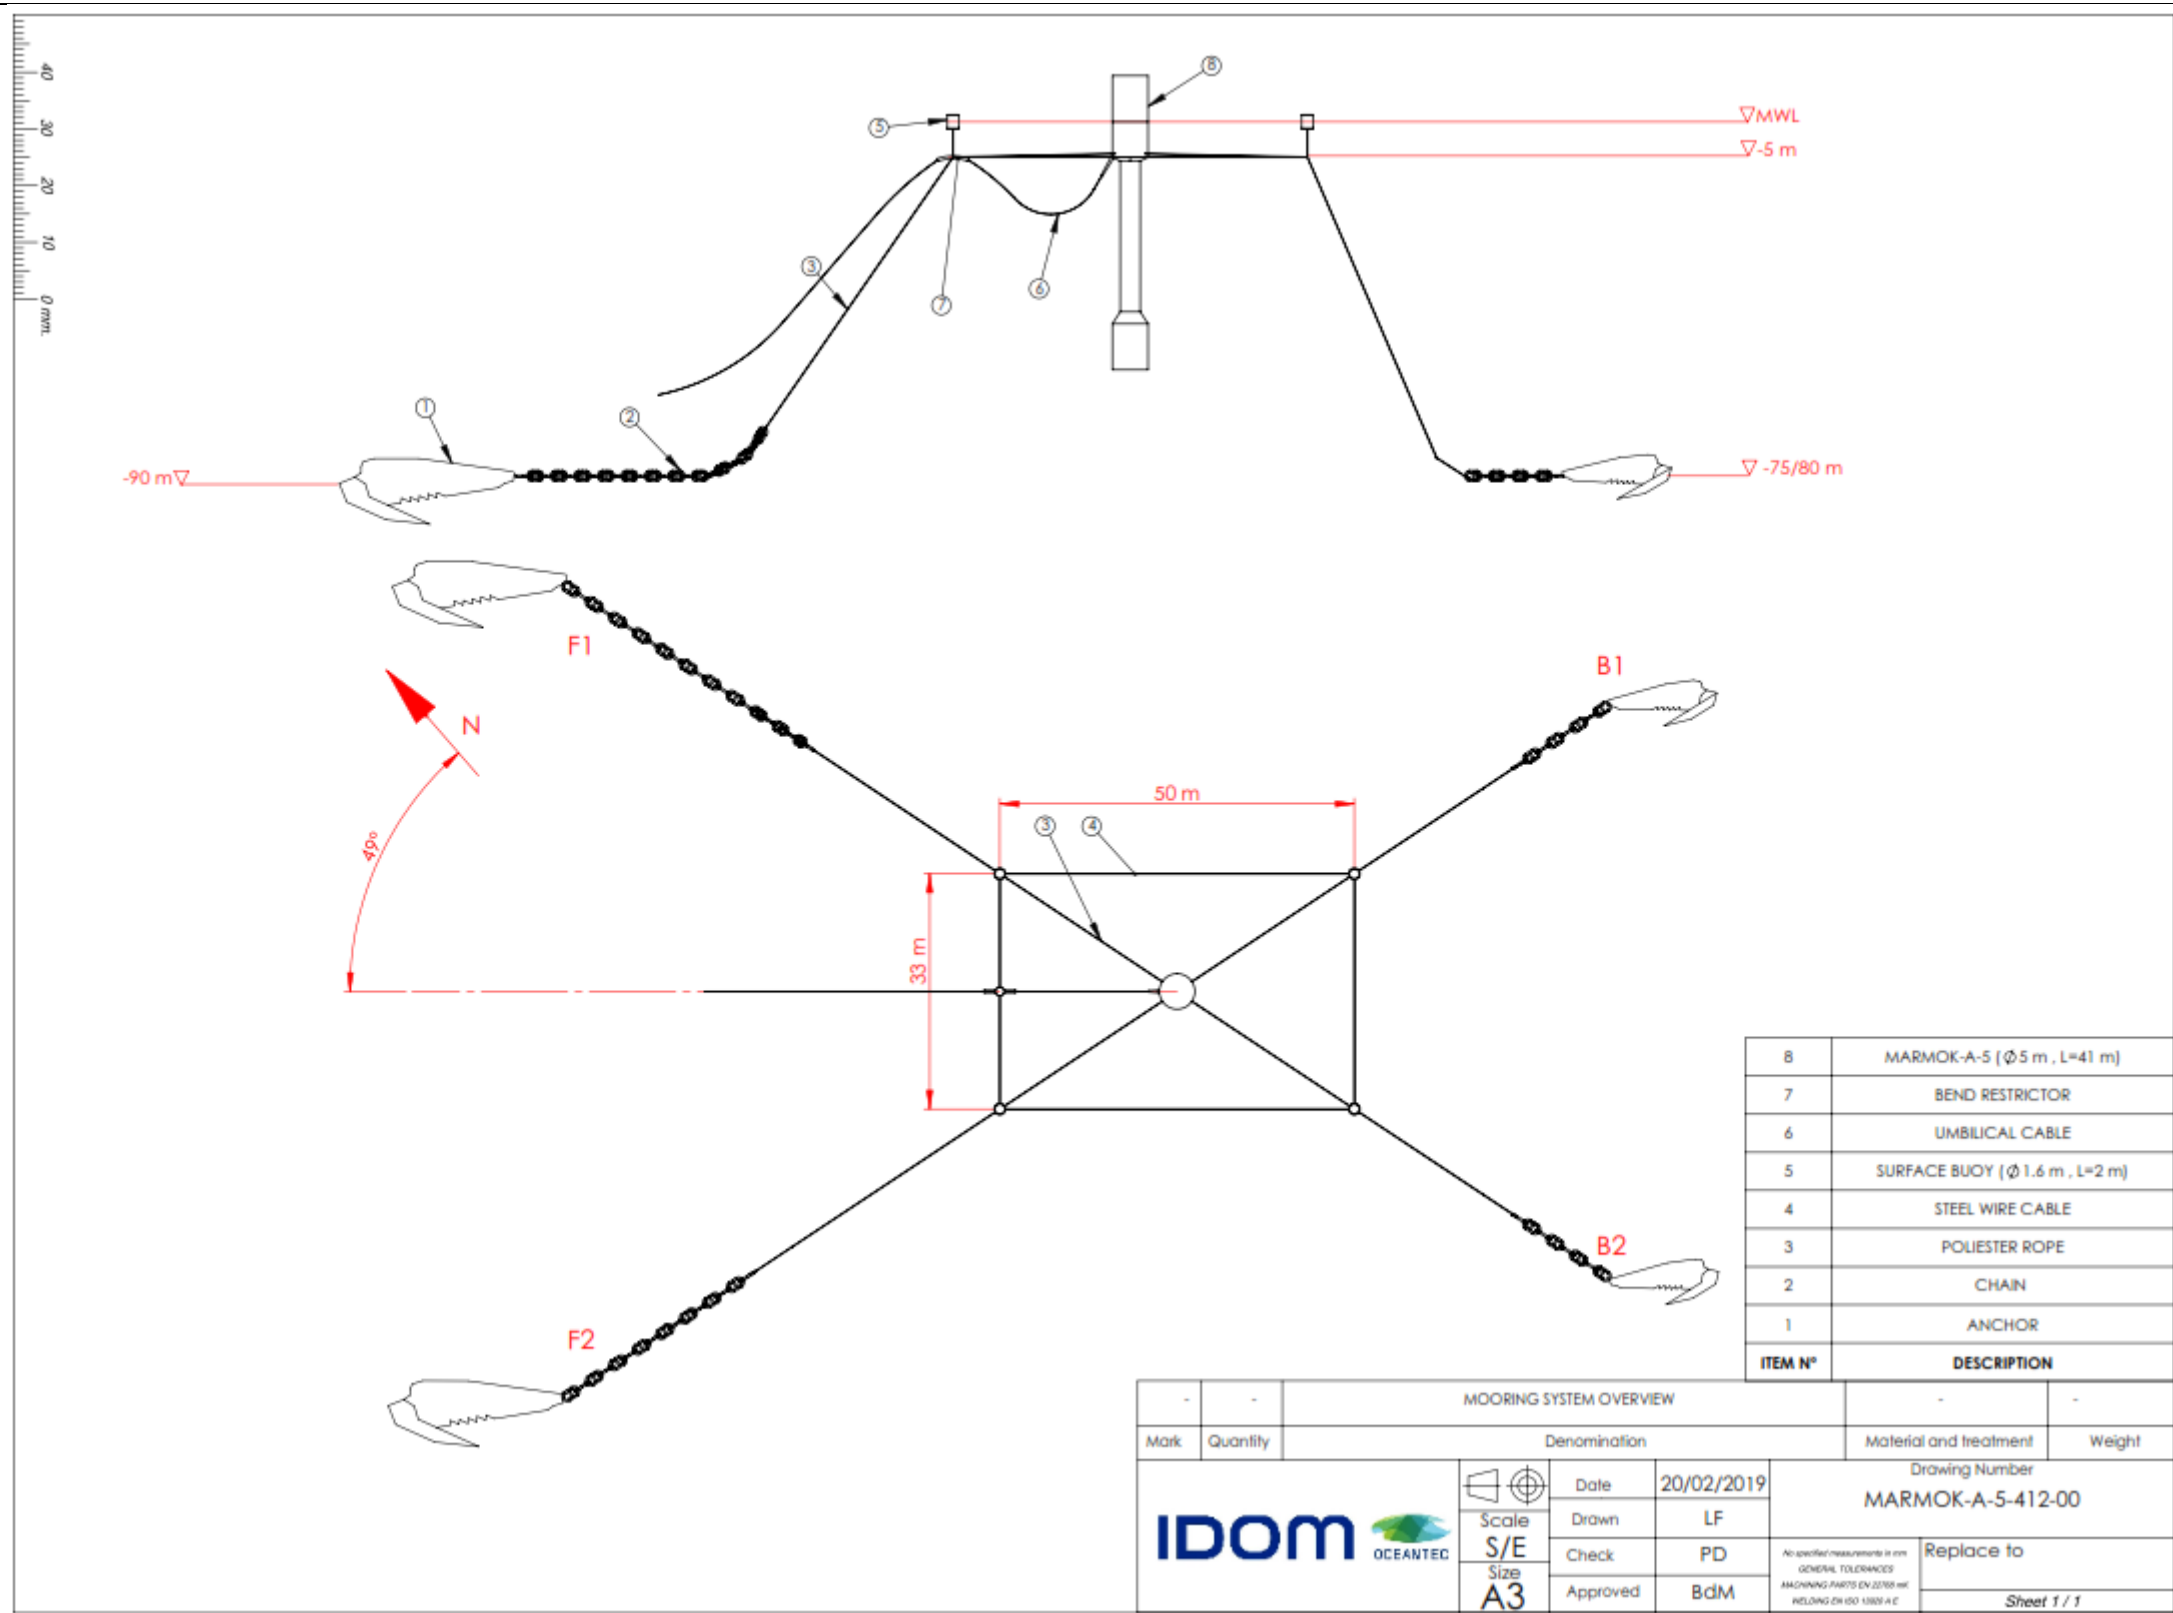
Length: 11,95 m. Width: 5,64 m.		
15 May 2019					
Sea State	Wind Speed (knots): 6 Wind Speed (km/h): 5 Wind direction: 000° Sea-State (Beaufort force): 2 Wave height: 0.5 m				
Comments	The objective of the ROV inspection was to record images of the moorings, mooring lines and umbilical cable and connector of the MARMOK-A-5 device of IDOM. In the following picture we can see a detail of the mooring system of the IDOM device.

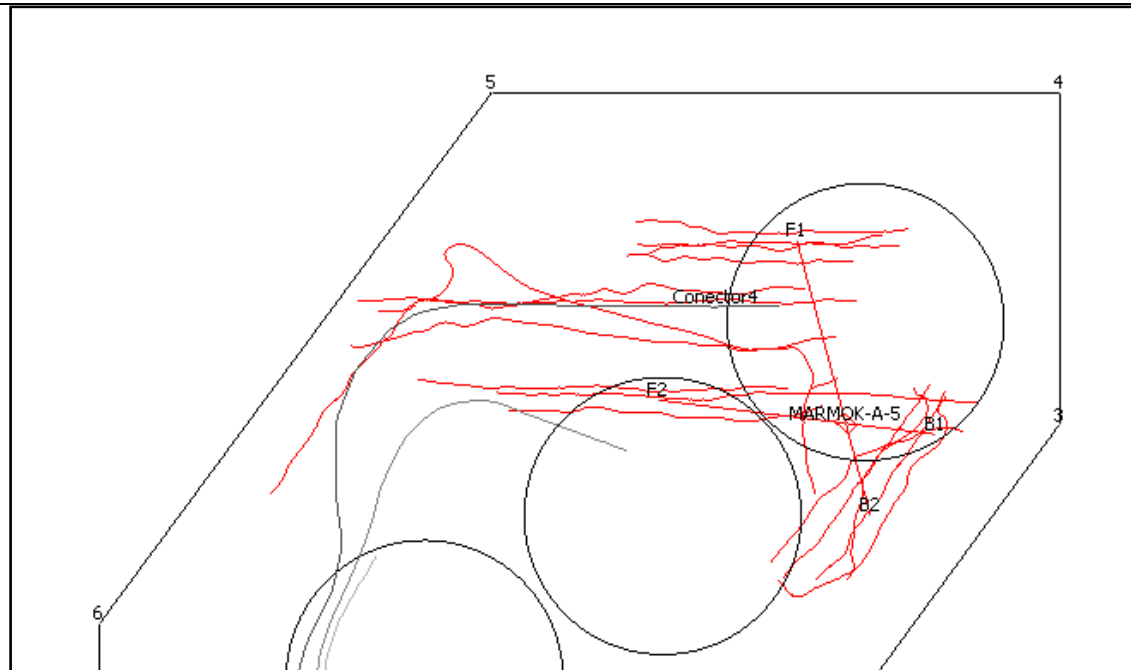
<p>14 May 2019</p>			
<p>Sea State</p>	<p>Wind Speed (knots): Wind Speed (km/h): Wind direction: Sea-State (Beaufort force): Wave height: 1,5-2 m</p>		
<p>Comments</p>	<p>The objective of the ROV inspection was to record images of the moorings, mooring lines and umbilical cable and connector of the MARMOK-A-5 device of IDOM through different transects over these elements. These can be seen in the following picture:</p>

The work went well but the sea conditions were not the best for side scan sonar recording. For security reasons the transducer was not approached very close to the seafloor due to the risk of entanglement with the mooring lines. On the other hand, the waves provoked pulls in the system and consequently the introduction of artefacts in the data acquisition. Due to this, the obtained data are not the expected and didn't offer clear results.
