**Annual work report 2018**

**Offshore wind energy power plant**

# **Belwind**

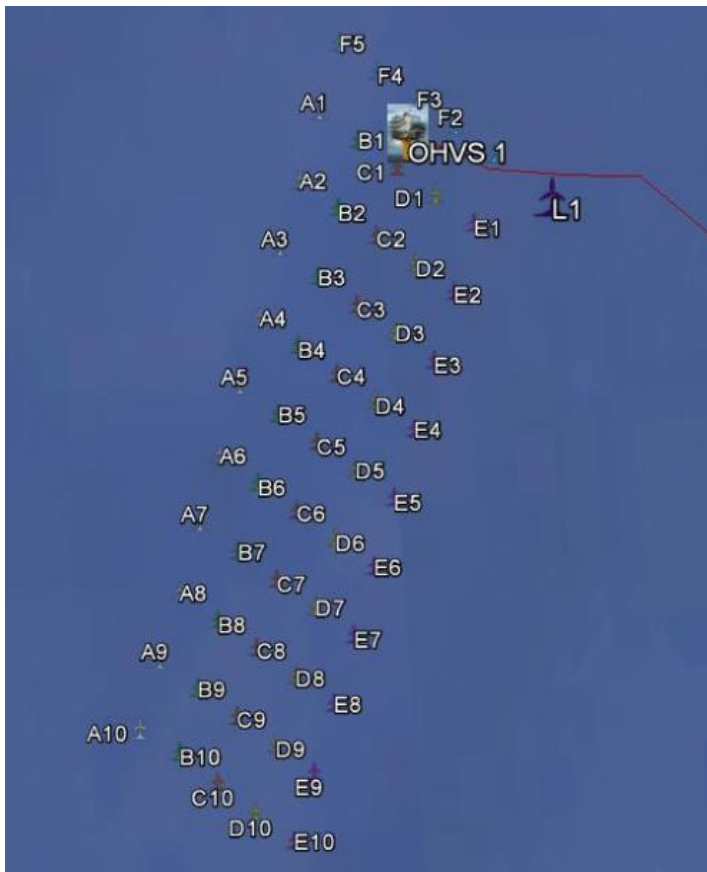
Belwind consists of 55 wind turbines of 3 MW each (Vestas V90) and an Offshore High Voltage Station (OHVS). Via a local grid (33 kV) the wind turbines are connected to the OHVS. The energy is transported to shore by a 150 kV submarine cable. Belwind has been erected in 2009 and 2010 and is fully operational since January 2011.

*Locations of the wind turbines and the grid connection of Belwind*

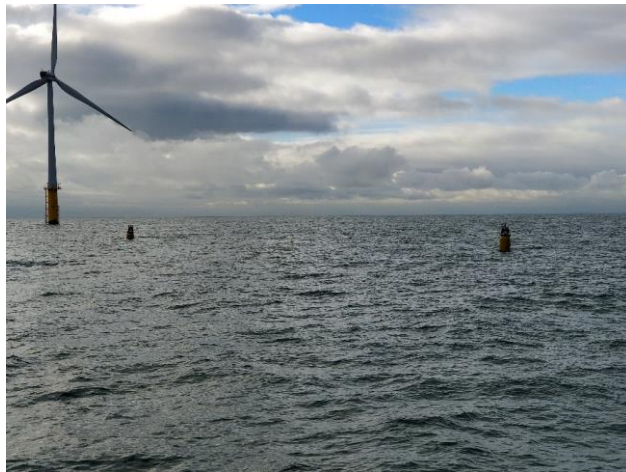
In 2017 Belwind agreed to participate in the Edulis project (Installation of a long line, already with full growth mussels, equipped with sensors for monitoring of the forces in the line and anchors, dynamic position of the anchoring and lines, in order to be able to design a optimal mussel farm offshore). The long line was installed in December 2017 and during 2018 Belwind supported the Edulis-project with the visual inspections of equipment in the concession:

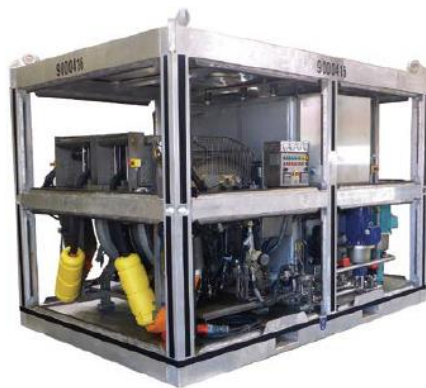
- **Oil exchange campaign:** On 15/08/2018 MVOW initiated a campaign to change hydraulic and gearbox oil on the turbines in the windfarm. For this campaign a subcontractor was hired by MVOW to assist. The company OceanTeam has a SOCOT-unit available that is designed for these operations.

*OceanTeam SOCOT unit*

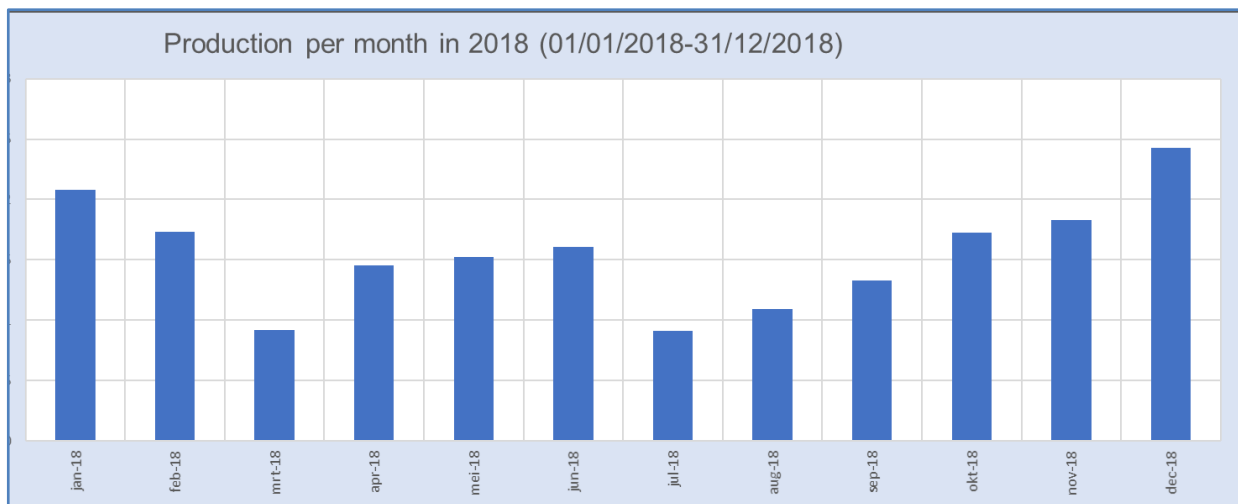
Monthly production GE-Haliade 2018
