**Annual work report 2020**

**Offshore wind energy power plant**

# **Belwind**

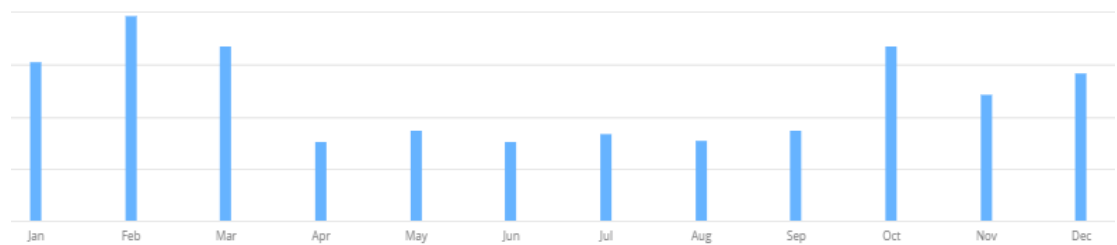
Monthly production V90 2020

Below figures cover the 55 MVOW V90 turbines. The GE Haliade demo project is covered in chapter 5.

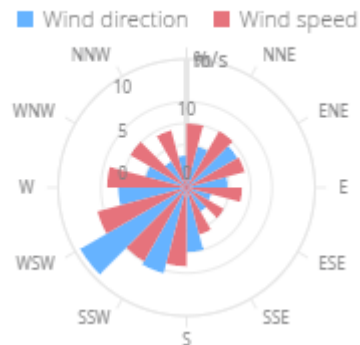
Wind-rose

The displayed wind rose is a graphical representation of the wind speed and direction measured all over the wind farm.

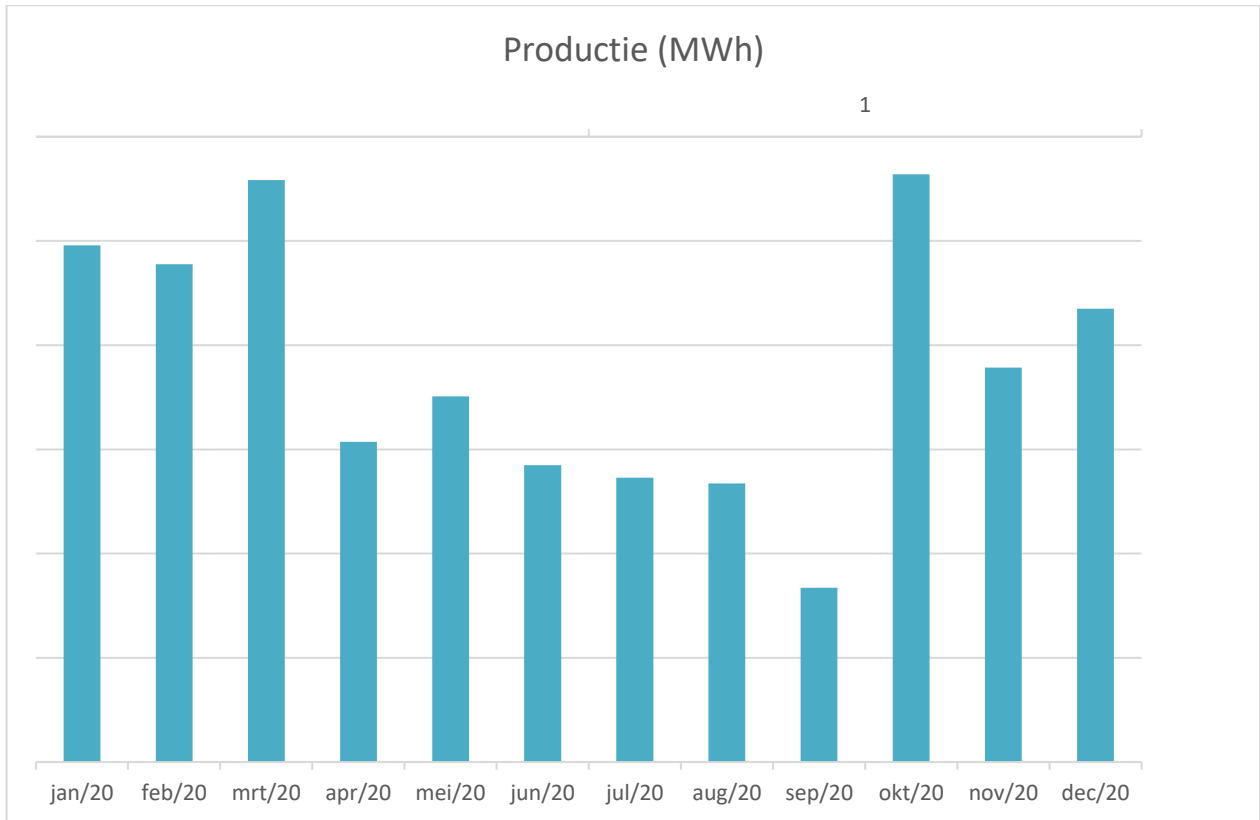
Monthly production GE-Haliade 2020
