**Final Report** 15 May 2015

# **Investigation of the effectiveness of bat and bird detection of the DTBat and DTBird systems at Calandawind turbine**

3MW Wind Turbine  
Calandawind AG  
Feldstrasse 17  
7023 Haldenstein  
[www.calandawind.ch](http://www.calandawind.ch)

Calandawind Turbine at Oldis, 7023 Haldenstein - 760'010 / 195'797  
(Geographical coordinates acc. to construction permit BAB-Nr. 2011-0410, Amt für  
Raumentwicklung Graubünden)

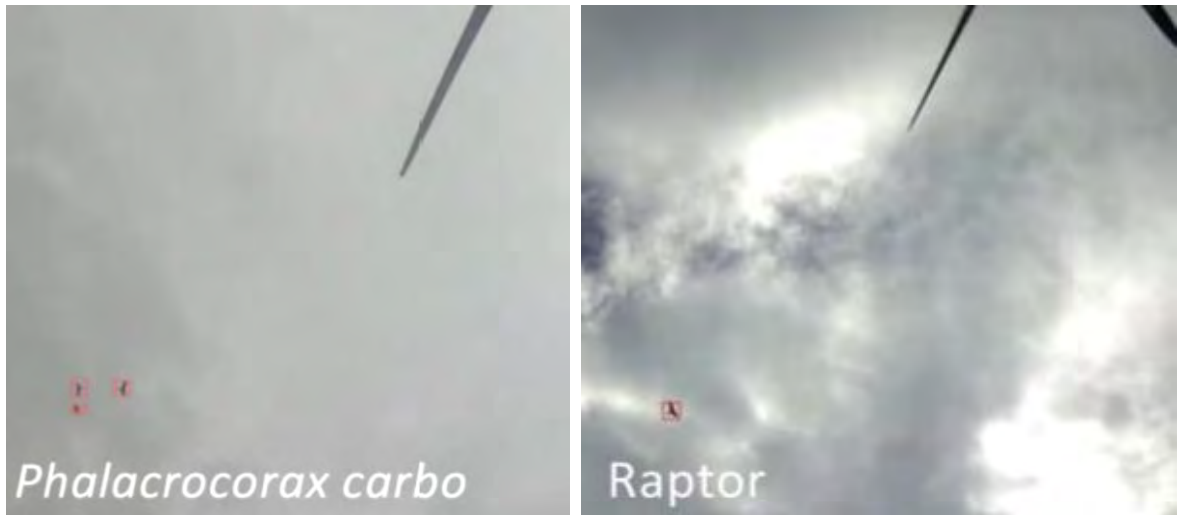
Fig. 2 Flock of Great Cormorants and an individual raptor recorded by DTBird Cameras (Annex II – Appendix I)

Occasionally individual birds and flocks actually located at further distances were also detected (**Fig. 2**).

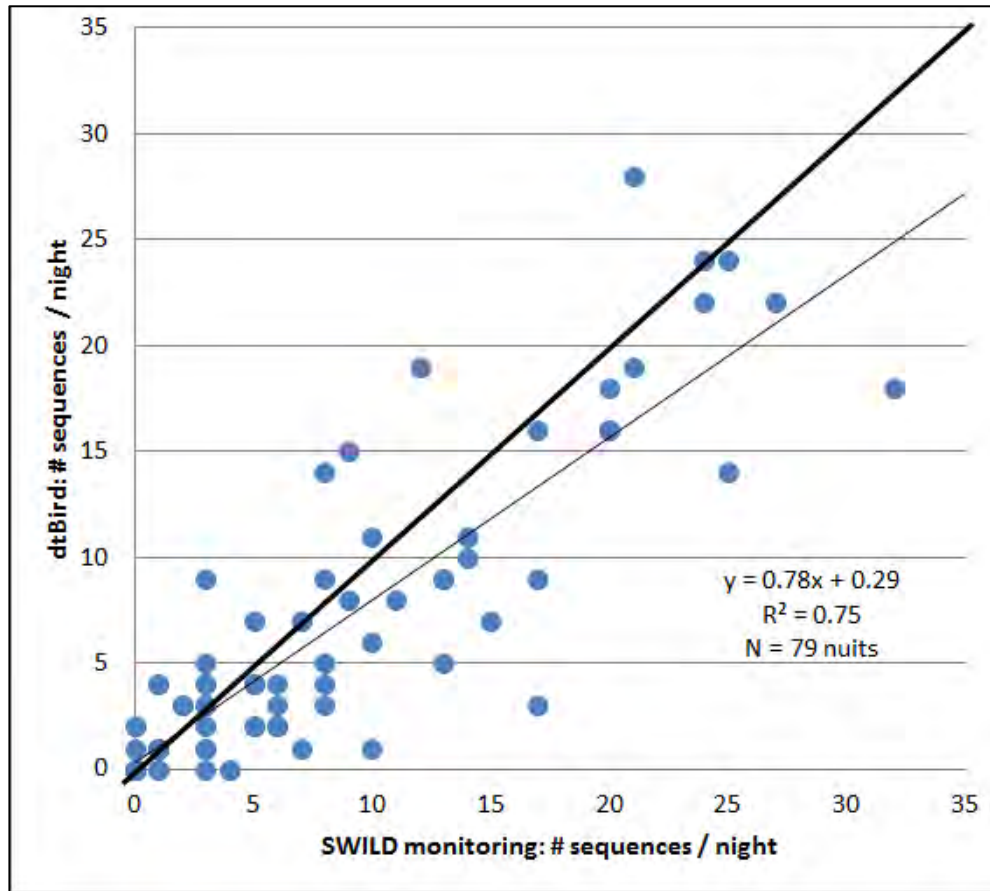
Fig. 3 Number of bat passes recorded per night: comparison of DTBat vs. SWILD monitoring at nacelle (119m). (Annex III - Fig. 7)

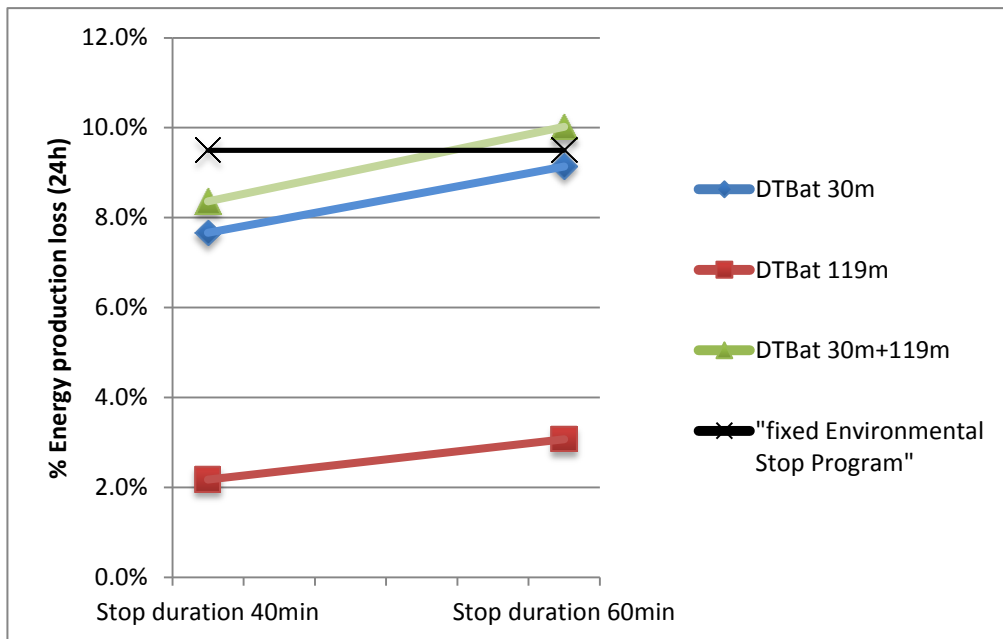
Fig. 4 Comparison of energy production loss (%) in relation to total energy in the "Assessment Period" using different stop algorithms and stop durations. An estimate of annual energy loss is about 3 times smaller (Annex III - Fig. 13)

both SWILD and DTBat algorithms, annual production loss with DTBird algorithms will be in the same order of magnitude, that is approximately 3% (see also Tab. 1).

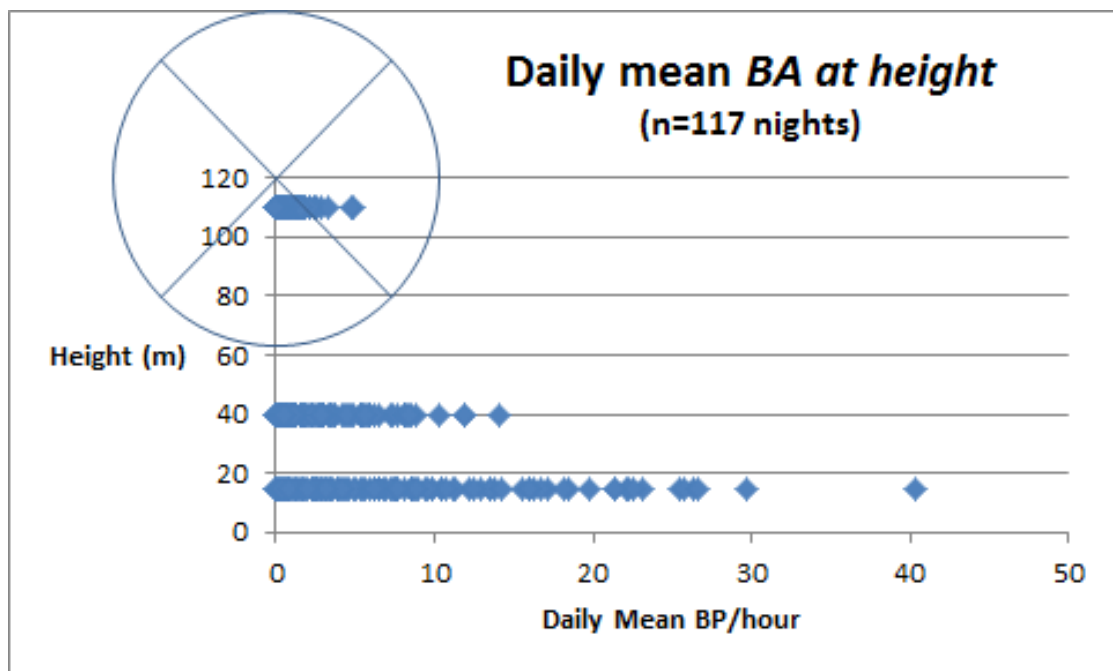
Fig. 5 Height Distribution of Bat activity at Calandawind site, Study Period (Annex IV - Fig. 2)

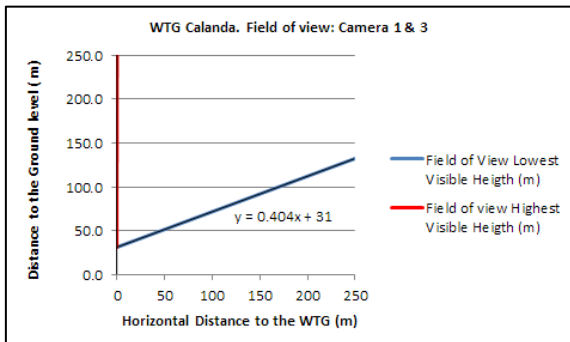
Fig. 1. Surveillance angle of the cameras placed at 31 m above ground (copy of the specifications of DTBird).

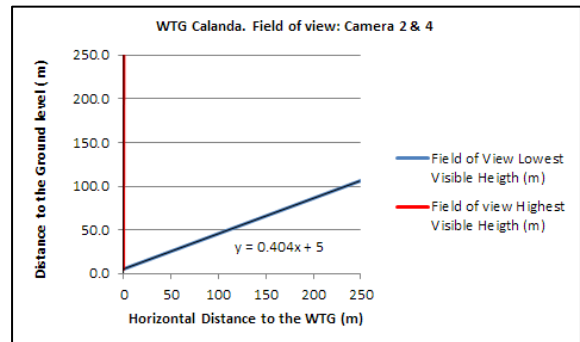
Fig. 2. Surveillance angle of the cameras placed at 5 m above ground (copy of the specifications of DTBird).

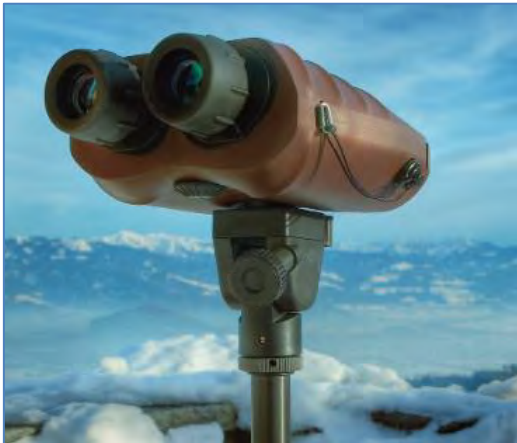
Fig. 5. Laser range finder Vector 21 Aero ([www.vectronix.ch](http://www.vectronix.ch)).

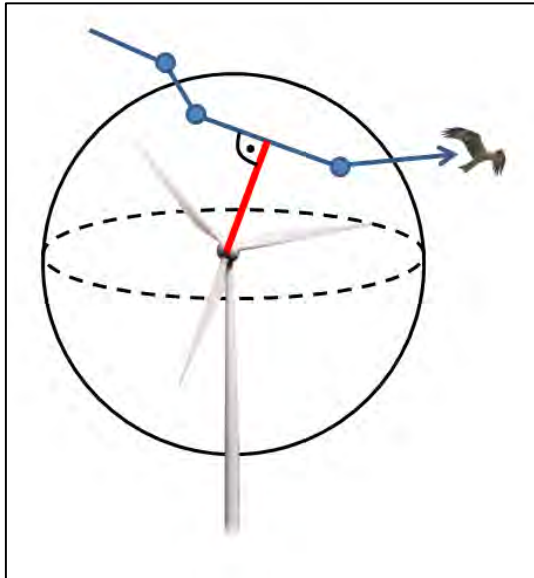
Fig. 8. Determination of the closest distance (red line) of a flight trajectory (blue line) composed of single 3D-localisations (blue spots) to the nacelle of the wind turbine.

In a first step, three-dimensional flight trajectories were composed out of the single localisations of a target. In a second step, for each flight trajectory, the closest point to the nacelle of the wind turbine was determined by dropping a perpendicular from the line connecting two localisations to the nacelle (Fig. 8). Thus, it was possible to calculate the closest approaching distance of a bird in respect to the wind turbine.

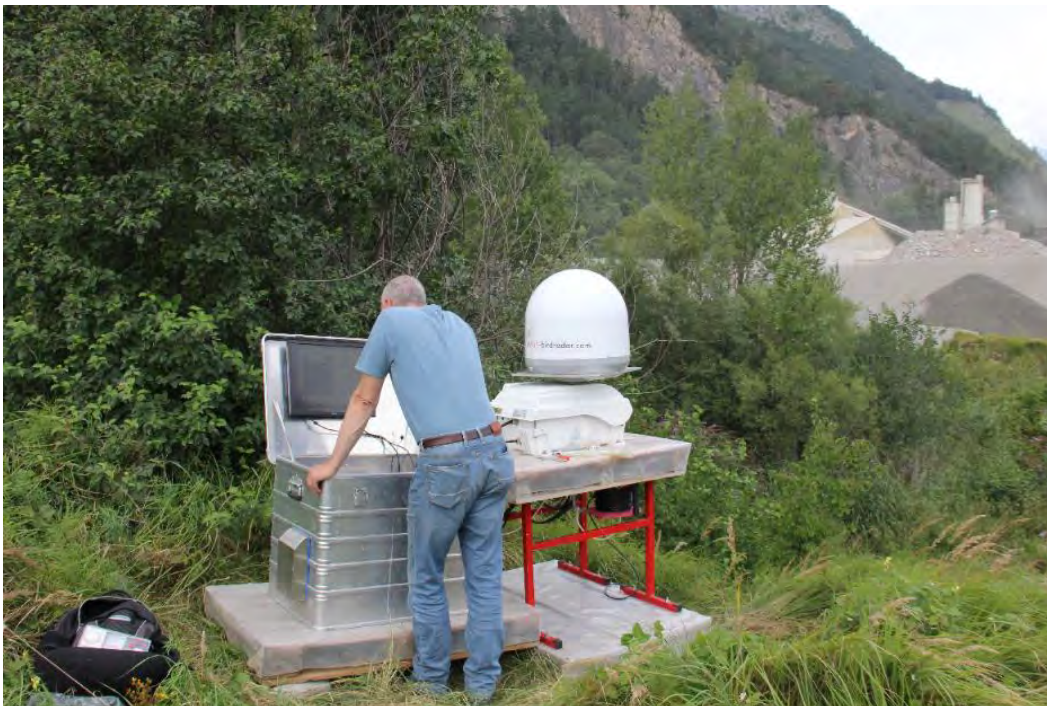
*Fig. 10. Radar device model BirdScanMV1 on the rack at the right side with the radome (white dome) covering the antenna. The metal box contains the computer for the data registration and radar control.*

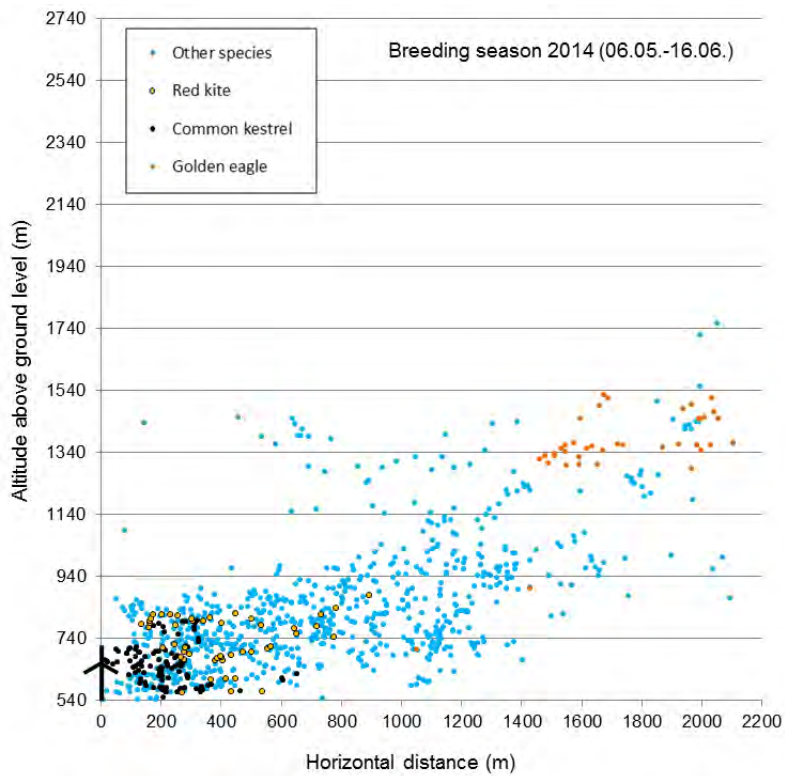
Fig. 16. Altitudinal distribution of single localisations in relation to the horizontal distance from the wind turbine independent of the geographic direction observed between 06.05.-16.06.2014 during the breeding season. Several localisations of Common Kestrel were very close to the rotor of the wind turbine while the rotor was not turning.

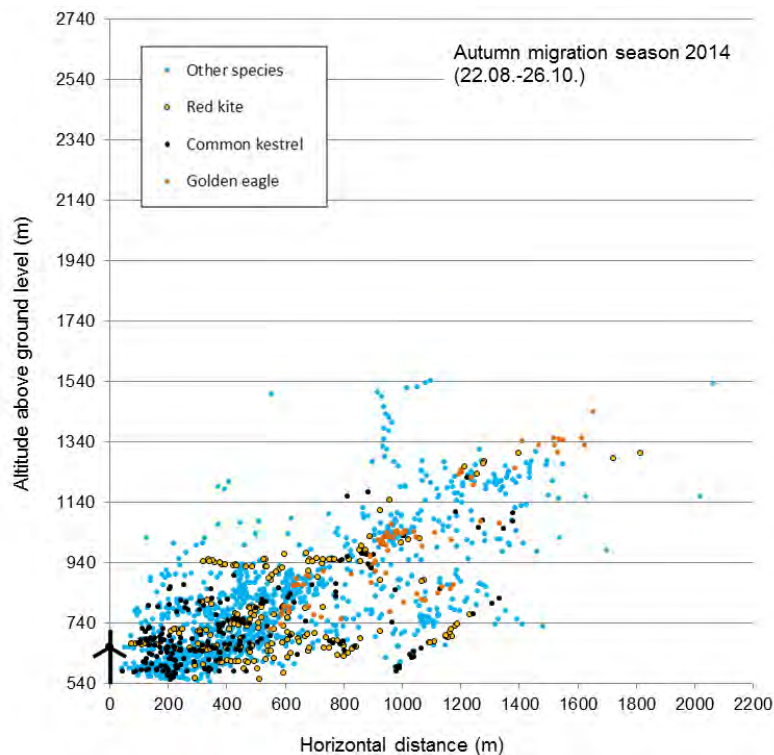
Fig. 17. Altitudinal distribution of single localisations in relation to the horizontal distance from the wind turbine independent of the geographic direction observed between 22.08.-26.10.2014 during the autumn migration season.

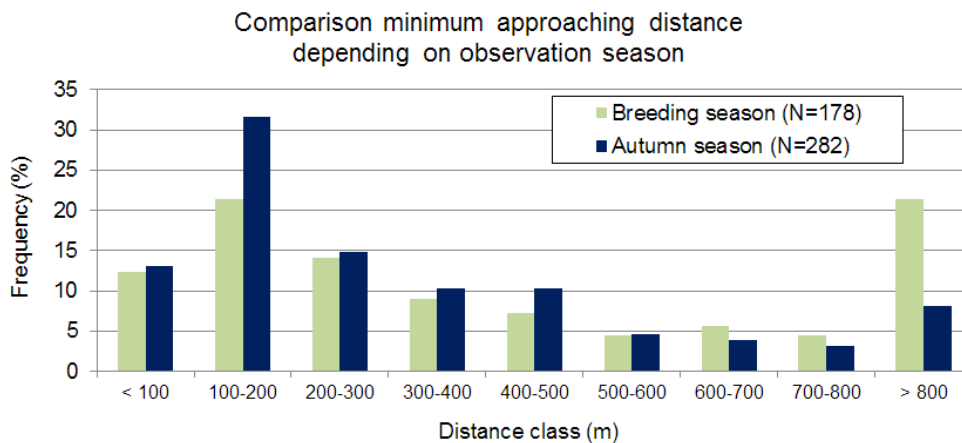
Fig. 18. Comparison of the frequency of the minimum approaching distance in relation to the nacelle of the wind turbine per distance class depending on the observation season (breeding season 06.05.-16.06.2014, autumn migration season 22.08.-26.10.2014).

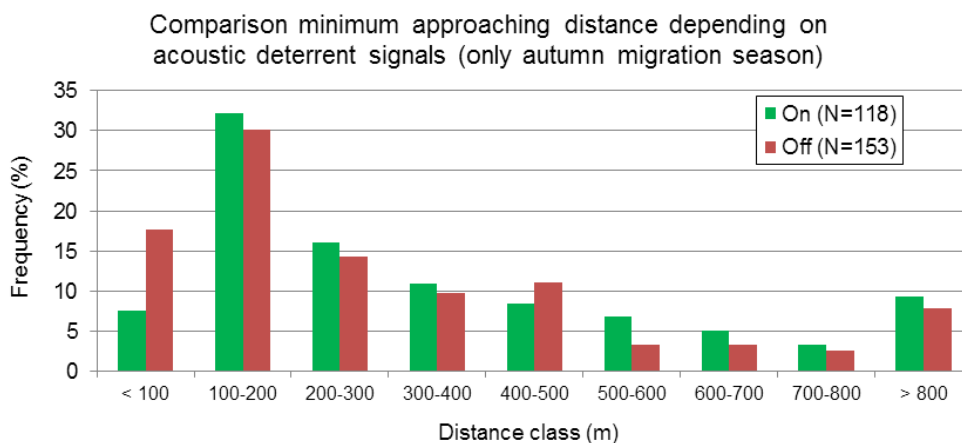
Fig. 19. Comparison of the frequency of the minimum approaching distance in relation to the nacelle of the wind turbine per distance class depending on the emission of acoustic deterrent signals of the DTBird-system in the autumn migration season (25.08.-26.10.2014).

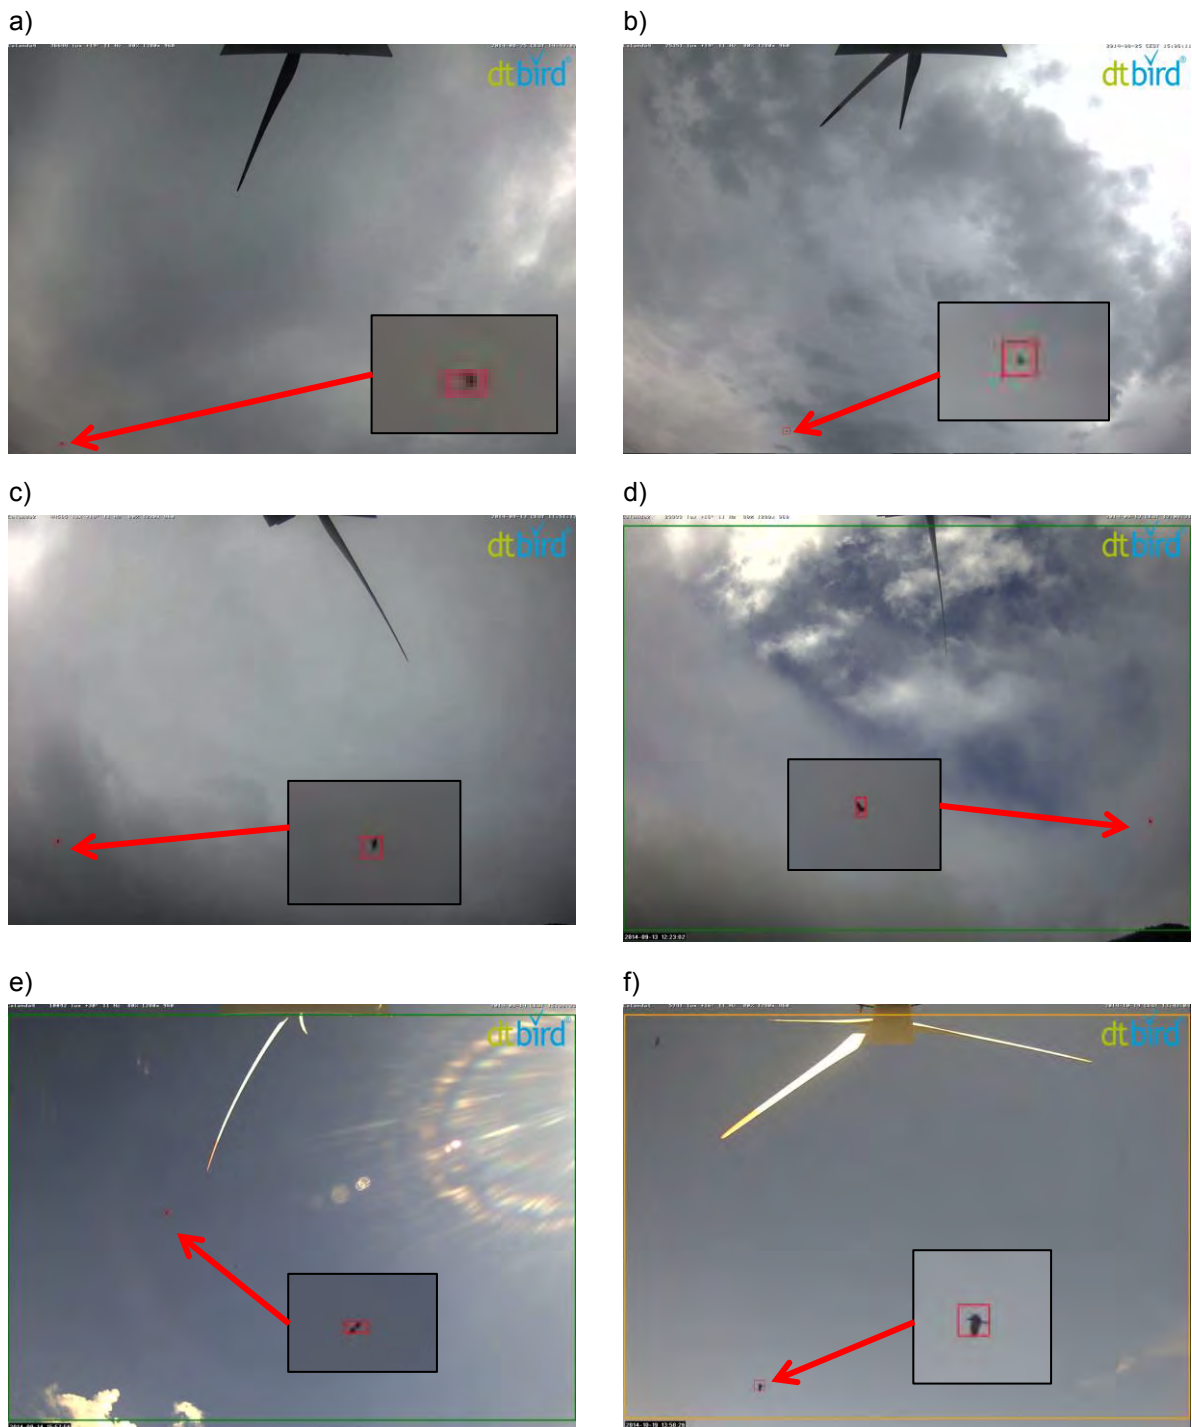
Fig. 23. Screen shots of the DTBird videos and increased detail of the bird. a) Corvid (ID 52), b) Corvid (ID 53), c) Corvid (ID 540), d) Medium sized bird (ID 541) e) Big-sized bird (ID 571) f) Corvid (ID 1160).

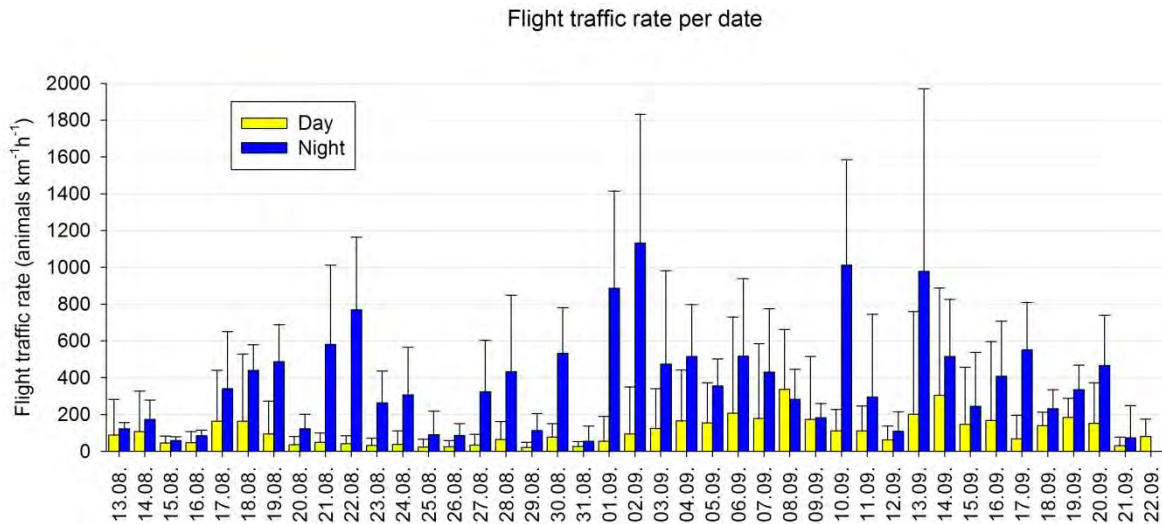
Fig. 24. Mean flight traffic rate per date (with standard deviation) splitted for day and night.

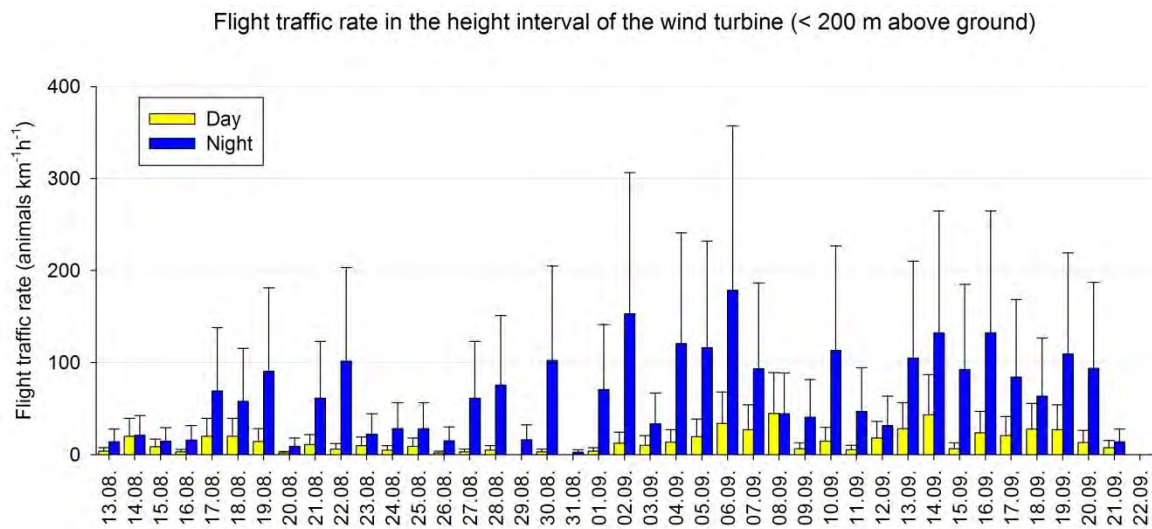
Fig. 25. Mean flight traffic rate per date (with standard deviation) in the height interval of the wind turbine (< 200 m above ground level) splitted for day and night.

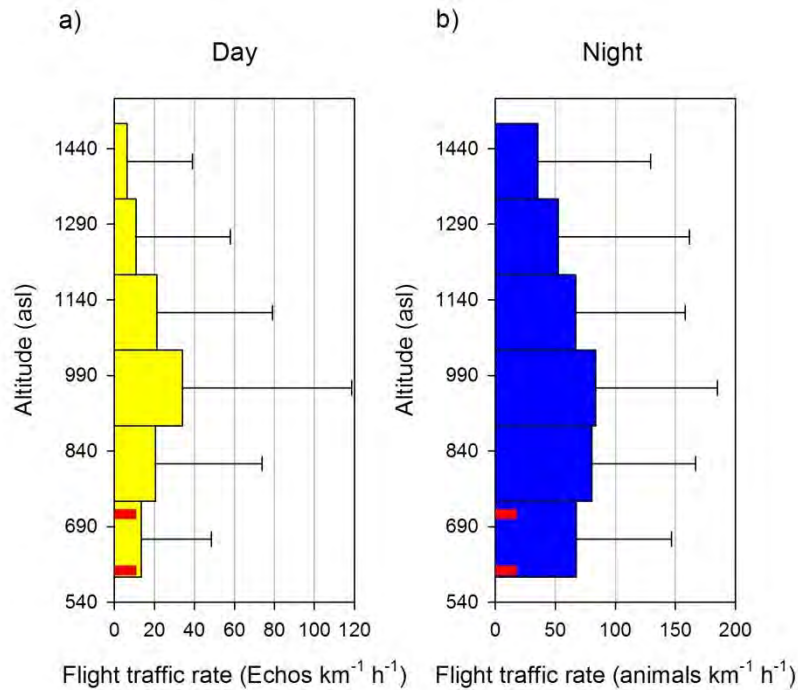
Fig. 26. Altitudinal distribution of the diurnal (a) and nocturnal (b) mean flight traffic rate (with standard deviation). Red bars display the upper and the lower limit of the wind turbine rotor diameter.

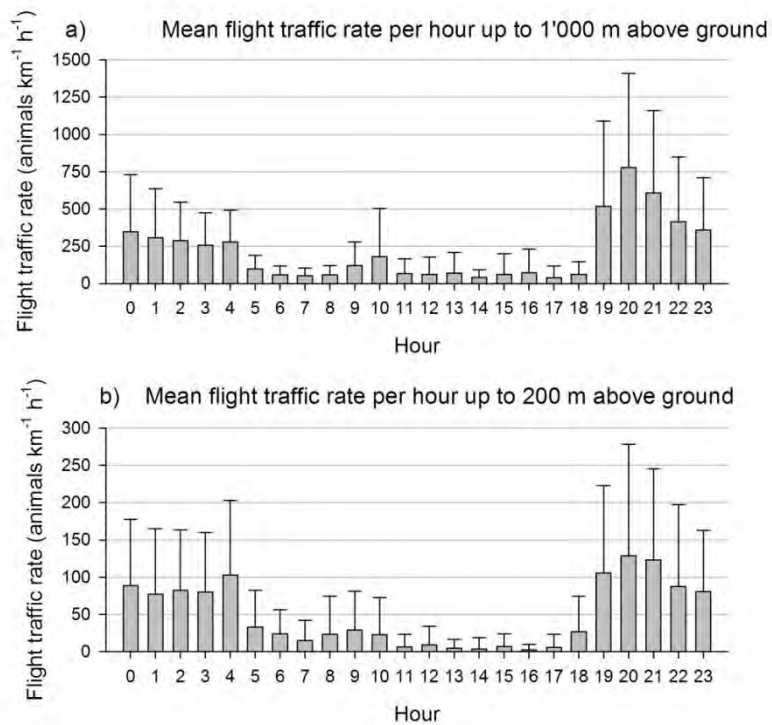
Fig. 27. Hourly distribution of the flight traffic rates (with standard deviation) for all height intervals up to 1'000 m above ground level (a) and within the height interval of the wind turbine up to 200 m above ground level (b).

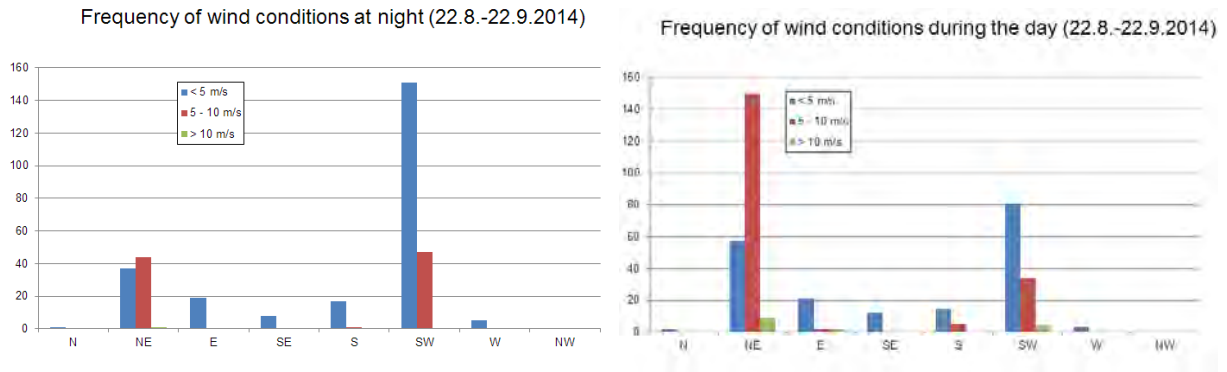
Fig. 29. Frequency of wind conditions at night (left) or during the day (right).

The most frequent wind conditions were weak wind (< 5 m/s) from southwest at night and medium strong wind (5-10 m/s) from northeast during the day which reflects a channel effect along the orientation of the valley (Fig. 29). Flight traffic rate was high especially during weak wind conditions independent of the wind direction, or during medium strong wind conditions with wind either coming from south, southwest or southeast (Fig. 30). From animals' point of view migrating towards southwest, northeasterly winds mean tailwind while south- and southwesterly winds mean head wind conditions.

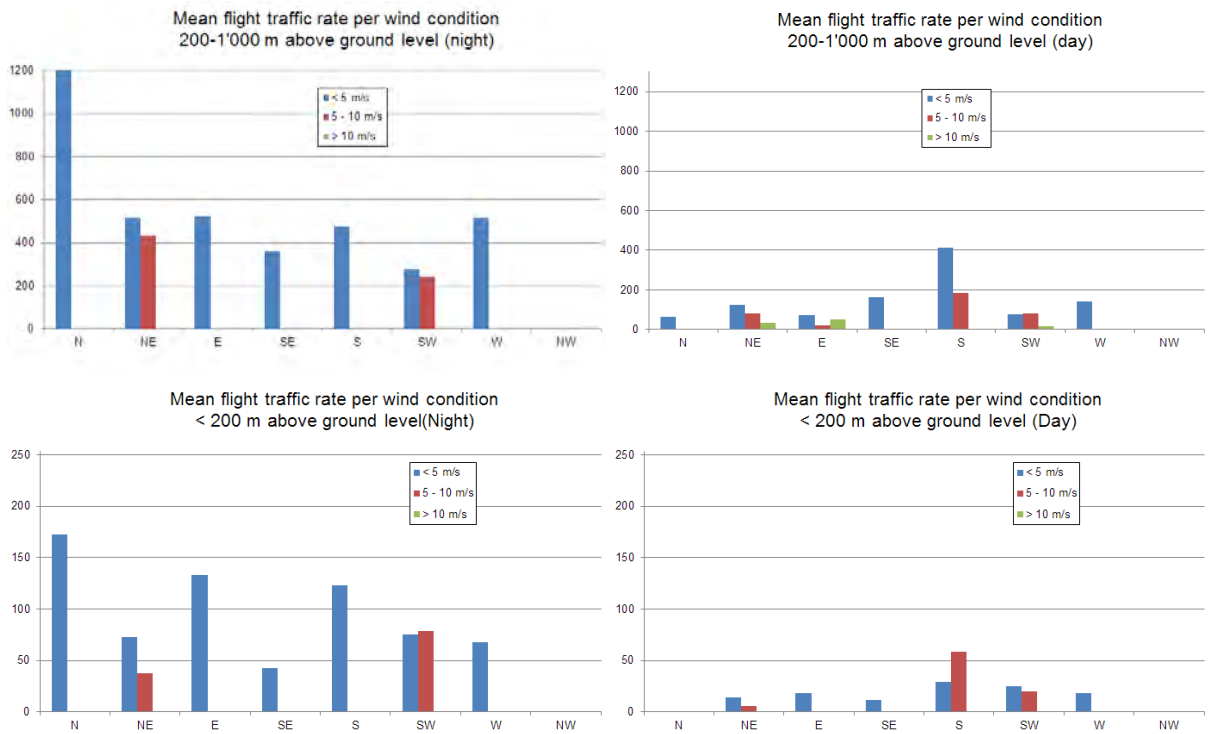
Fig. 30. Mean flight traffic rate per wind condition of all height intervals from 50 m up to 1'000 m above ground level (upper graphs) and of the height level lower than 200 m (50-200 m) above ground level (lower graphs) either for the night (left graphs) or for the day (right graphs).

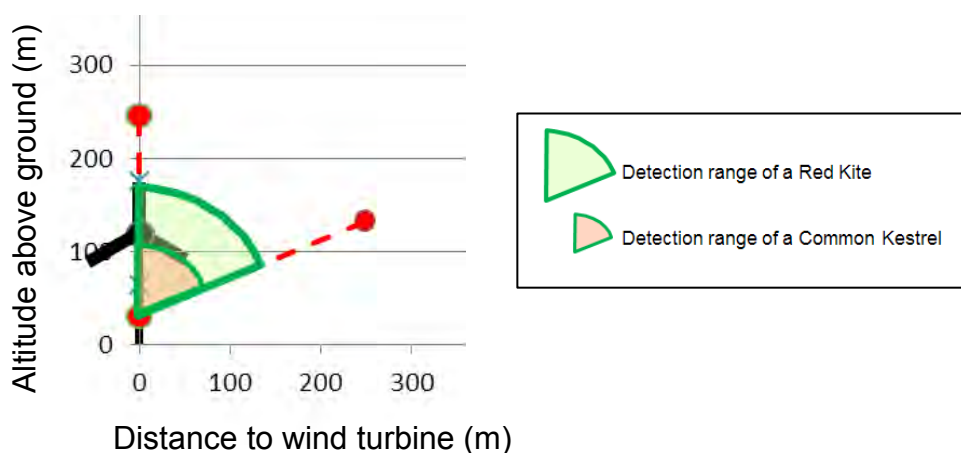
Fig. 31. Size of the detection range for Red Kites and Common Kestrels in relation to the camera position at the wind turbine.

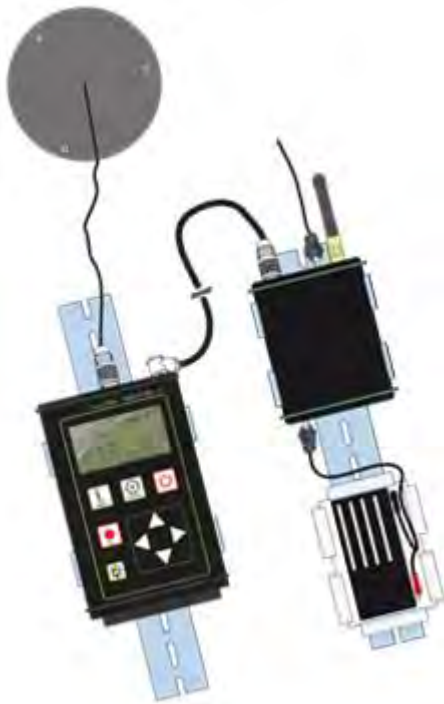
**Fig. 1:** Batcorder 2.0 with GSM remote control unit

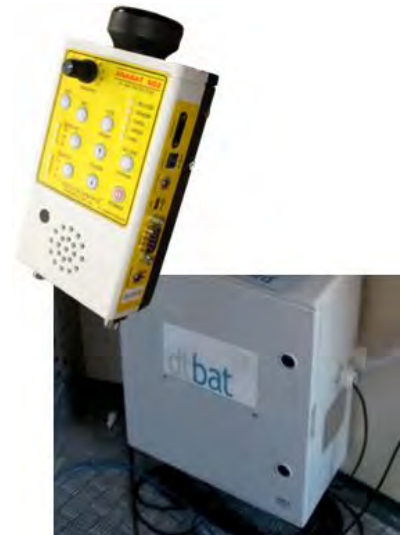
**Fig. 3:** DTBat, Anabat SD2

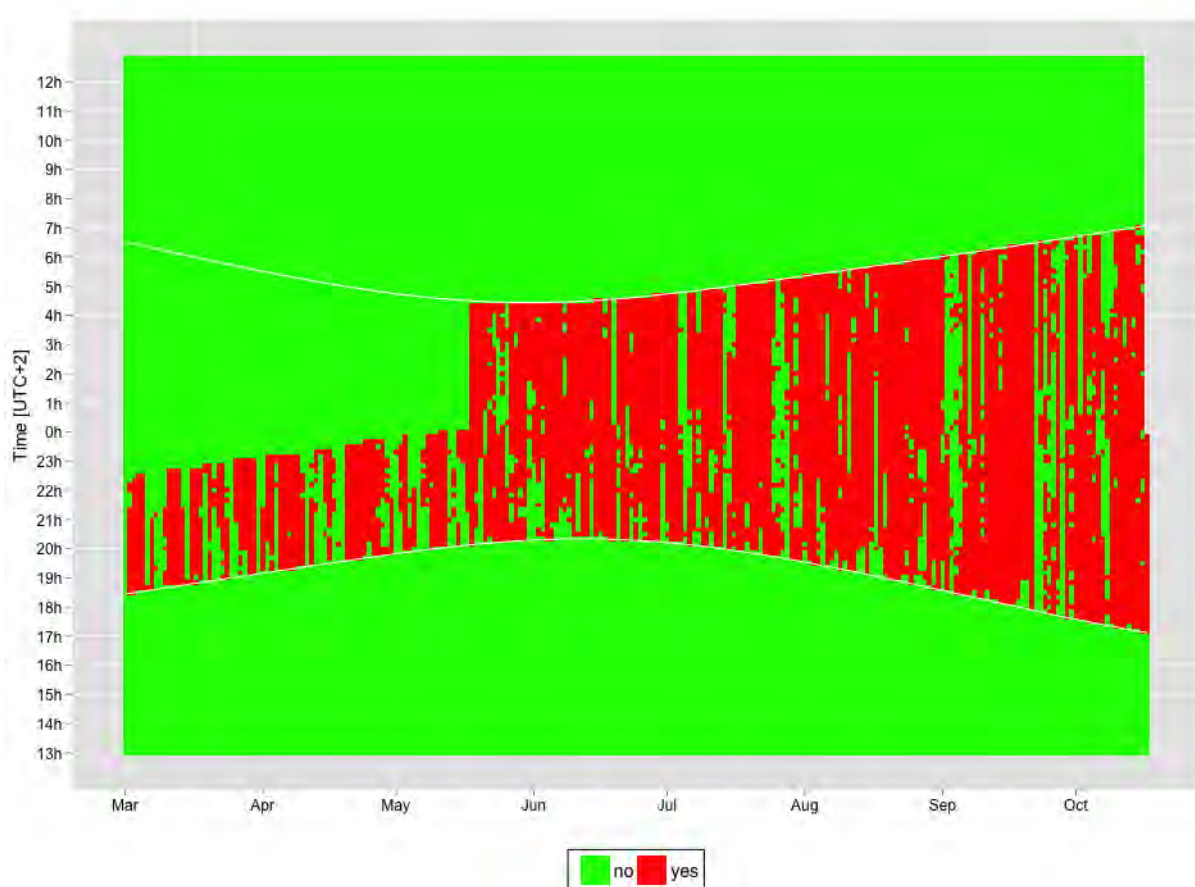
**Fig. 11.** Control output of the Fixed Environmental Stop Program during the full season 2014. The criteria of the stop plan was fulfilled in 68% of the time between sunset and sunrise (10min intervals marked red), in the rest of the time of the night the WT was running (green).

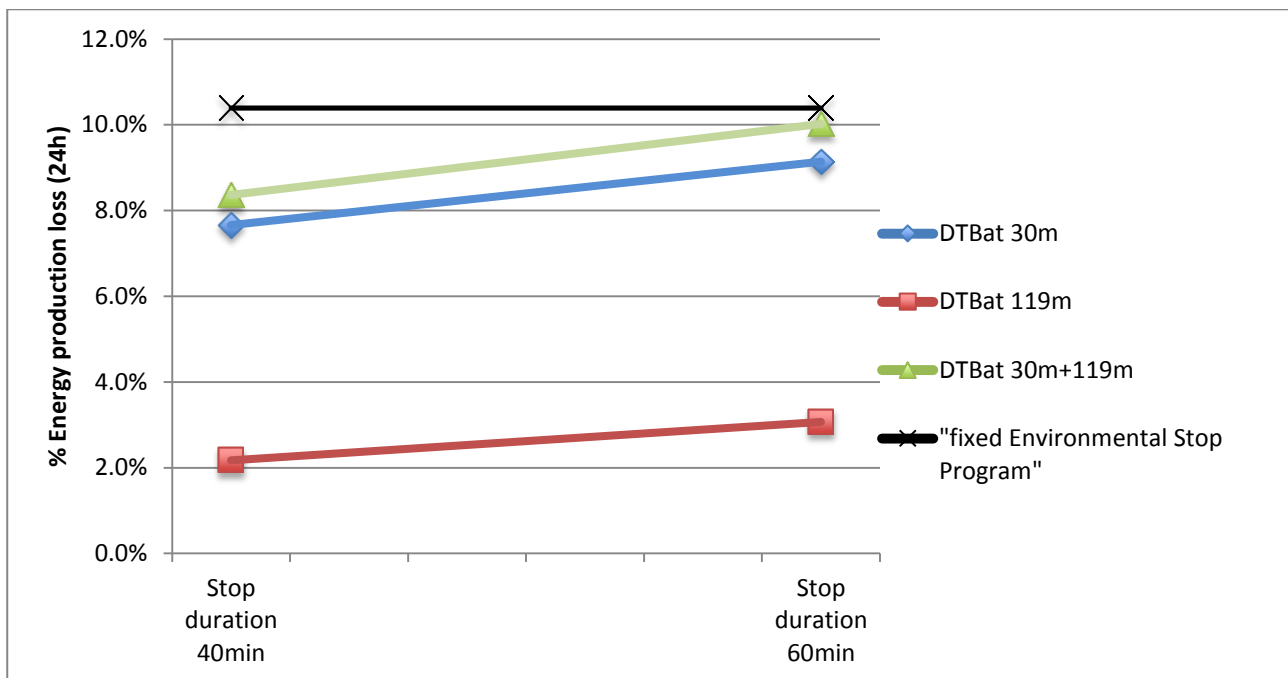
**Fig. 13:** Percentage of energy production loss using different stop durations and compared to energy production loss using current Fixed Environmental Stop Program

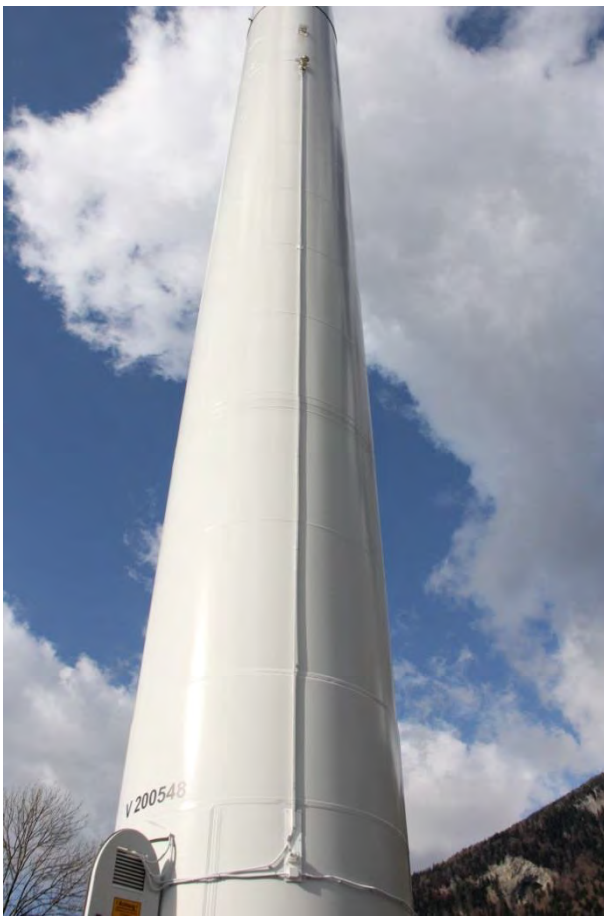
Camera, Loudspeakers, Microphone - NORTH

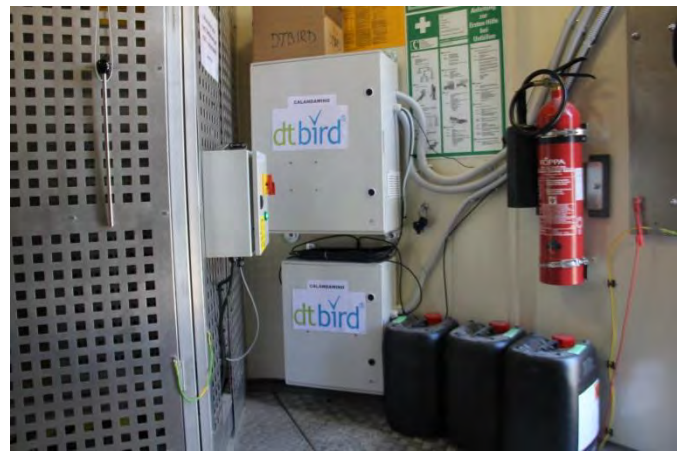
DTBird (above) and Bat (below) Computers

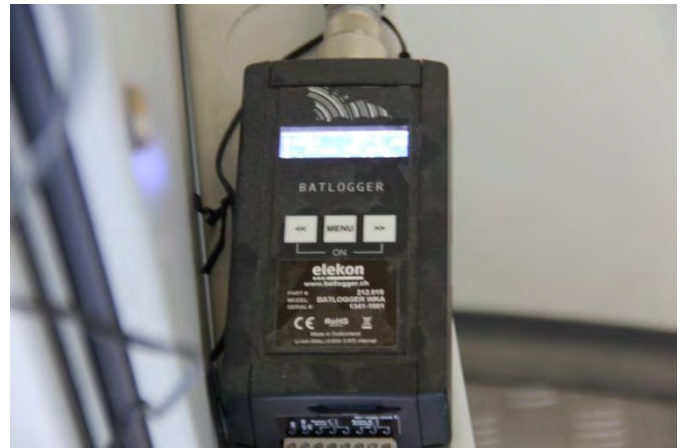
BATLogger SWILD
