Shetland Tidal Array Monitoring Report July 2023 to June 2024

Title:	Shetland Tidal Array Monitoring Report July 2023 to June 2024
Document ID:	STA013
Version	Revision 1.0
Prepared for:	Marine Directorate Licensing Operations Team and Shetland Islands Council
Author:	Kate Smith
Approved by:	Gavin McPherson
Release date:	31-Dec-24
Confidentiality:	PUBLIC REPORT

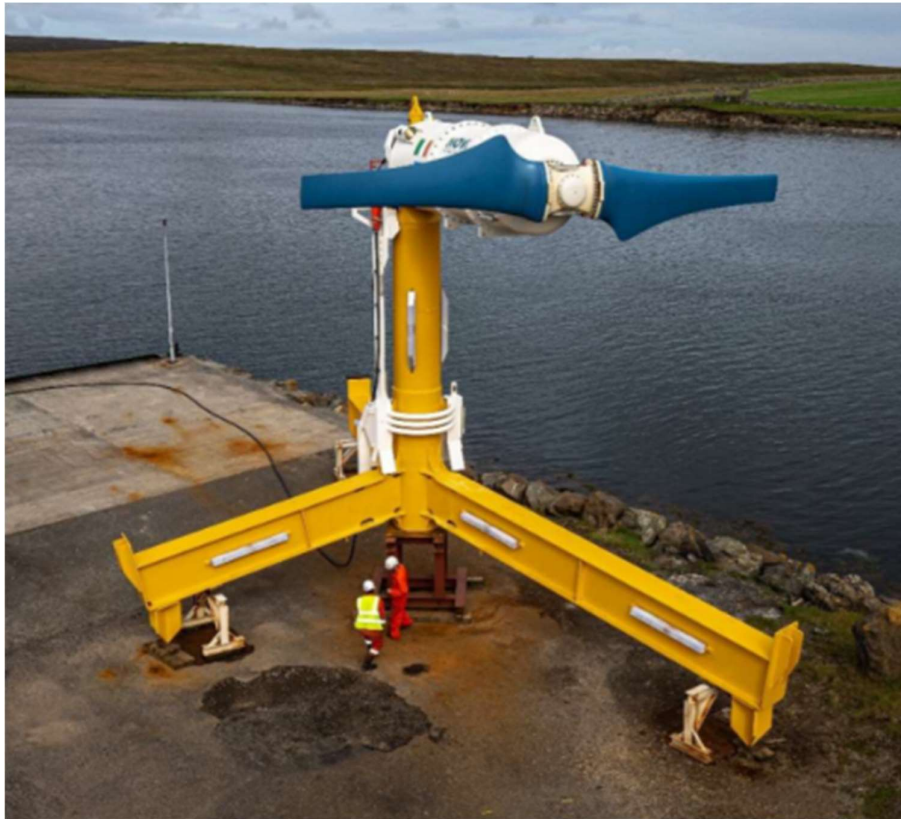
Figure 3-2: The Nova M100-D turbine. *Source: Nova Innovation.*

Figure 3-2 shows an M100-D turbine on the quayside in Bluemull Sound, before being installed in the Shetland Tidal Array.

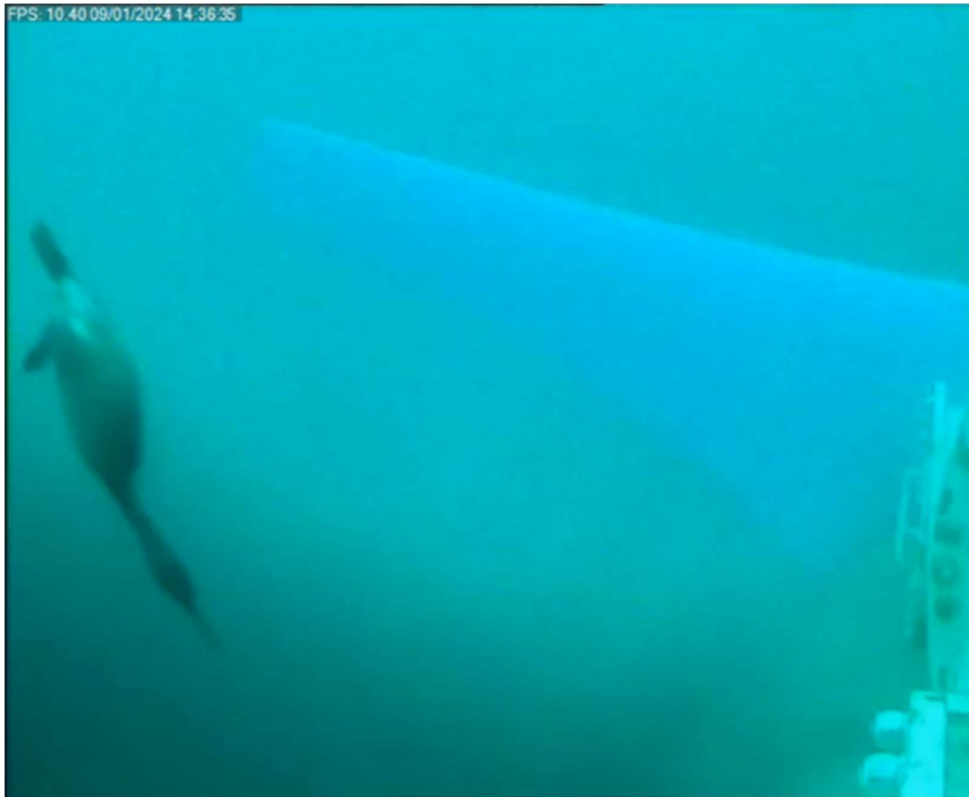
Figure 6-2: European shag (*Gulosus aristotelis*) observed in video footage on 01/09/2024.

The first of these three observations of European shag was on 09/01/2024 at 14:36 when a single European shag was observed diving past camera towards the seabed in apparent pursuit of prey. Figure 6-2 shows a still image of the bird taken from this video file.

No fish were seen throughout this video. Tidal flow was minimal throughout this video (decreasing ebb tide), and the turbine was stationary.

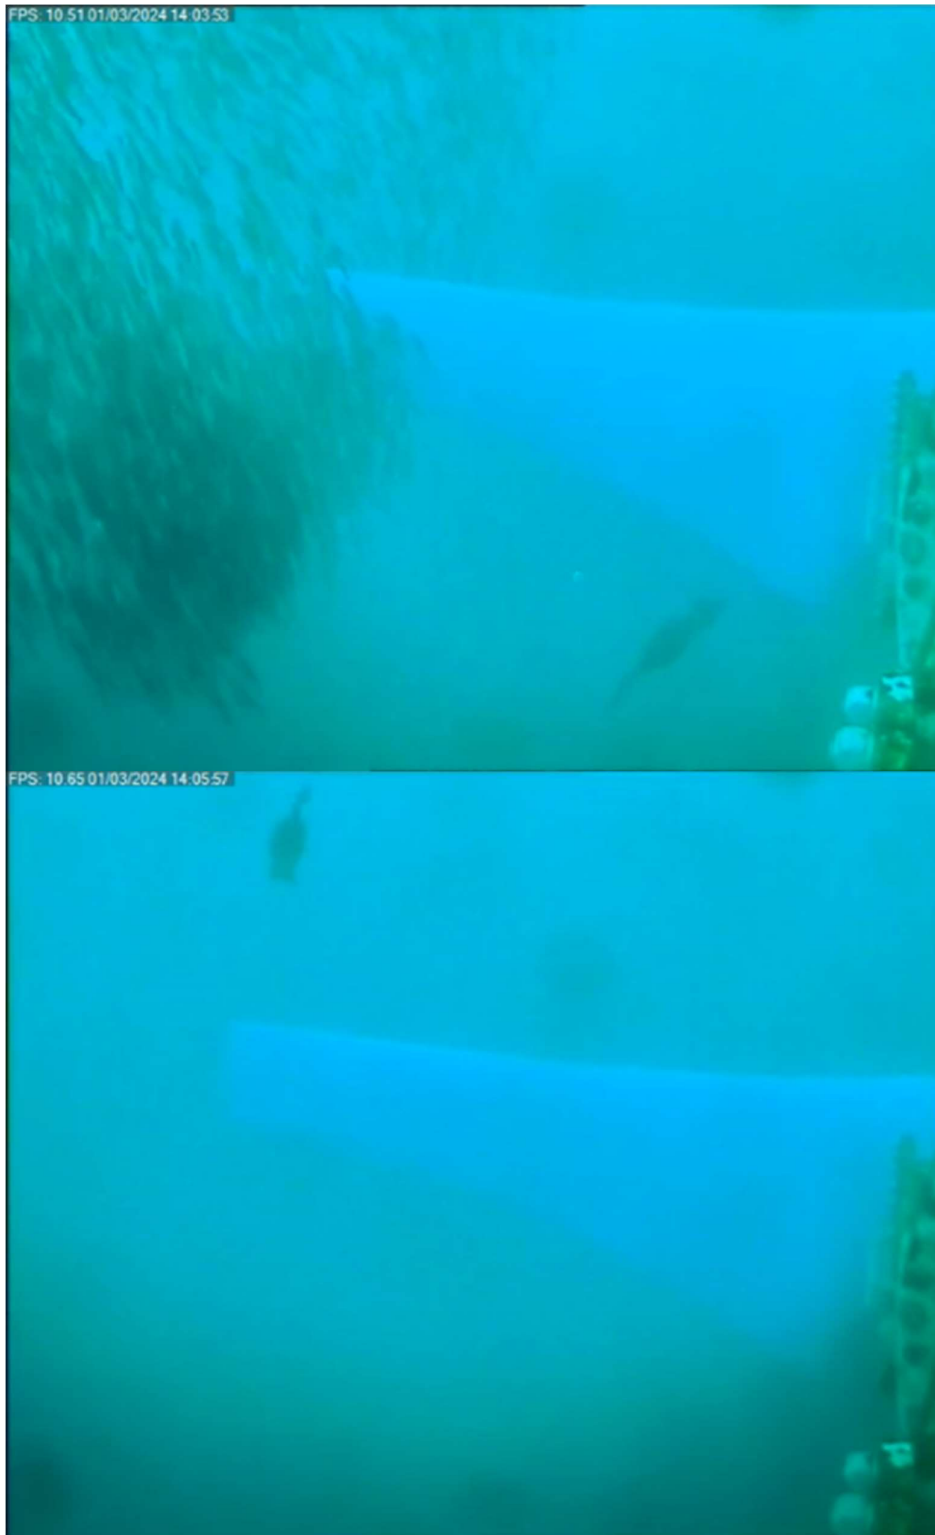
Figure 6-3: A European shag (*Gulosus aristotelis*) observed pursuing a large shoal of schooling fish on 01/03/2024 (top image). Two minutes later a shag was seen returning towards the sea surface (bottom image), possibly the same bird.

On 01/03/2024 two consecutive video files contained instances of individual European shag. The first was at 14:03, when a bird was seen in pursuit of a large shoal of fish (genus *Pollachius*). In the next video 2 minutes later at 14:05 a bird was seen returning towards the surface. Figure 6-3 (over) shows still images of the bird(s) taken from these video files.

These two videos may feature the same individual bird, since European shag are capable of foraging dives of periods of greater than two minutes (Carlsen et al, 2021). Analysis of data from vantage point surveys previously carried out as part of the Shetland Tidal Array monitoring programme recorded a maximum European shag dive duration of 164 seconds within the array area (Holmes, 2021). In both of these videos, the tidal state was decreasing flood and the turbine was stationary.

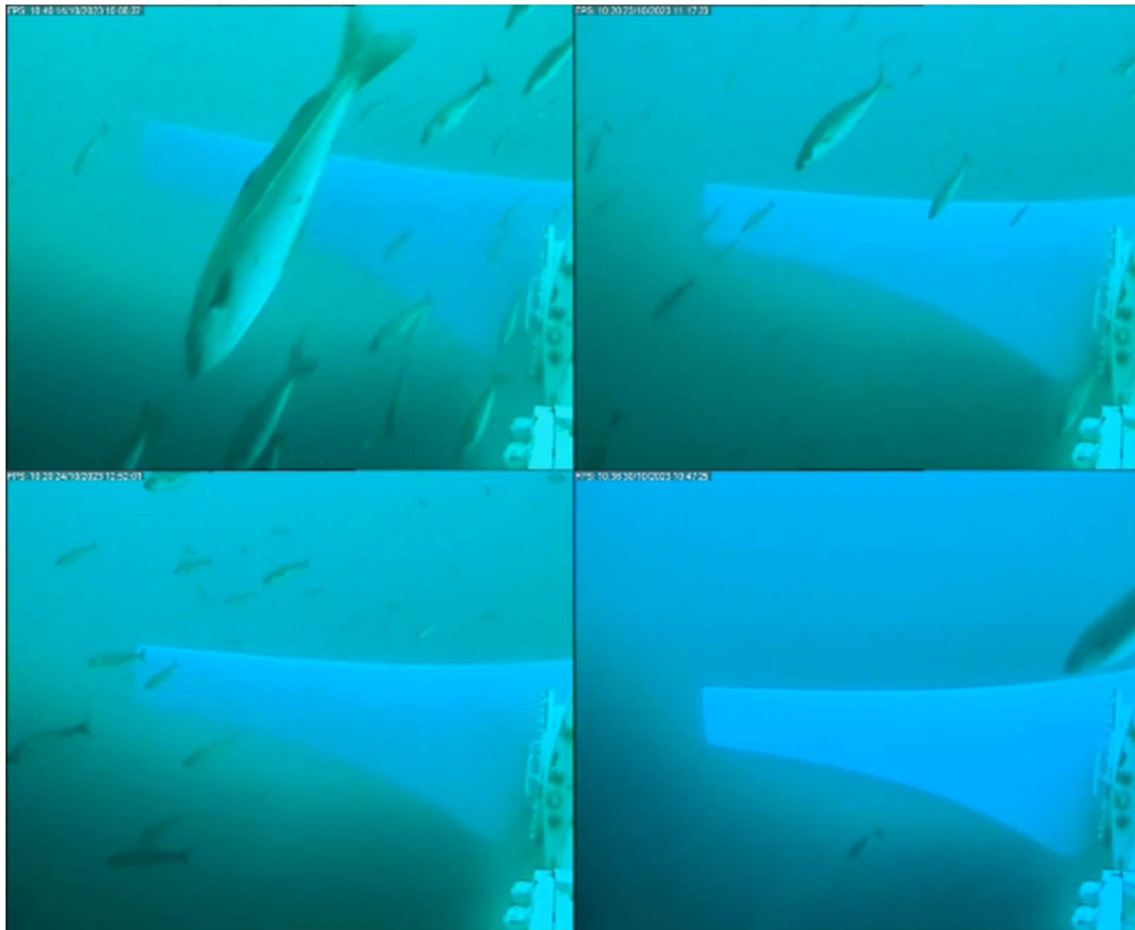
Figure 6-4: Examples of fish (*Pollachius* sp.) aggregating at hub height when tidal flow was absent or very limited.

Fish displaying this behaviour generally occurred in groups, with individuals mostly swimming independently to one another. Some examples of this behaviour observed in footage from July 2023 to June 2024 are shown in Figure 6-4. This behaviour is typical of species of pollack, which are known to aggregate around shipwrecks and other artificial subsea structures.

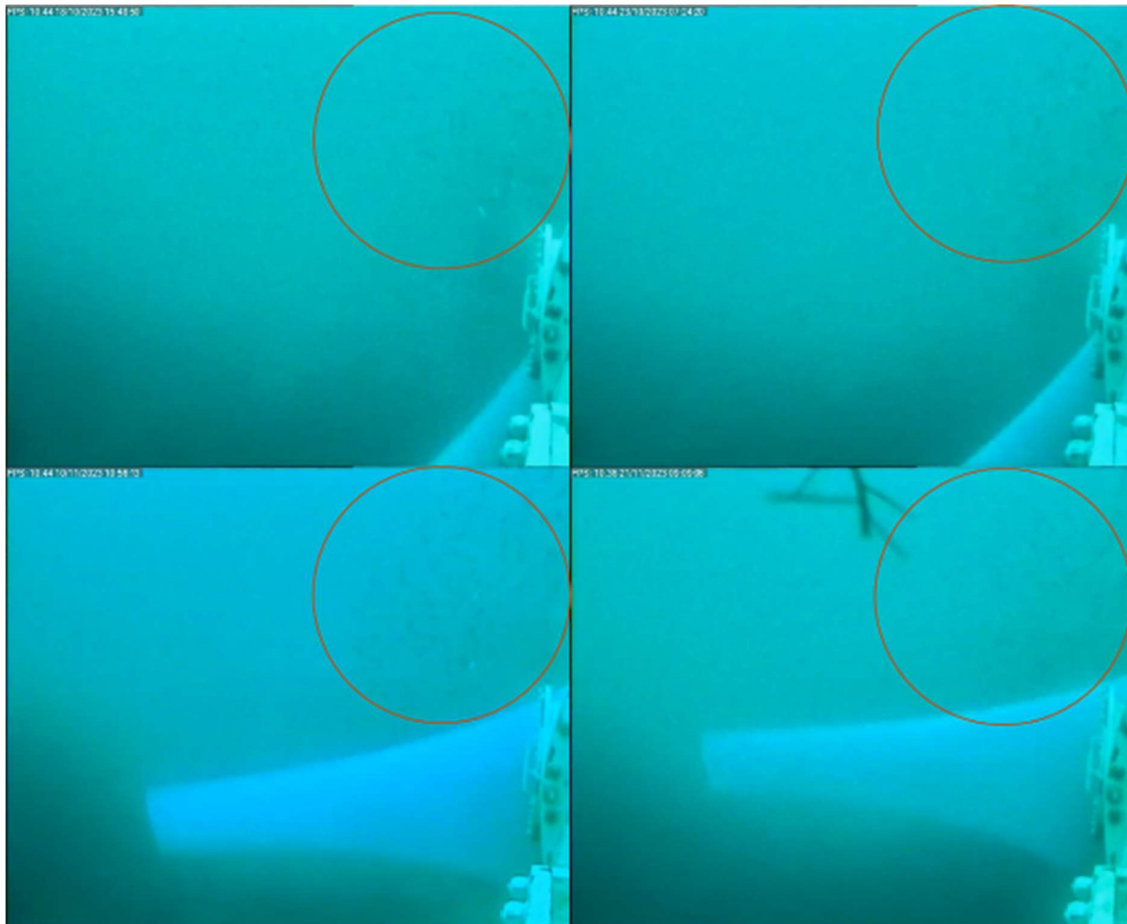
Figure 6-5: Groups of fish (circled in red) observed downstream of the operating turbine during the ebb tide when flow runs south to north through Bluemull Sound.

The aggregations of fish downstream of operating turbines on the ebb tide were often positioned at nacelle height some distance beyond the turbine. Their distance from the turbine meant that they were at no risk of collisions and individuals were never observed near the rotor-swept area. The behaviour of these fish was suggestive of feeding activity in the turbulent flow created in the wake of the turbine. Examples of these observations are shown in Figure 6-5.

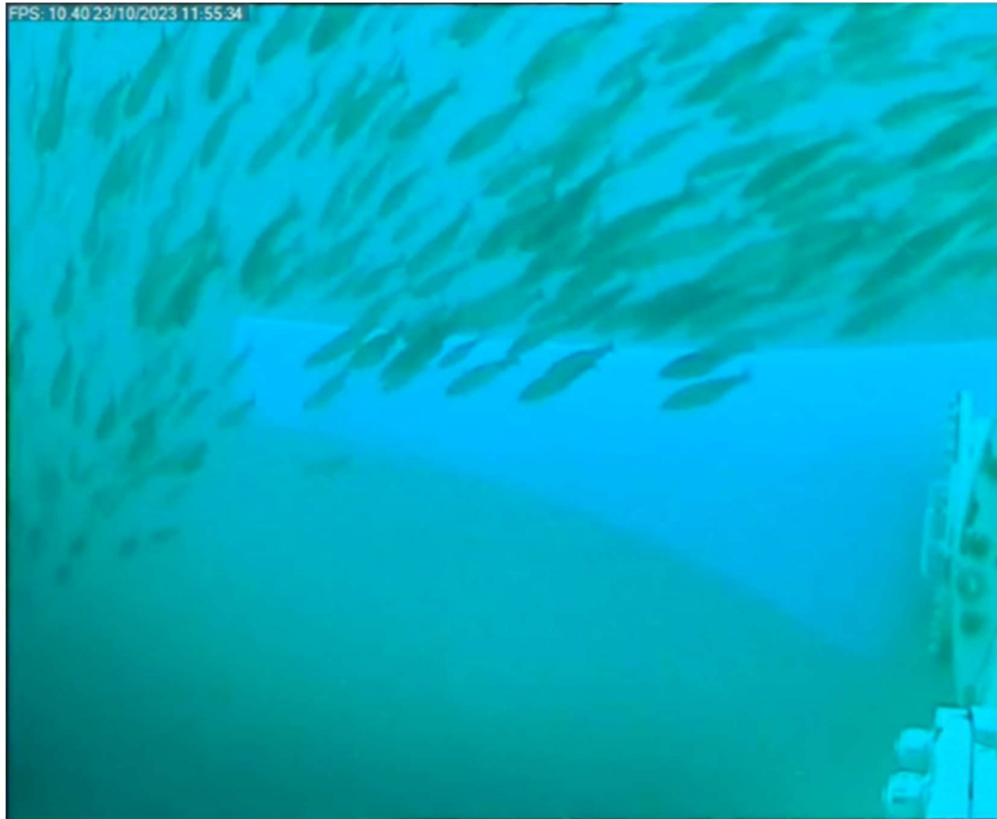
Figure 6-7: A large shoal of fish displaying sudden and rapid schooling behaviour towards the seabed on 23/10/2023. No predator was observed in footage.

As detailed in Section 6.3, on 01/03/2024 a European shag was seen on a decreasing flood tide (the turbine was stationary) pursuing a large group of schooling fish. On 23/10/2023 (11:55) on a decreasing ebb tide (the turbine was stationary) a large shoal of fish milling at hub height displayed sudden and rapid schooling towards the seabed, shown in Figure 6-7. No diving birds or mammals were observed in any of the footage analysed for 23/10/2023³, but the presence of a predator may have induced this rapid schooling response, which could also have been caused by other factors such as a passing vessel.

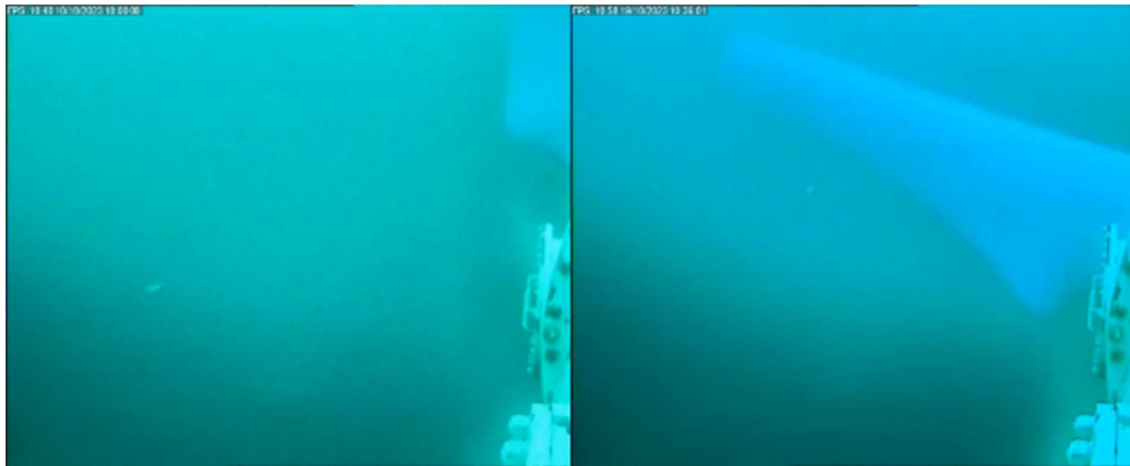
In six video files (1.2% of all footage analysed) objects which may be small whitefish were detected passing quickly through the camera's field of view with fast flowing currents, on both the ebb and flood tides. It has not been possible to identify these individuals to species level nor confirm with total confidence that they are live fish. While some of these objects (assumed to be fish) were observed to pass through or close to the rotor-swept area no collisions with the turbine blades were observed when video was viewed at the slowest possible speed.

Examples of these possible whitefish transiting turbines at fast current speeds in video from July 2023 to June 2024 are shown in Figure 6-8.

Figure 6-8: Examples of potential whitefish observed passing turbines in fast flowing tide, on 10/10/23 (left image) when tidal state was increasing ebb and 30/10/2023 (right image) when tidal state was maximum flood. Turbines were operating in both images but no collisions or near misses were observed.

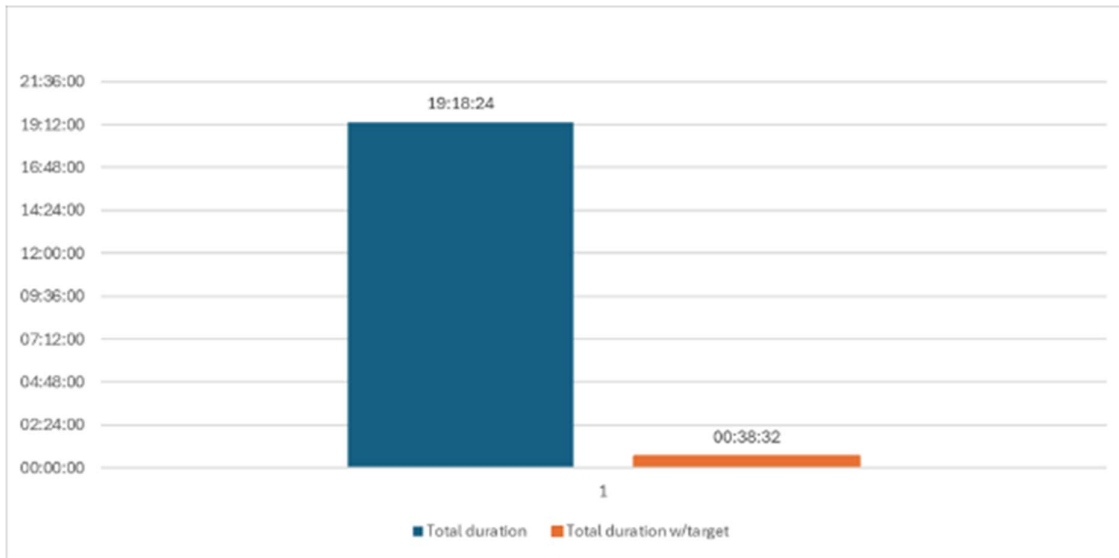
Figure 6-9: Dataset reduction by automated video analysis. Data reduction is shown as a) the number of videos and size of the dataset (GB), and b) the length of the video dataset (hours).

a) Size of dataset (GB and number of video files)

b) Length of footage (hours)

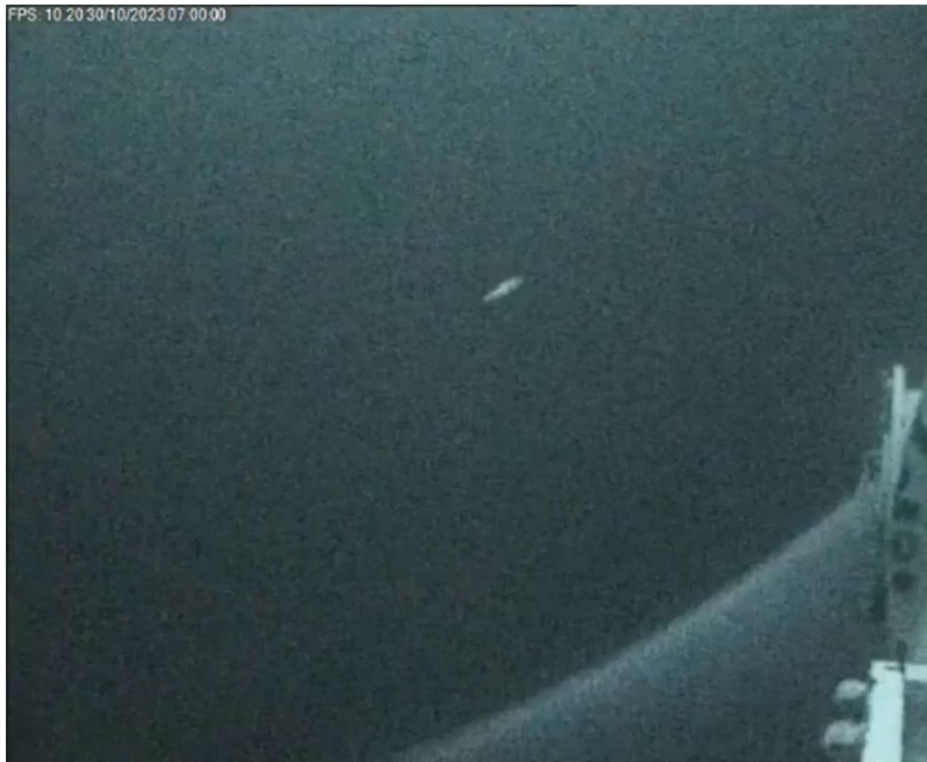
Figure 6-10: Example of a whitefish detected by the machine learning model in low light levels and passing the turbine on fast flow during the increasing flood tide.

Figure 6-10 shows an example of one of the most ‘cryptic’ targets detected by the model in the data analysed within this report, demonstrating its capabilities. In this video, captured at 07:30 on 30/10/2024 in very low light levels just after dawn⁵ a small whitefish was detected quickly passing the turbine on an increasing flood tide.

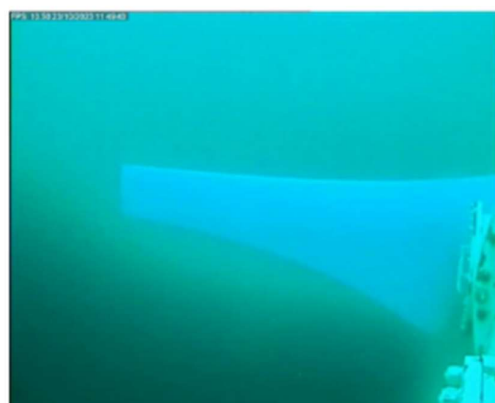
1_2023-10-23_11-49-34.mp4

Filename (.mp4)	Date	Time GMT	Turbine operating?	Tidal state	Details
1_2023-10-23_11-49-34	23/10/2023	11:49	No	Decreasing ebb	Single fish at hub height including around rotor.
1_2023-10-23_11-50-22	23/10/2023	11:50	No	Decreasing ebb	Small group of fish milling at hub height including around rotor.
1_2023-10-23_11-55-22	23/10/2023	11:55	No	Decreasing ebb	Large group of fish milling at hub height including around rotor. Some schooling behaviour observed, but no predators in field of view.
1_2023-10-23_11-58-06	23/10/2023	11:58	No	Decreasing ebb	Small group of fish milling at hub height including around rotor.
1_2023-10-23_11-59-31	23/10/2023	11:59	No	Decreasing ebb	Small group of fish milling at hub height including around rotor.
1_2023-10-23_11-59-42	23/10/2023	11:59	No	Decreasing ebb	Large group of fish milling at hub height including around rotor.
1_2023-10-23_12-00-32	23/10/2023	12:00	No	Decreasing ebb	Large group of fish milling at hub height including around rotor.
