# OERA Research on Tidal Marine Energy

## Sensor Testing Research for Environmental Effects Monitoring (STREEM)

### FINAL PROJECT REPORT

### ACER Technical Report No. 127

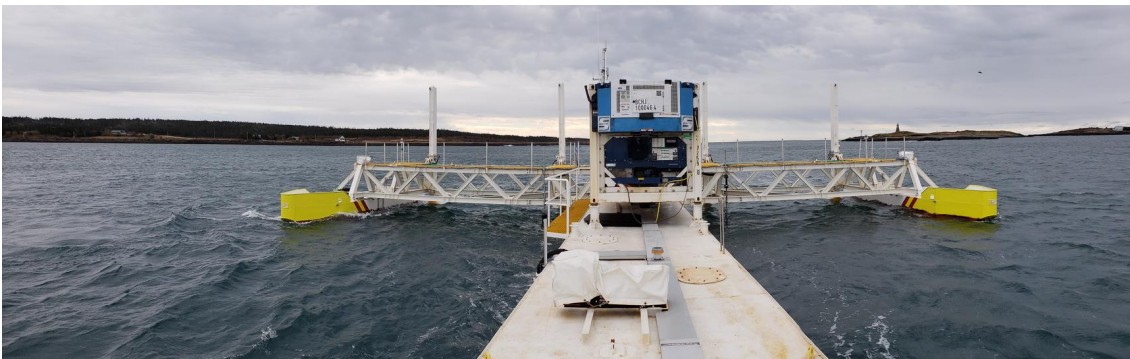
Figure 1: Wide-angle view of Sustainable Marine Energy’s (SME’s) PLAT-I looking sternwards from the bow. Photographs and image stitching by Mike Adams.

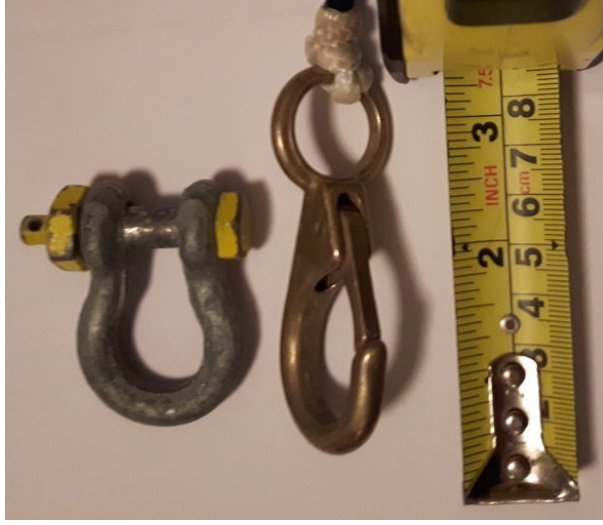
Figure 3: Shackle and brass clip: Brass clips were used on the cross-line for the target float on 13 October 2018. The shackle was used to weight targets that were cast from PLAT-I on 23 October 2018. Photo credit: Connor Sanderson.

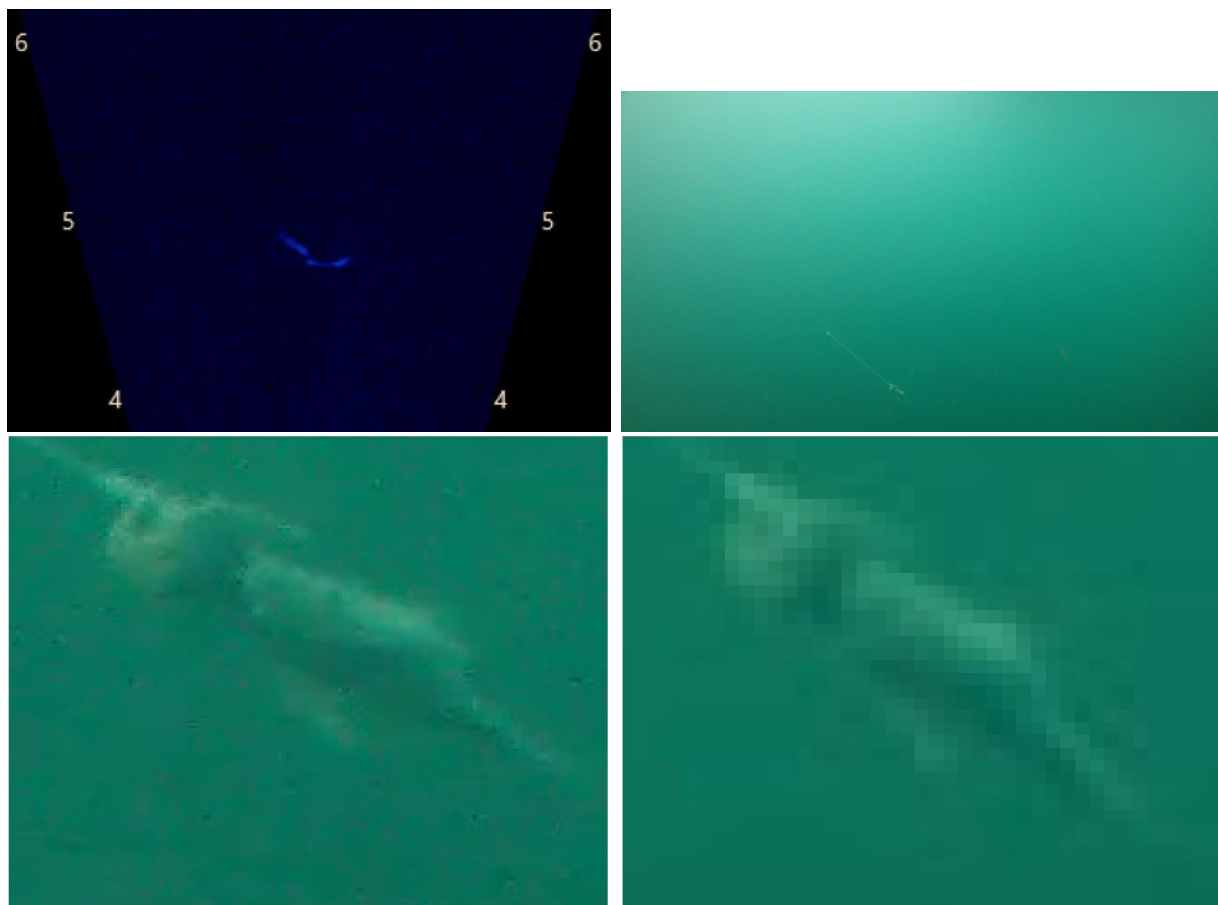
Figure 20: TOP-LEFT: Aris image of the target (shackle with line to a 20 cm herring) at 4.5 m range. TOP-RIGHT: GOPRO image ( $3840 \times 2160$  pixels) showing the target at 3.3 m range. BOTTOM-LEFT: Zooming in on the 20 cm herring, full resolution of the GOPRO. BOTTOM-RIGHT: Same image as to the left, except that the pixel size is increased by a factor of 2. Measurements were made at 1912 UTC on 23 October 2018.

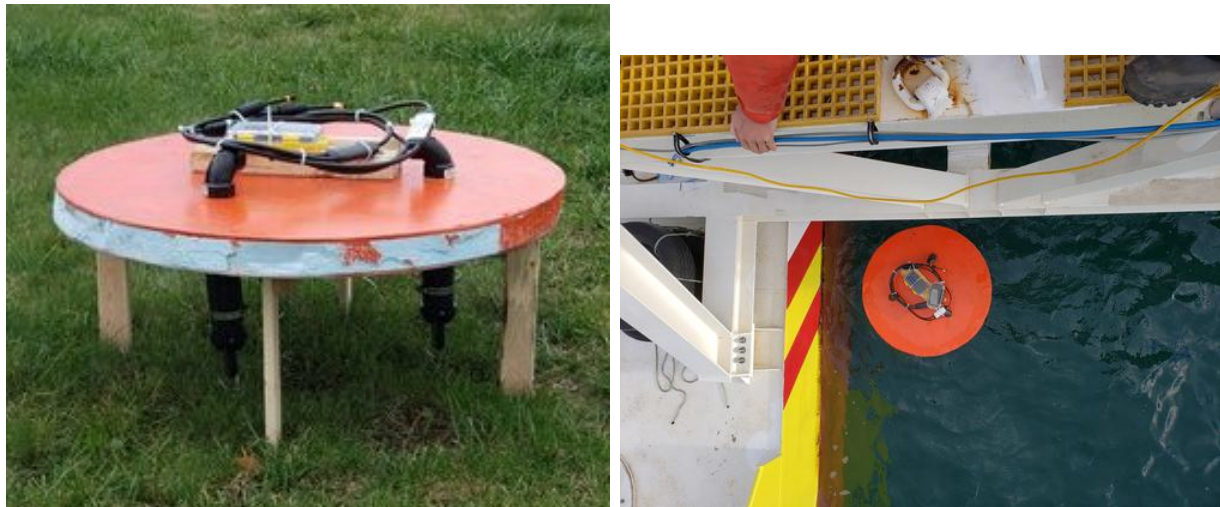
Figure 36: LEFT: Pad-float hydrophone-array on a wooden stand, showing Smart Cable and GPS/compass above and hydrophones below. RIGHT: Deployed and passing between the hulls of PLAT-I. Photo credit: Mike Adams.
