# Field report installation test reef and research into reef conditions

Gemini OWF

De Rijke Noordzee

WP1220\_R2r0

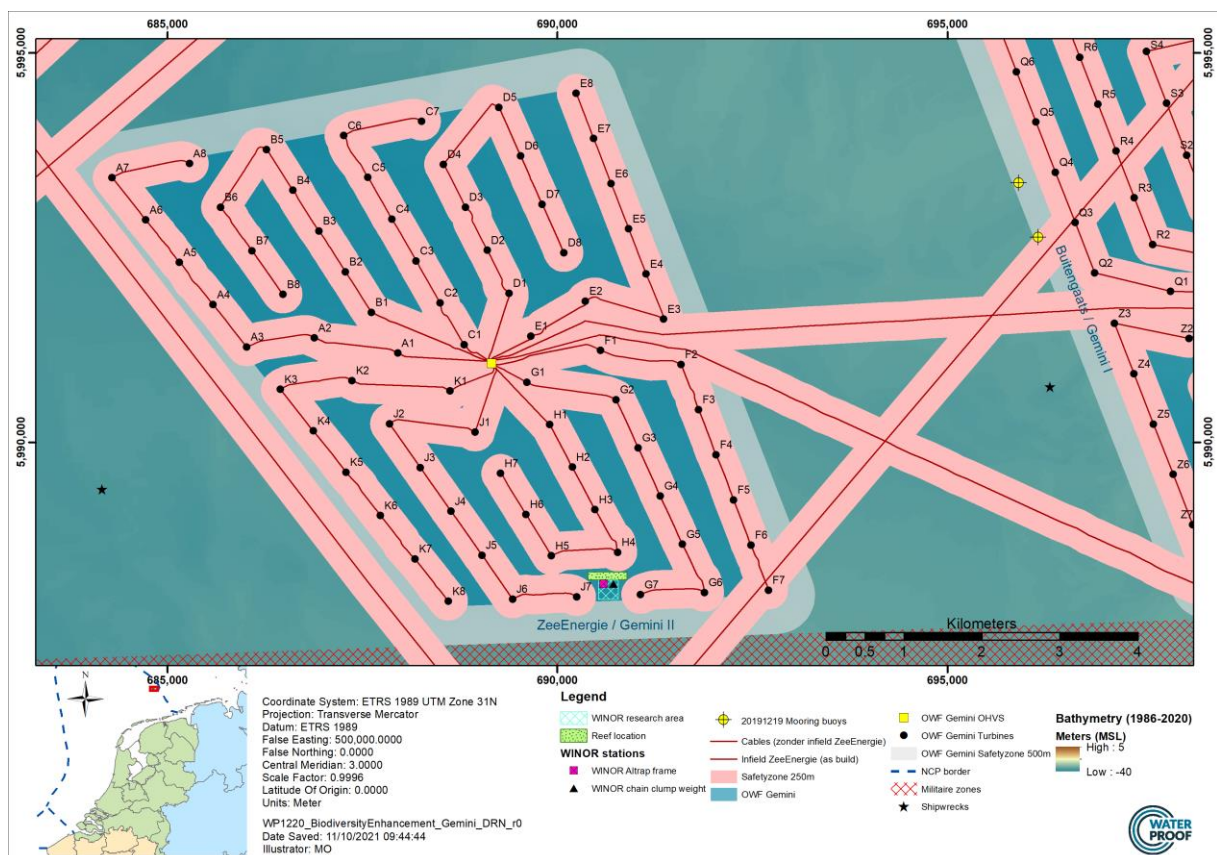
The location of the oyster reef and WINOR research location is shown in Figure 1.1.

Figure 1.1 Selected flat oyster reef and WINOR location.

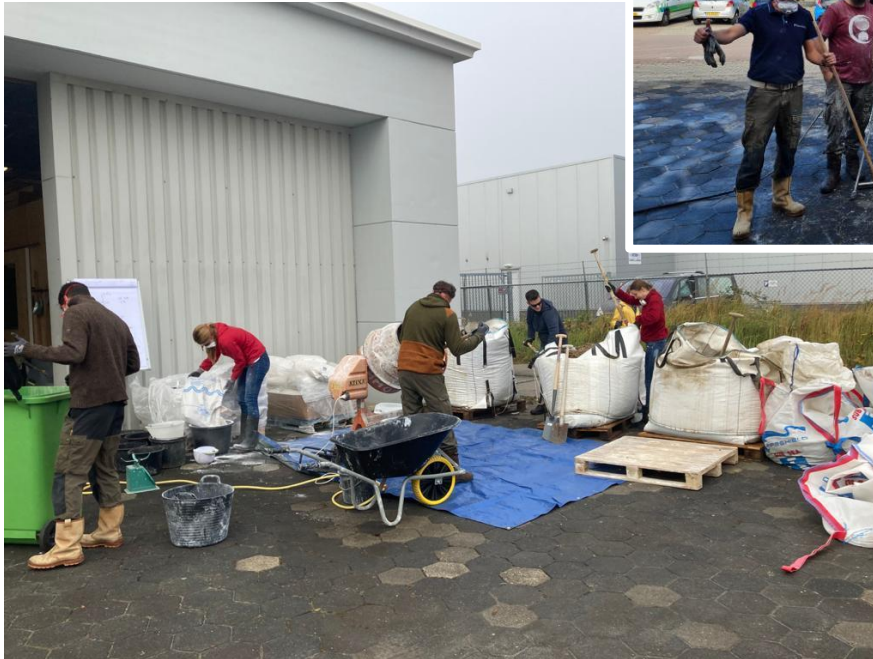
To build the reef, substrate needs to be added to the seafloor, to provide suitable substrate for oyster larvae to settle on. As part of the research, substrate (shells) are treated with BESE reef paste, to enhance stability of the substrate once deployed. Moreover, several studies showed oyster spat is attracted to settle on material treated with BESE reef paste. Before treatment, several experiments were conducted to determine the best ratio of different substances.

*Figure 2.3 Treatment of substrate with BESE paste at Bureau Waardenburg.*

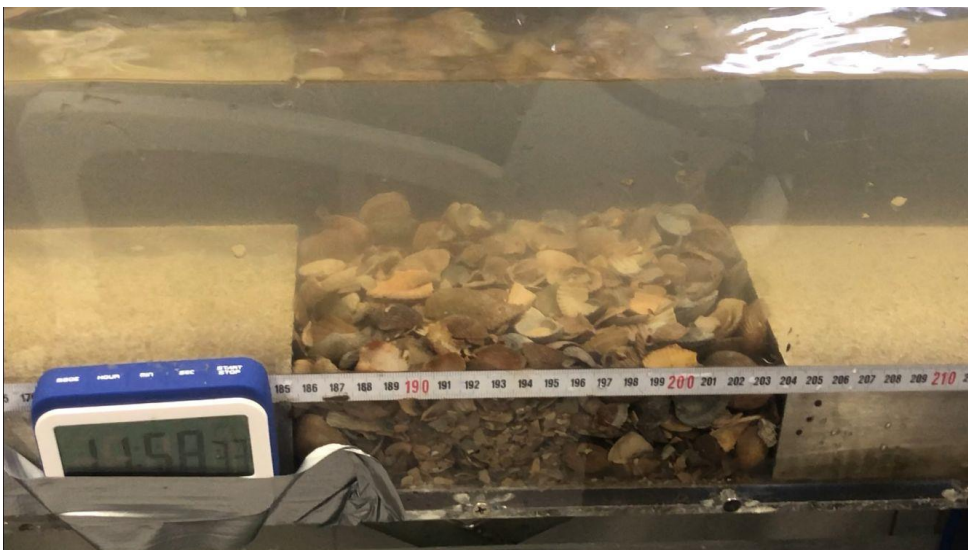
Stability of the substrate with and without treatment has been assessed by means of various flume experiments in the WaterProof lab (Figure 2.4). Based on the experiments and supplementary calculations, the substrate was concluded to be sufficiently stable to withstand hydrodynamic conditions on the project location. Also, treatment with BESE paste was concluded to enhance stability.

*Figure 2.4 Flume experiments WaterProof BV.*

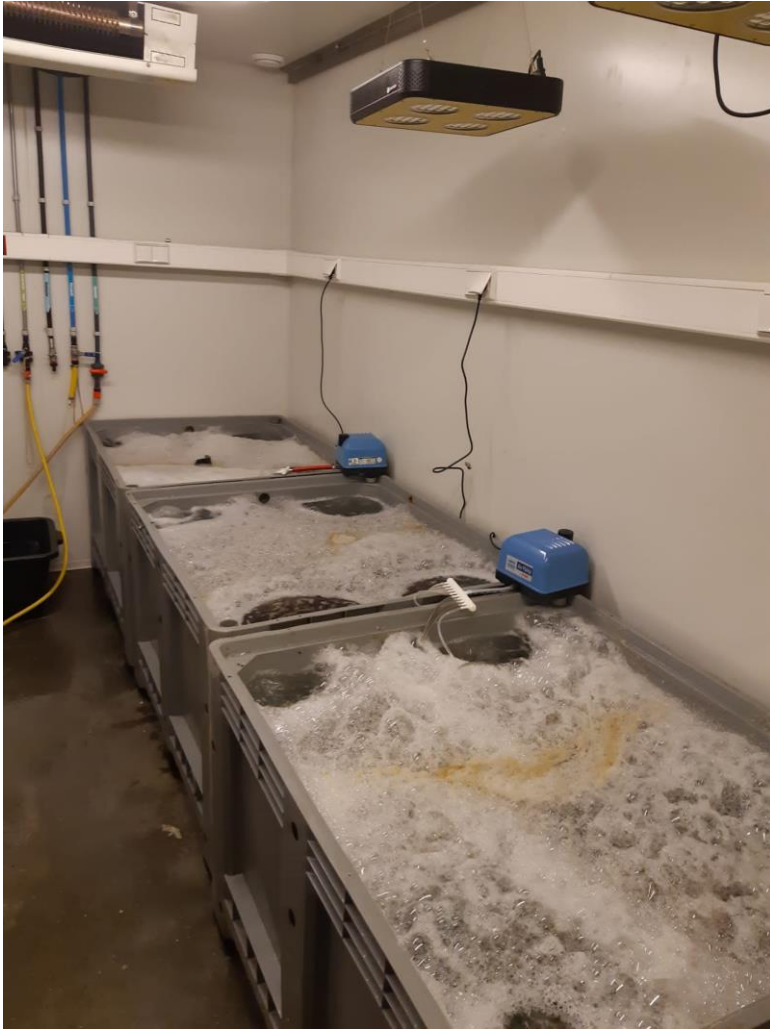
1512 oysters were purchased in Norway, transported by cooled truck in 7 days to the Netherlands, kept in cold and filtered seawater (see Figure 2.6) for 12 days with only 5 mortalities.

*Figure 2.6 Tanks at WMR with adult flat oysters.*

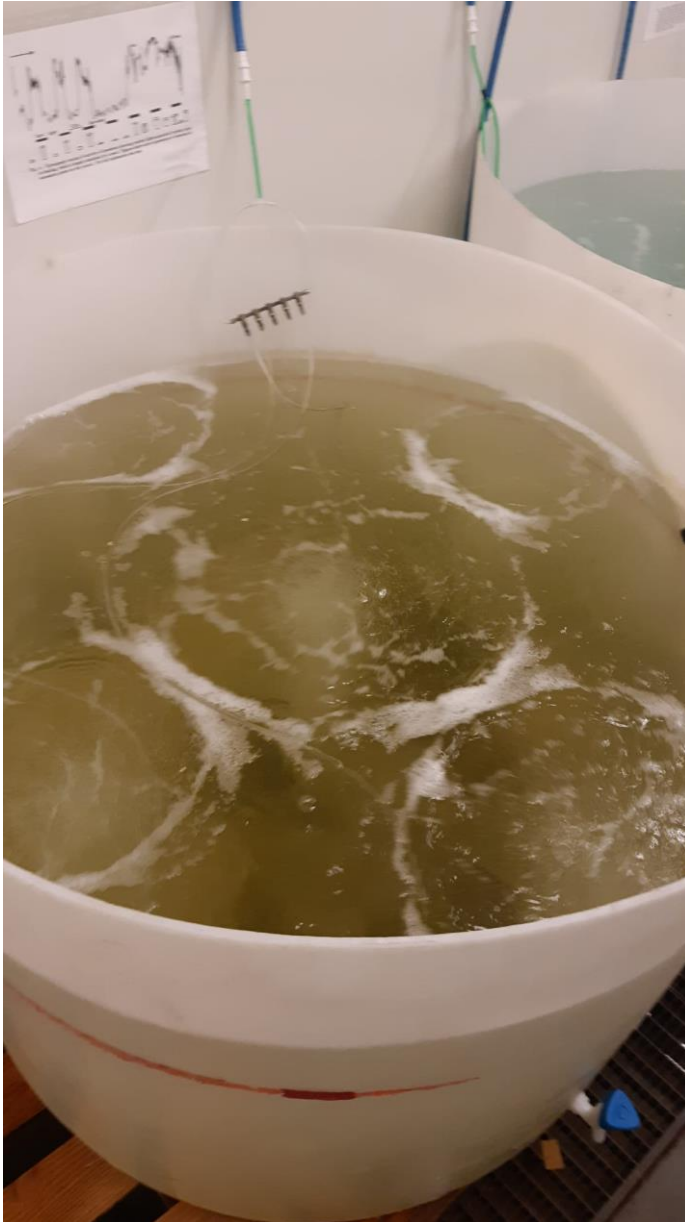
WMR initiated the remote settling process at their basins to let the larvae settle on substrate (see Figure 2.7). However, the condition of the larvae was unfortunately insufficient for successful settlement. Several lessons learned are taken from this experiment and optimizations of this procedure can be made.

*Figure 2.7 Remote settling experiments at WMR.*

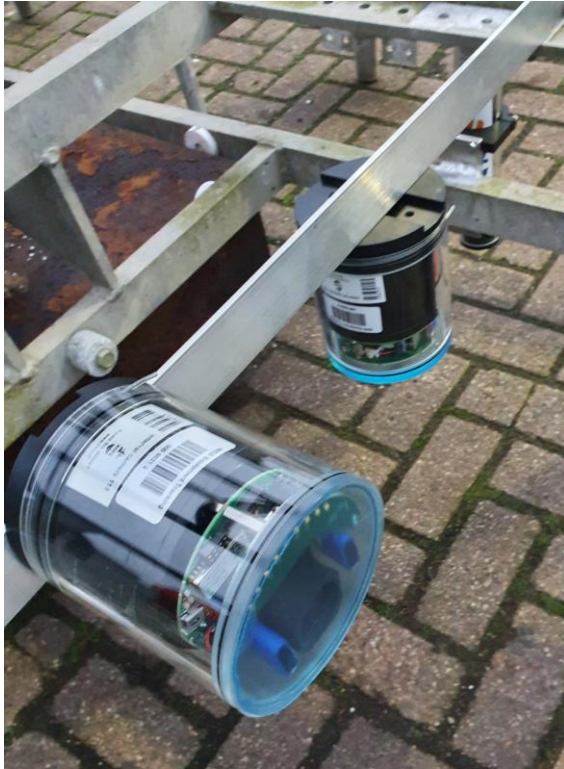
Extensive preparations have been made with the setup of the various sensors on the measurement frame (see Figure 2.8). The MIXLander frame has been customized to host all the sensors. The following sensors are placed on the frame:

- ADCP HR-system;
- ADCP HR-system;
- C3-Turner (turbidity, chlorophyll);
- C3-Turner (turbidity, chlorophyll);
- A-SED sensors;
- BioPhys sensors – valve-gape monitoring
- One basket with flat oyster shells (spat on shell not placed – see Section 2.6)
- Two baskets with flat oysters (41 in total)
- Time laps camera

*Figure 2.8 Various NIOZ sensors equipped on the measurement frame.*

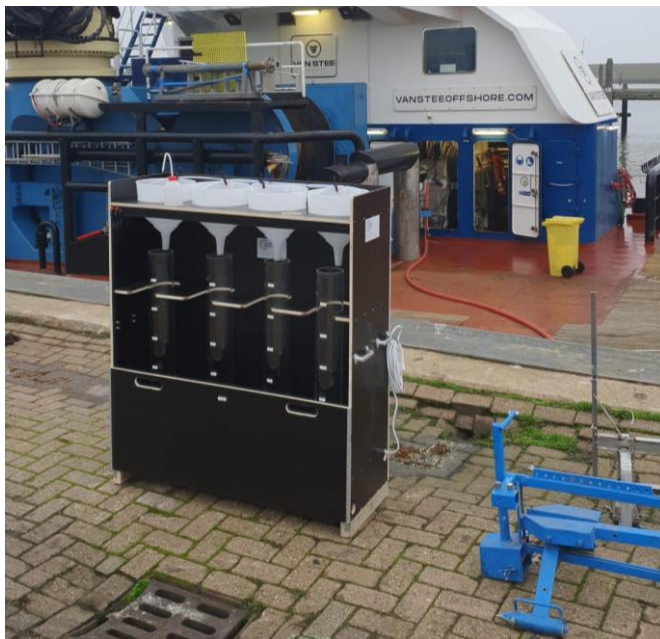
To measure actual sediment transport and sediment in the water at the oyster reef location, the Blue Marlin and Barracuda measurement fishes are prepared for sediment and water sampling. The water sampling cabinet used for this is shown in Figure 2.9.

*Figure 2.9 Water sampling cabinet and Blue Marlin measurement fish of WaterProof*

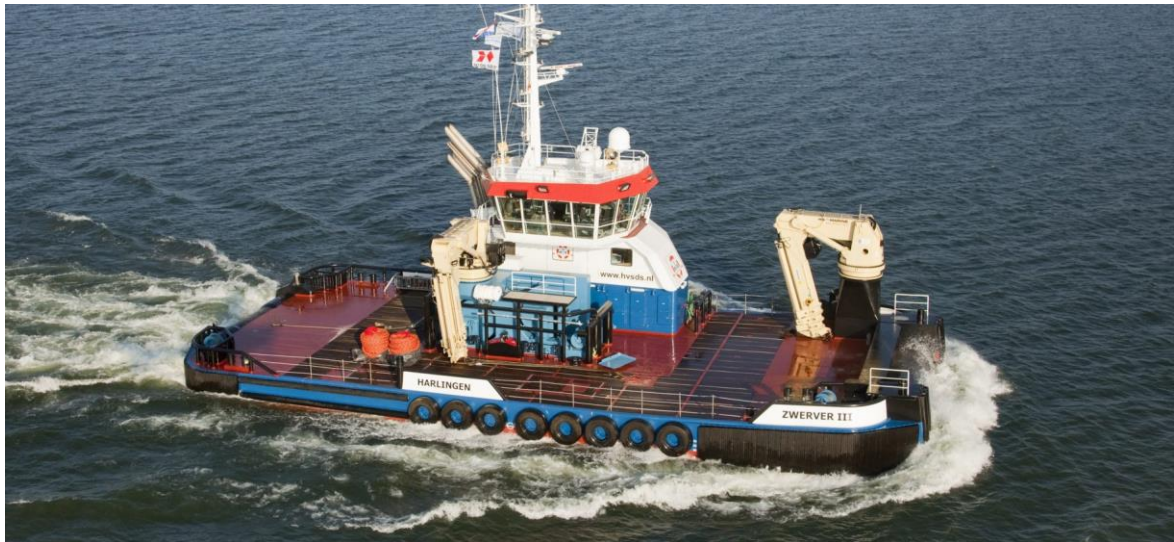
Figure 3.1 Zwerver III, van Stee Offshore.

Works have been carried out from the vessel Zwerver III, operated by Van Stee Offshore (see Figure 3.1).

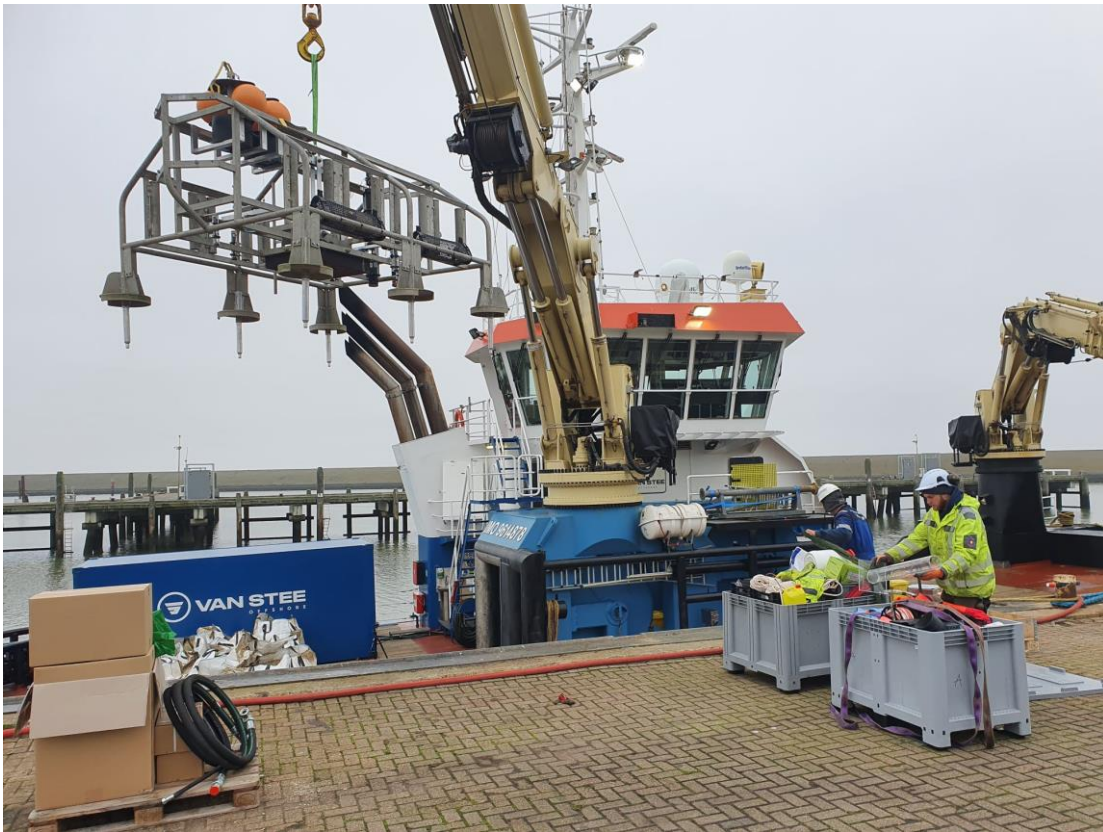
On the 15<sup>th</sup> of November 2021, mobilization of all equipment to the vessel was done (Figure 3.2).

*Figure 3.2 Mobilization of measurement frame on the Zwerver III.*

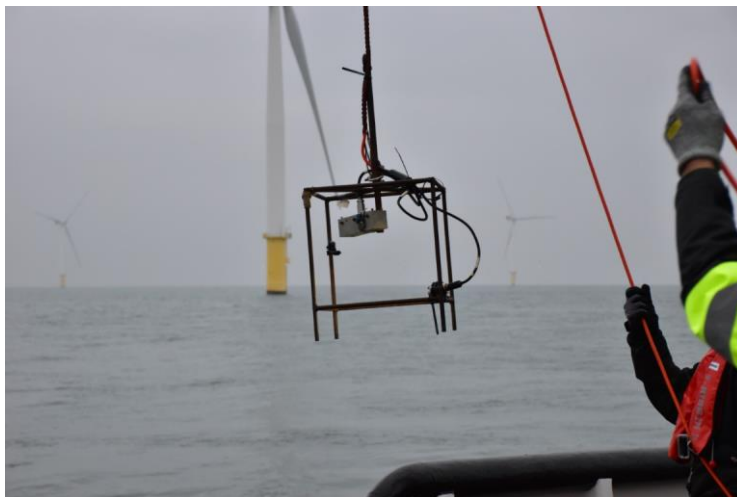
Figure 3.4 Drop cam monitoring prior to deployment

A photo impression of the works is given below (Figure 3.4 to Figure 3.11). Figure 3.12 shows the verification of the reef by means dropcam monitoring by Bureau Waardenburg. Clearly visible is the deployed substrated and adult oysters on top of the substrate.

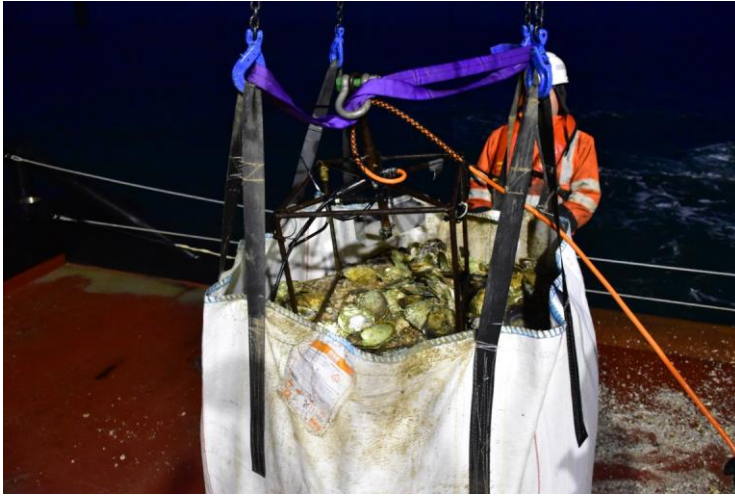
Figure 3.5 Big bag with adult oysters on top of substrate.

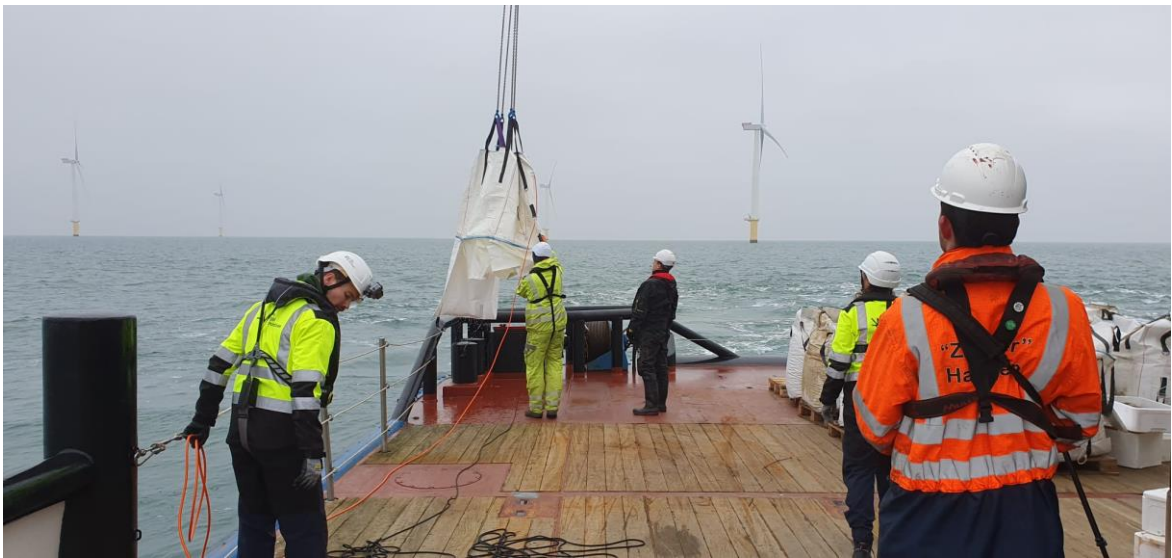
Figure 3.6 Deployment of substrate: bag successfully emptied on the seafloor.

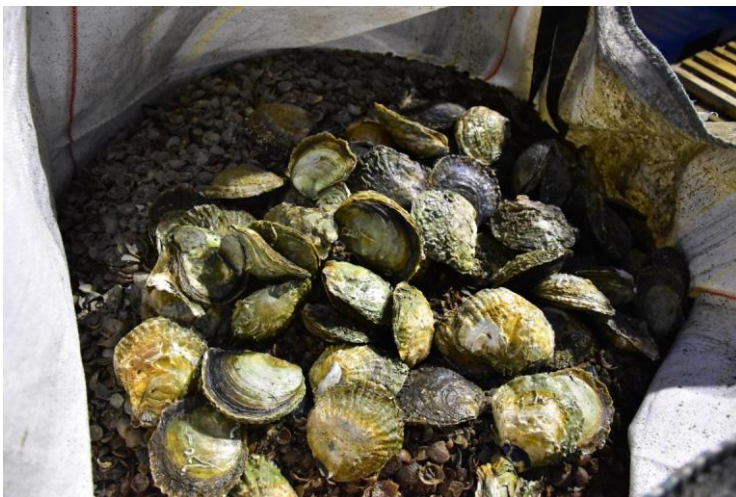
Figure 3.7 Deployment of substrate with adult oysters on top.

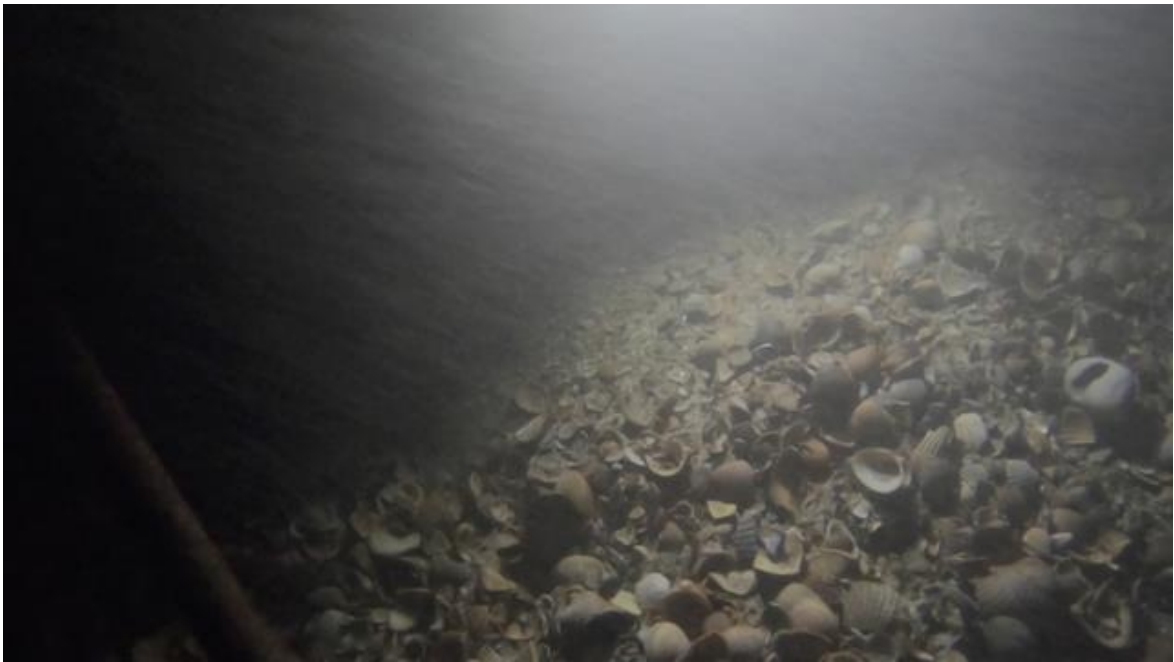
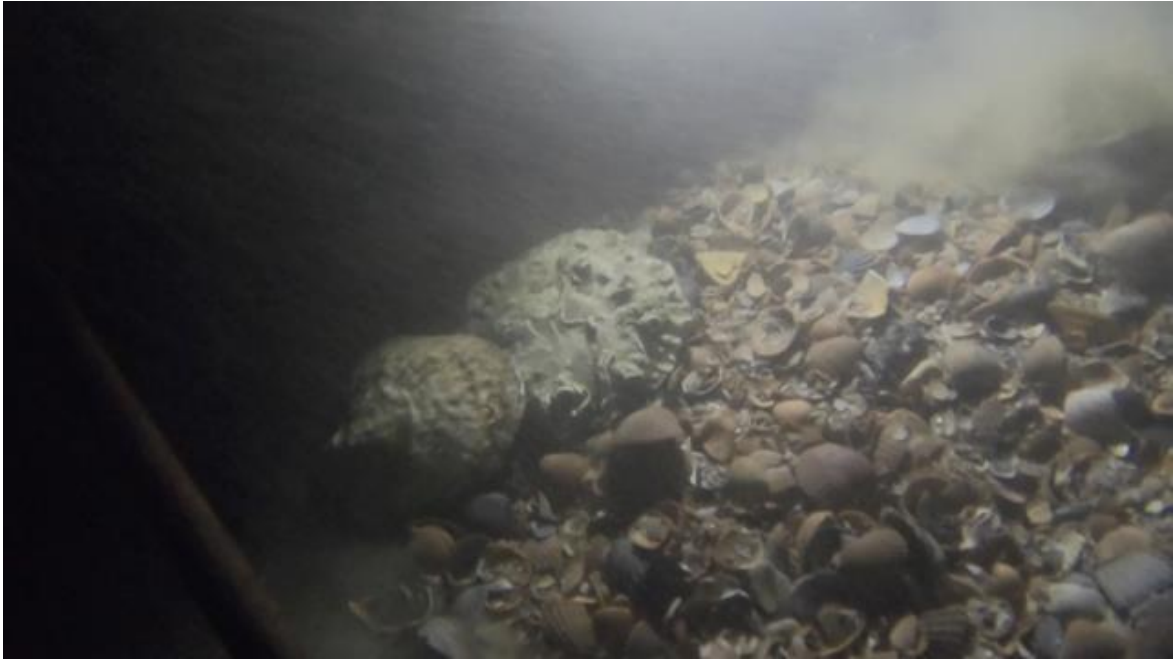
*Figure 3.12 Drop cam verification by Bureau Waardenburg, showing the substrate with adult oysters on the seafloor.*
