# Estimating microplastic emissions from offshore wind turbine blades in the Dutch North Sea

Marco Caboni<sup>1</sup>, Anna Elisa Schwarz<sup>2</sup>, Henk Slot<sup>3</sup>, and Harald van der Mijle Meijer<sup>1</sup>

<sup>1</sup>TNO, Wind Energy Technology, Westerduinweg 3, 1755 LE Petten, the Netherlands

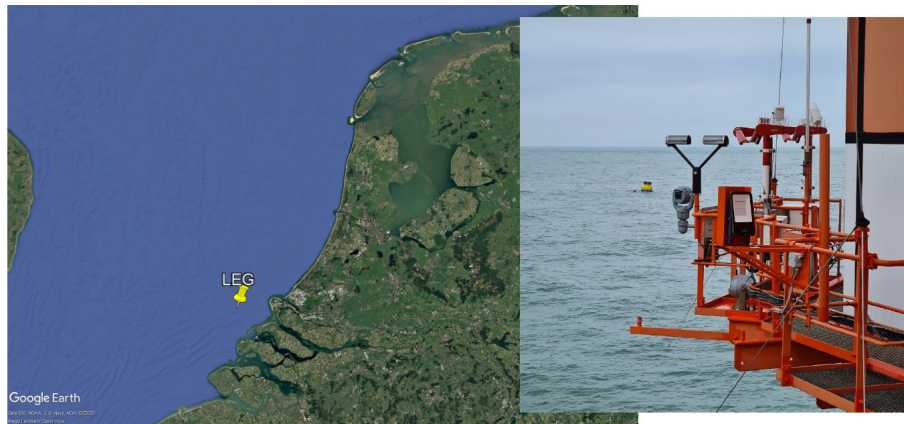
**Figure 1.** A map showing the location of the Lichteiland Goeree (LEG) platform, where concurrent rain and wind speed measurements were conducted (Caboni et al., 2024), and a picture of the OTT Parsivel<sup>2</sup> disdrometer installed on the platform are shown. Map courtesy of © Google Earth.

Measured offshore weather data supported this work by providing input to the erosion model. Rain measurements provided information on the number and size of droplets, as well as their fall velocity, while wind speed was correlated with rotor speed, dictating the impact speed between raindrops and blades. Concurrent measurements of rain and wind at the Dutch North Sea are scarce. The only available source of measurements is provided by TNO (Caboni et al., 2024) for a relatively short period. More specifically, over a period of 1 year, from March 2022 to March 2023, TNO carried out concurrent rainfall and wind speed measurements at the offshore Lichteiland Goeree (LEG) platform. Figure 1 depicts the exact location of the platform. Rainfall measurements were carried out by means of an OTT Parsivel<sup>2</sup> disdrometer. Wind speed was measured by means of a Leosphere WindCube V2 lidar. Since the current investigation focuses only on rain-induced erosion, measured events with snow and hail have been filtered out, retaining just rainy intervals. Hailstones, being larger, heavier, and harder than raindrops, can cause delamination, indentations, and surface cracking depending on their size and falling velocity (Verma et al., 2023). The impact of hailstones on blade erosion in the North Sea is not yet fully understood, so this topic has been excluded from the scope of this work. In 2022, the average wind speed at 140 m above sea level at LEG was 9.3 ms<sup>-1</sup>, which is slightly lower than the 2015–2022 average of 9.9 ms<sup>-1</sup> (Vitulli et al., 2023). 2022 was a relatively dry year in the Netherlands, with a national average rainfall of 729 mm (KNMI, 2022). Typically, the country’s average annual rainfall is 795 mm.

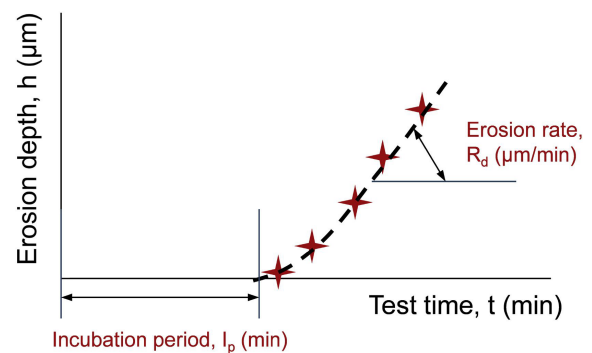
**Figure 2.** The figure illustrates the leading edge erosion process, showing a schematic of erosion depth over time during a droplet erosion test. Figure reproduced from Slot et al. (2015).

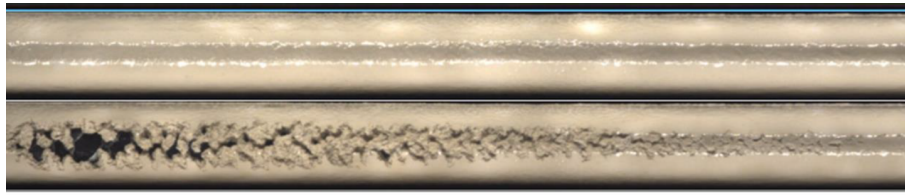
**Figure 3.** Examples of an initial and a tested specimen in the rotating arm tester. This figure is adapted from Hawkins and Nyboe (2019).

wind turbine blades. The RET method, as detailed in DNV-RP-0171 (2008) (DNV, 2021), demonstrates the highest accuracy and reliability when compared to real rain conditions. Figure 3 illustrates an example of a specimen both at the initial stage and after prolonged exposure in the rotating arm test. For example, Fig. 4 collects the results of regular inspections of the specimen surface at intervals during a rain erosion test conducted on a Teknos' LEP system. The graph correlates the number of drop impacts at a specific specimen location, thus characterized by a certain tangential velocity, that lead to the end of incubation, defined as the onset of material loss (see Fig. 2). The graph illustrates that as the local velocity decreases, the incubation period, measured by the number of drop impacts, increases. The local drop impact velocity is considered equal to the local specimen tangential velocity. Depending on the type of LEP system sometimes large scatters in obtained data points have been observed. The best fit using a power function for these data points gives the relation between the incubation period and drop impact velocity resulting in the fit constants exponent  $m$  (–) and a constant  $C$  ( $\text{m s}^{-1}$ ) (see Eq. 13).

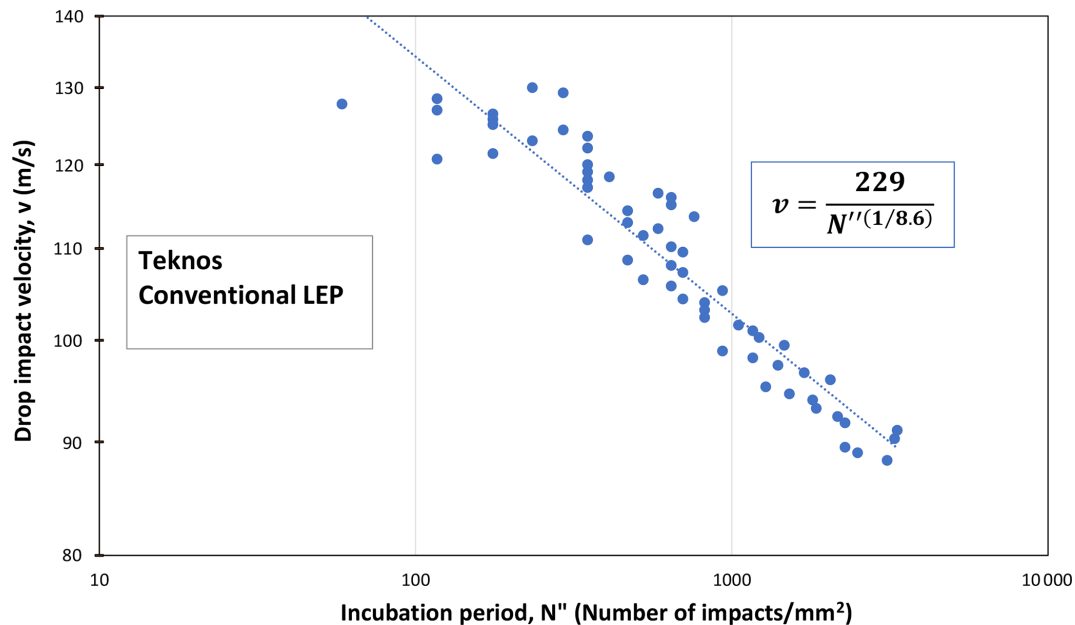
**Figure 4.** The results of periodic inspections of the specimen surface during a rain erosion test on Teknos' LEP system are presented. The fitting equation is displayed.

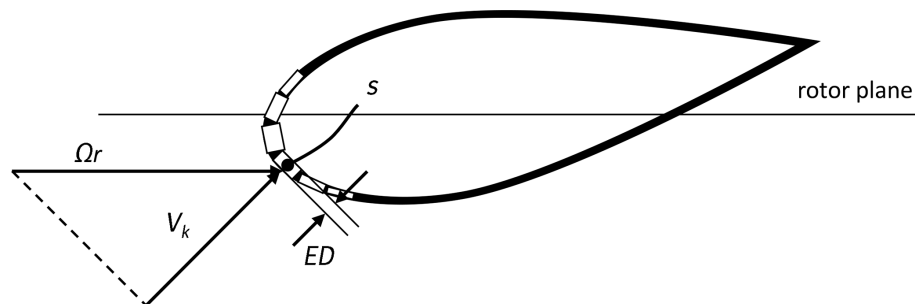
**Figure 5.** A sketch illustrating the parameters used to evaluate the erosion depth of a generic chord-wise element.  $\Omega r$  represents the assumed relative velocity between the raindrop and the blade section, where  $\Omega$  is the rotor's angular velocity and  $r$  is the radial distance of the section from the rotor center.  $V_k$  is the component of  $\Omega r$  normal to the surface element. ED and  $s$  denote the eroded depth and eroded surface area of the generic element, respectively.

The first challenge is determining the relative velocity between raindrops and the blade. Given the complexity of obtaining precise estimates of this parameter, certain assumptions were necessary. As mentioned earlier, the relative velocity between raindrops and the blade is primarily influenced by the blade's tangential velocity. However, the terminal velocity of the droplets (which is equal to around  $6 \text{ m s}^{-1}$  for a 2 mm droplet) and aerodynamic effects also play a role (Barfknecht and von Terzi, 2024). Small droplets are expected to be completely advected by the wind, whereas larger, heavier droplets experience less advection. Using a numerical methodology, Gires et al. (2022) estimated that rain droplets exceeding 0.6 mm in size experience minimal advection in a turbulent wind field. For simplicity, we assumed that the terminal velocity of the droplets and aerodynamic effects, including advection, are negligible compared to the blade's tangential velocity. In other words, we assumed that raindrops remain stationary in space from an absolute reference frame. Under these assumptions, the relative velocity between raindrops and a blade section is equal to the tangential velocity of that blade section. The tangential velocity,  $\Omega r$ , is aligned with the rotor plane, as illustrated in

Fig. 5. Due to the curved shape of the blade profiles, each section around the leading edge encounters the drops at different normal speeds,  $V_k$ . We discretized the shape of each blade profile into very small straight elements and calculated the normal component of the tangential velocity for each element, as shown in Fig. 5. This component was then used to assess the erosion amount from each element.

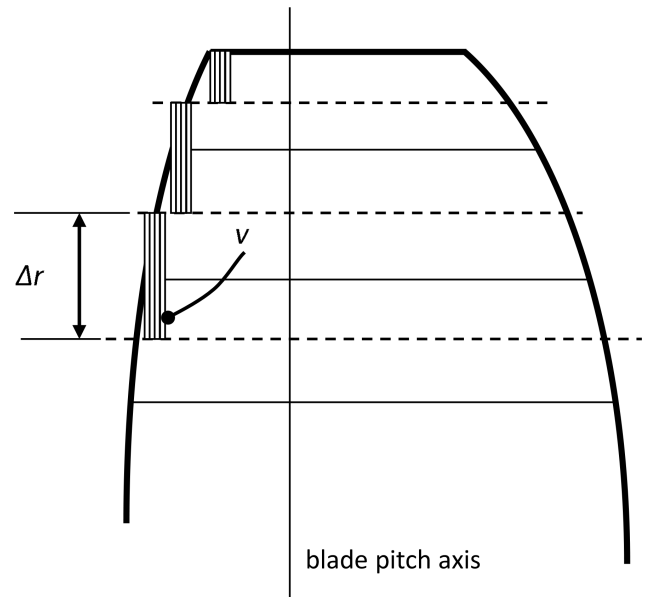
**Figure 6.** A sketch illustrating the parameters used to evaluate the eroded volume of a generic span-wise element.  $\Delta r$  represents the span-wise dimension of a generic element, and  $v$  denotes the eroded volume from that element.

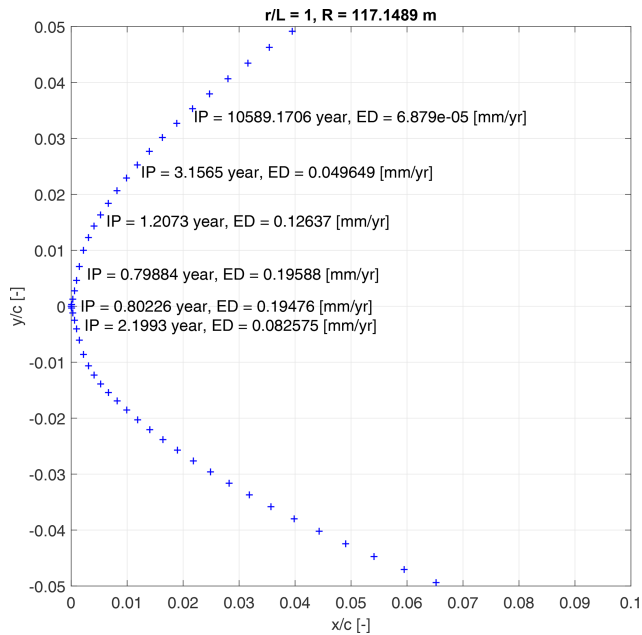
**Figure 7.** The figure illustrates the discretization of chord-wise elements of the tip airfoil. For certain elements, the incubation period, IP, and the yearly accumulated erosion depth, ED, are shown.  $r/L$  represents the relative position of the profile along the blade length, while  $R$  denotes the radial distance of the airfoil from the blade root.  $x/c$  and  $y/c$  are the airfoil coordinates, non-dimensional using the local chord length.

Figures 7 and 8 illustrate the leading edge discretization elements of the tip airfoil and an airfoil located at 75 % of the blade length from the root, respectively. For each element, the figures show the estimated incubation period and the yearly erosion depth using the aforementioned measured weather conditions. The erosion depth is expressed in millimeters of material removed per year. As expected, the erosion rate is greater around the leading edge, where the normal component of the relative velocity between the droplets and the blade is greater. As we move away from this zone towards the trailing edge, the erosion rate quickly decreases. For both profiles, the highest erosion rate is found on the upper surface. This is due to the section pitch angle (which is not shown in Figs. 7 and 8), rotating the profile counter-clockwise and increasing the exposure of the upper section to droplet impact. This is also evident in Fig. 5, where the rotor plane, representing the direction of the relative velocity between the droplets and the blade, intersects the profile on the upper side. This finding aligns with Vimalakanthan et al. (2023), which presents a 3D profile obtained using an optical scanner of a commercial wind turbine (63 m long) blade near

At the most exposed section of the tip, the incubation period is approximately 0.8 years, with an erosion depth of  $0.2 \text{ mm yr}^{-1}$ . At the section located 75 % of the blade length from the root, the incubation period for the most vulnerable element ends after 5 years, with the erosion depth progressing at a rate of  $0.04 \text{ mm yr}^{-1}$ . According to our estimation, erosion reaches a blade section located 75 % of the blade length from the root after approximately 5 years. Thus, to prevent erosion from propagating beyond this section, we assumed that one repair is conducted every 5 years. Under this assumption, we estimated the amount of plastic material eroded by rain from the leading edge of three blades over the assumed 25-year lifetime of the wind turbine. Table 3 summarizes the results. Following blade commissioning and each repair, the accumulated damage resets to zero. No material is removed during the first year, as none of the blade elements reach the incubation period. After 2 years, material begins to be released from the tip. The erosion then progresses inboard, increasing the amount of material lost. Once an erosion depth of 0.55 mm (the assumed thickness of the LEP system) is reached at a specific element of the profile leading edge, we assume that no further material can be released from that area. Indeed, by ensuring that operations and maintenance are effectively carried out, the appropriate maintenance and inspection strategy prevents excessive damage beyond the LEP system. Over the lifetime of

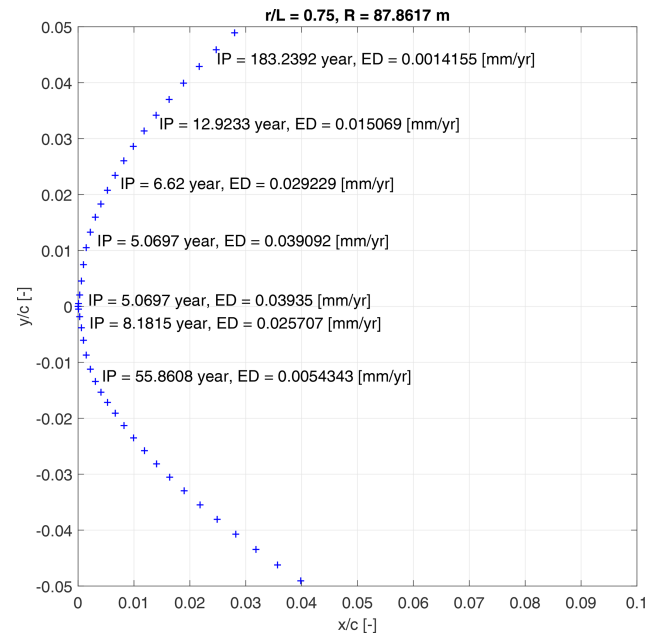
**Figure 8.** The figure illustrates the discretization of chord-wise elements of a blade profile located at 75 % blade length from the blade root. For certain elements, the incubation period, IP, and the yearly accumulated erosion depth, ED, are shown.  $r/L$  represents the relative position of the profile along the blade length, while  $R$  denotes the radial distance of the airfoil from the blade root.  $x/c$  and  $y/c$  are the airfoil coordinates, non-dimensional using the local chord length.

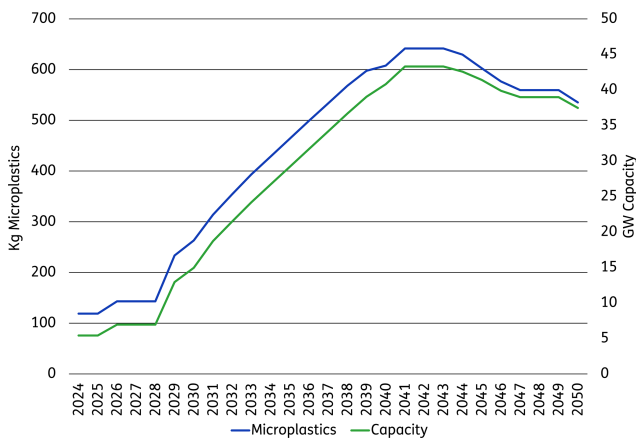
**Figure 9.** Annual microplastic emissions and the associated yearly capacity from Dutch offshore wind turbines in the North Sea.

In the previous section, we estimated that the IEA 15 MW Reference Wind Turbine (Gaertner et al., 2020), which has  $117 \text{ m}$  long blades, releases an average of  $240 \text{ g}$  of microplastics annually based on measured offshore weather conditions. Using this figure, we estimated the microplastics release from the different wind turbines installed in the Dutch North Sea by scaling the reference turbine's estimate linearly according to blade length. Figure 9 depicts the estimated release of microplastics into the oceanic environment from offshore wind turbines located over the Dutch North Sea between 2024 and 2050. Between 2024 and 2050, microplastic emissions are expected to rise due to the increasing in-

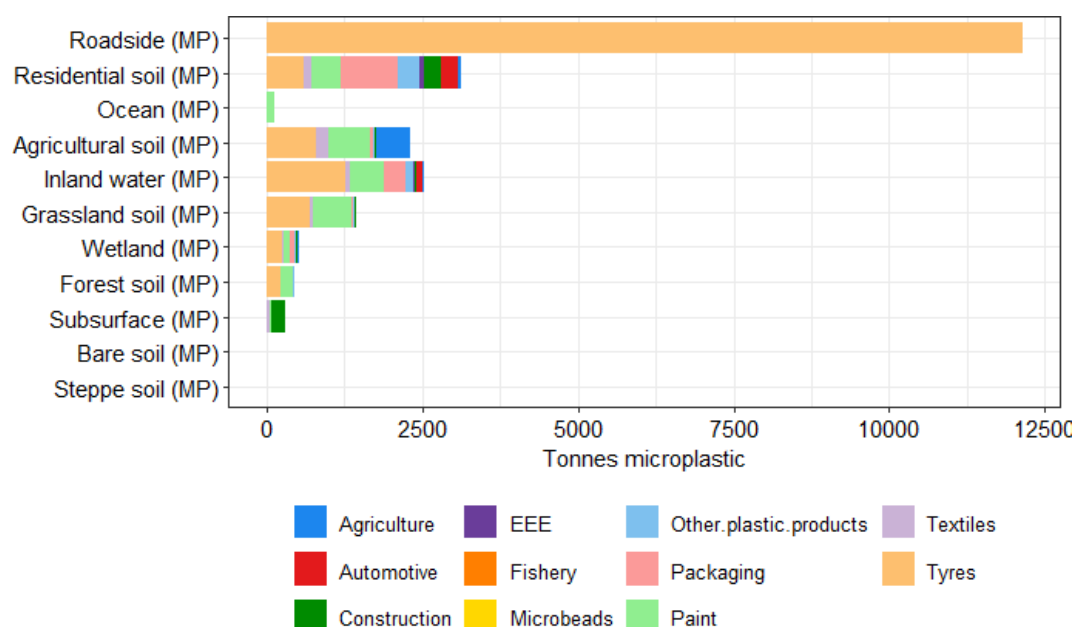
**Figure 10.** Microplastic emissions to the environment for the Netherlands in 2017, assessed through material flow analysis (Schwarz et al., 2023).

When comparing the yearly offshore wind turbine emissions to other microplastic emission sources in the Netherlands, wind turbines only contribute to small amounts to the total emissions. In 2017, around  $23 \text{ kt}$  of microplastics was directly released into the environment in the Netherlands, with approximately  $70 \%$  of that total originating from car tires (see Fig. 10). This value excludes any macroplastic emissions ( $> 5 \text{ mm}$ ), which include littering and improper waste management practices, such as dumping of (plastic) waste. Figure 10 indicates that microplastic losses from Dutch fisheries are assessed to be minimal. Additionally, we
